A Likely Weather Factor in the United Flight 169 Accident, Newark Liberty International Airport, 3 May 2026

Cruces Atmospheric Sciences Forum
16 May 2026

Bottom Line Up Front:

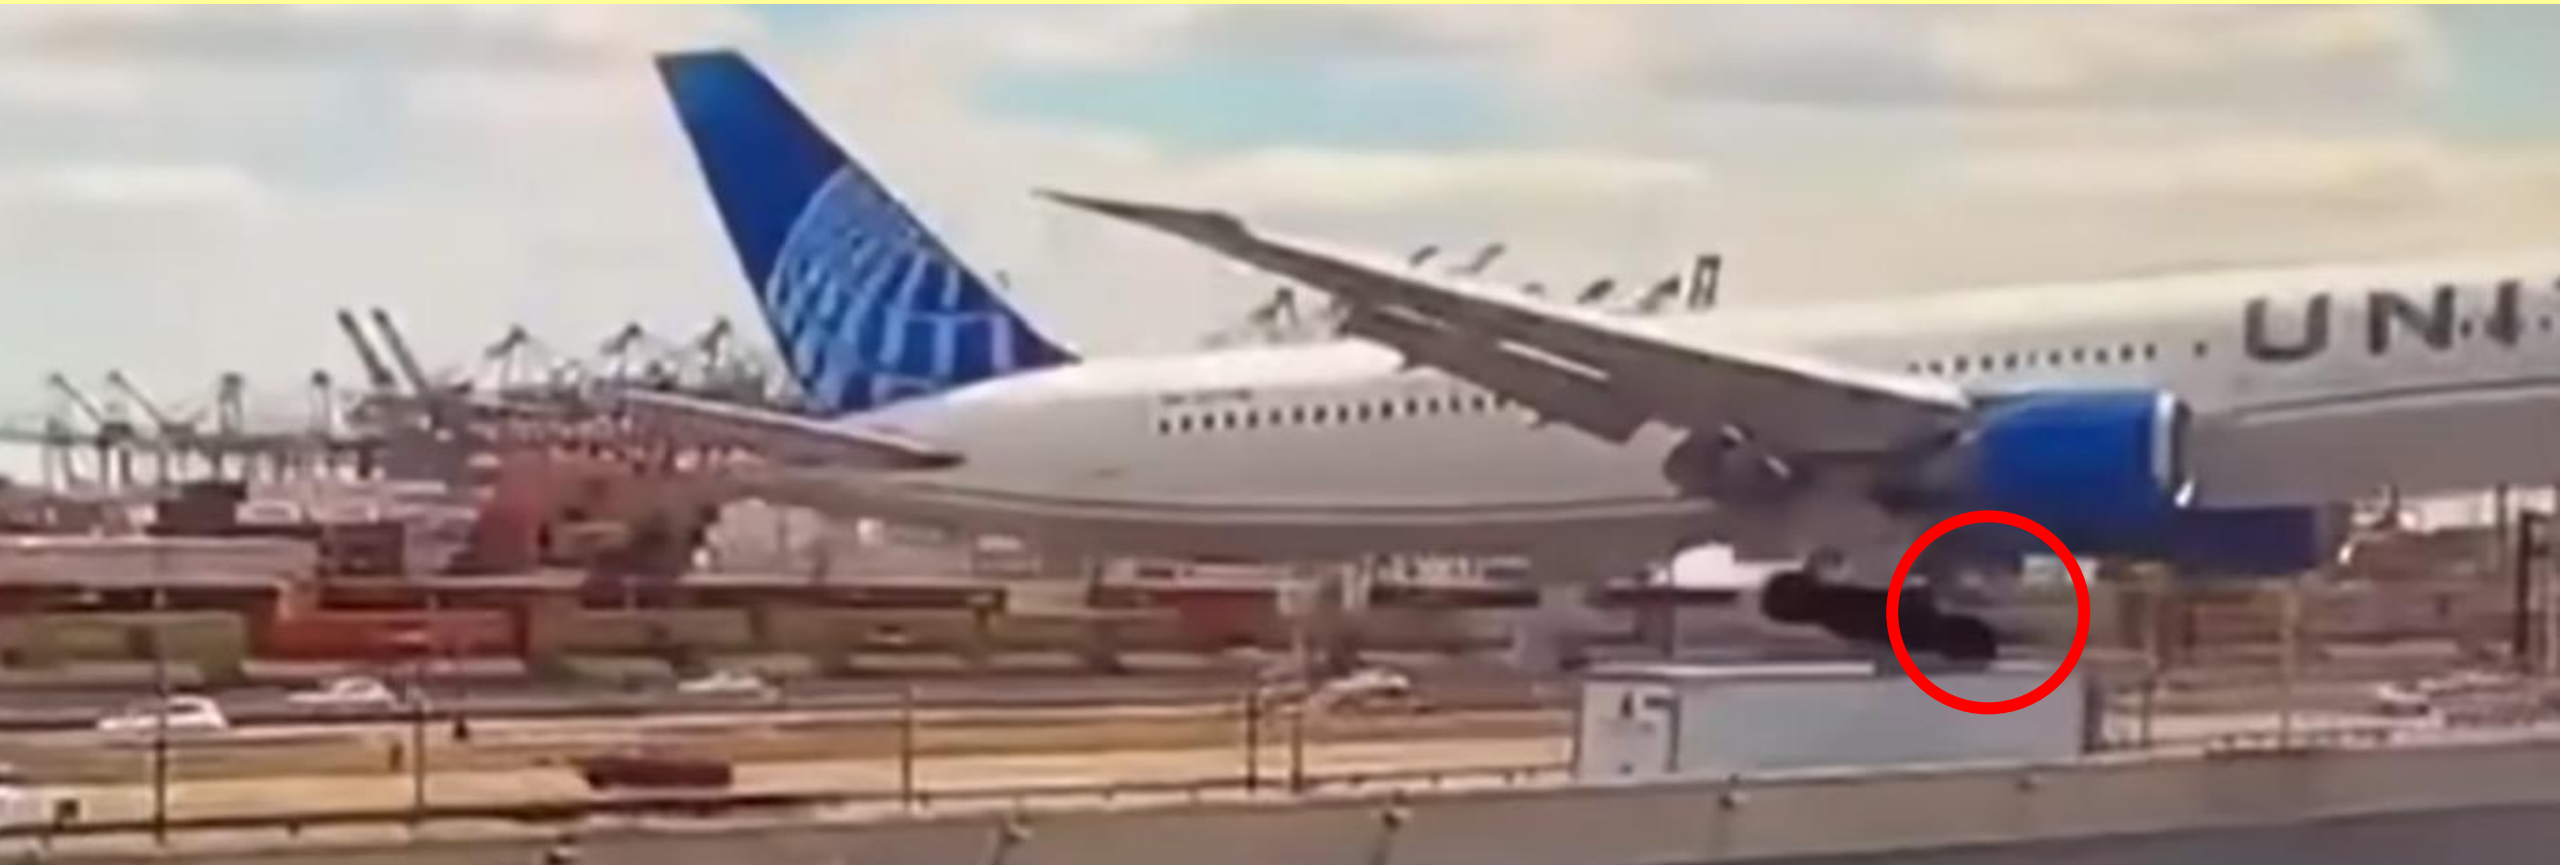
Accident was caught on video. This frame shows the Boeing 767-400 ER grazing the roof of a semi-trailer on the New Jersey Turnpike while landing, on the afternoon of 3 May 2026.

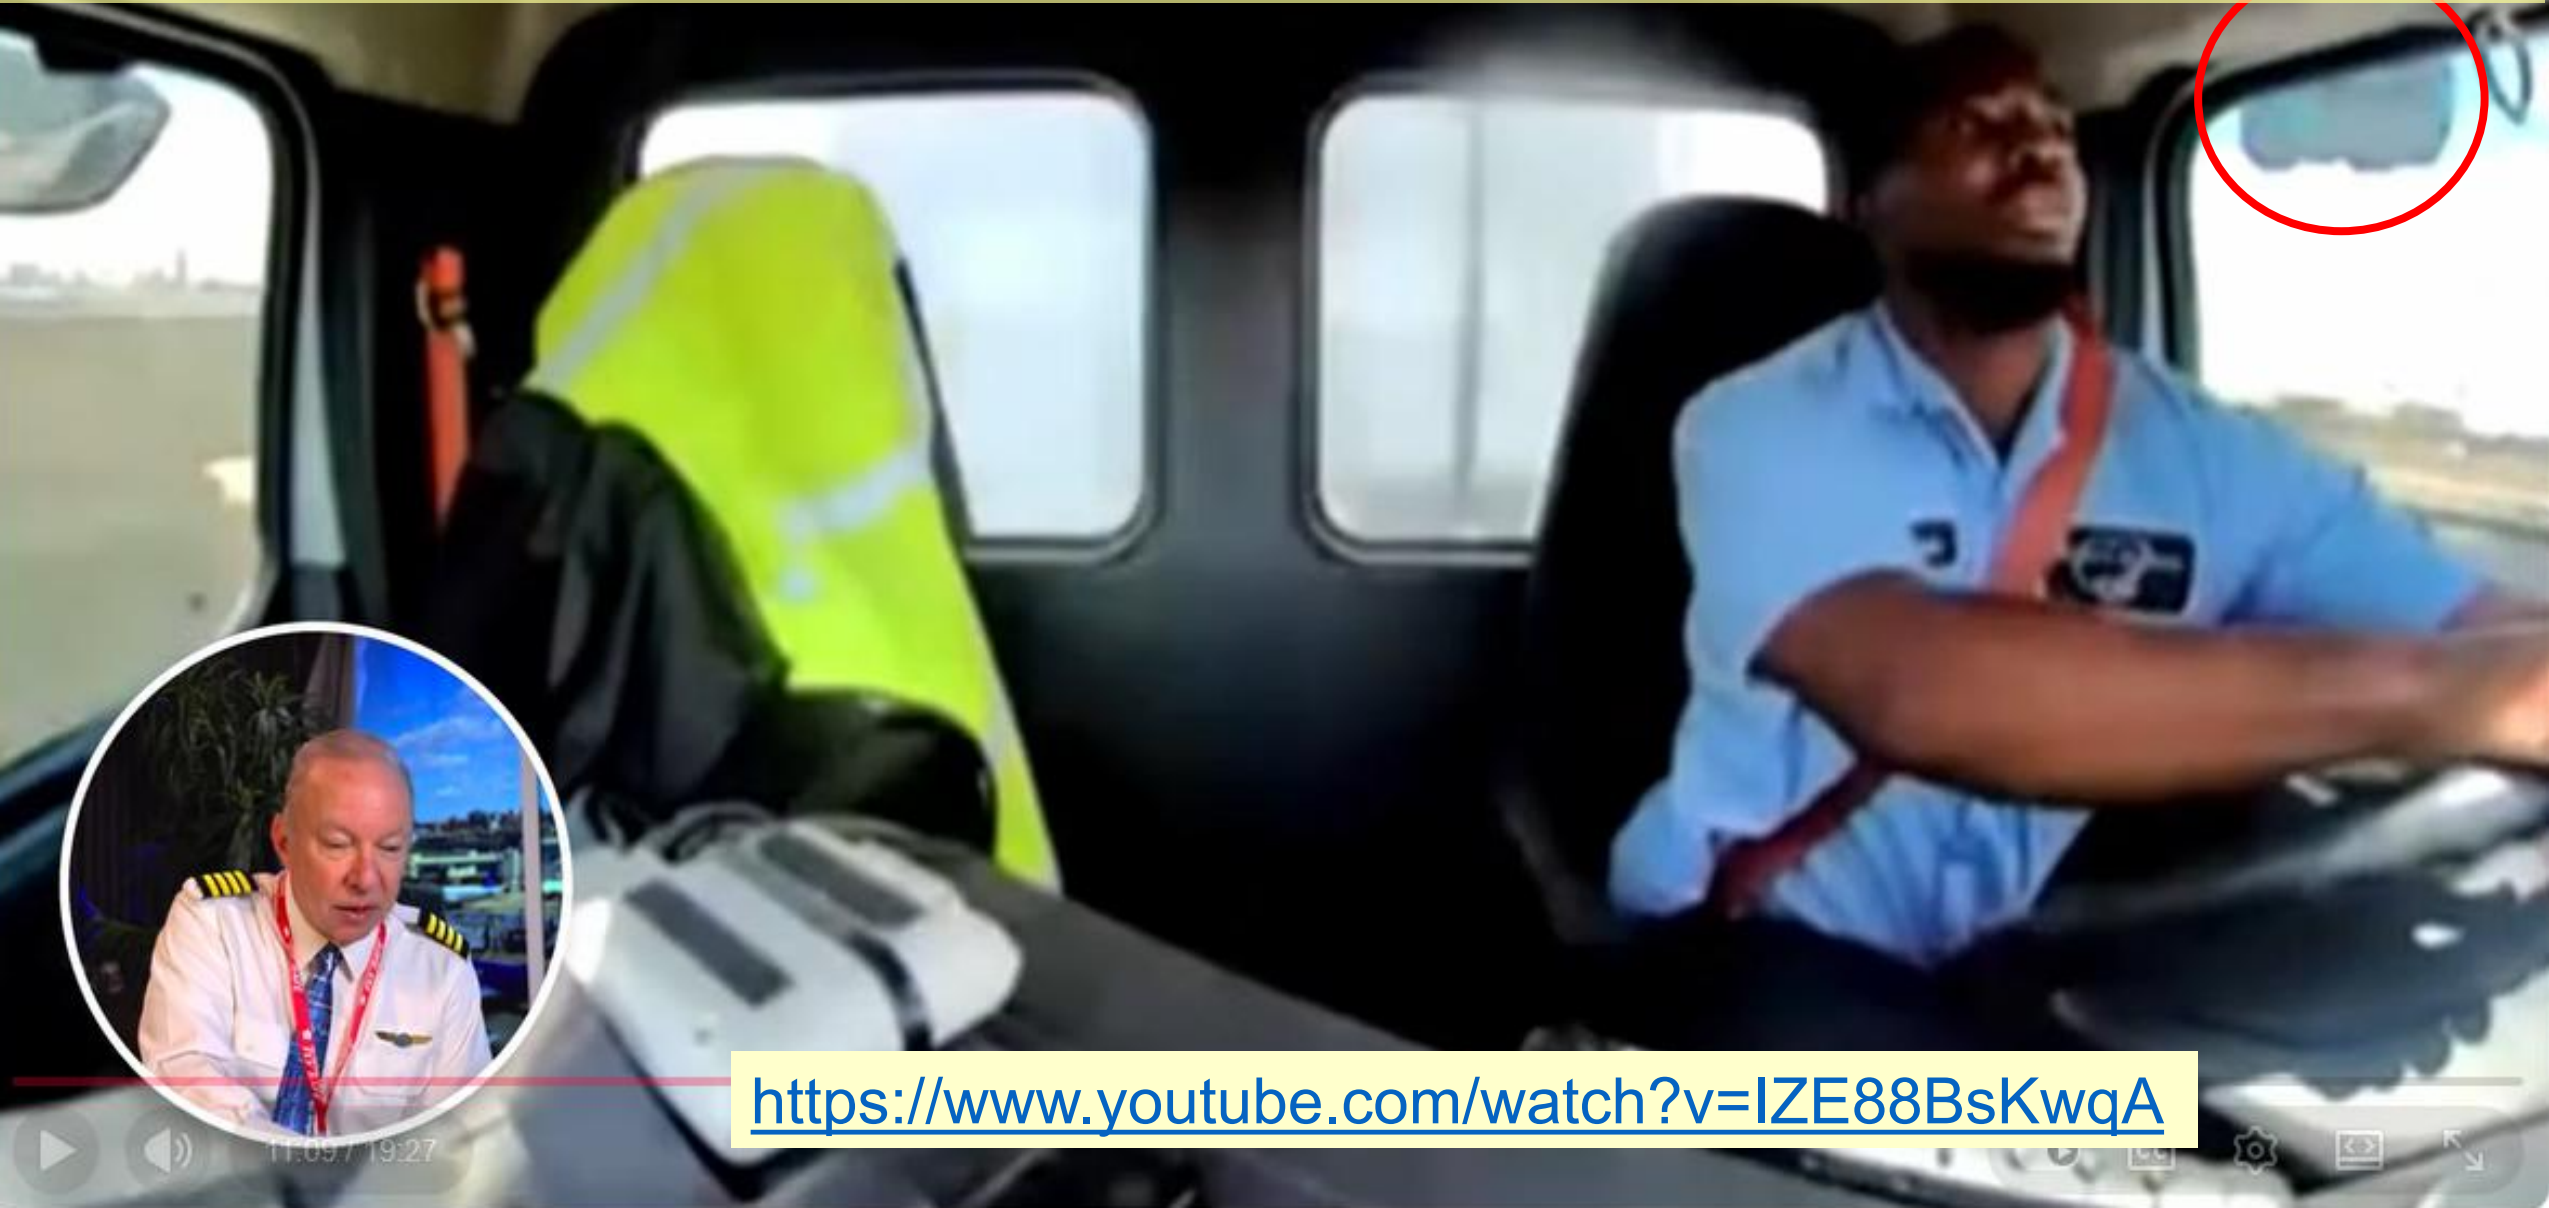
Red circle appears to show landing gear and tires of United Flight 169 at Newark just as the B-767 was grazing the Bakers Express semi.

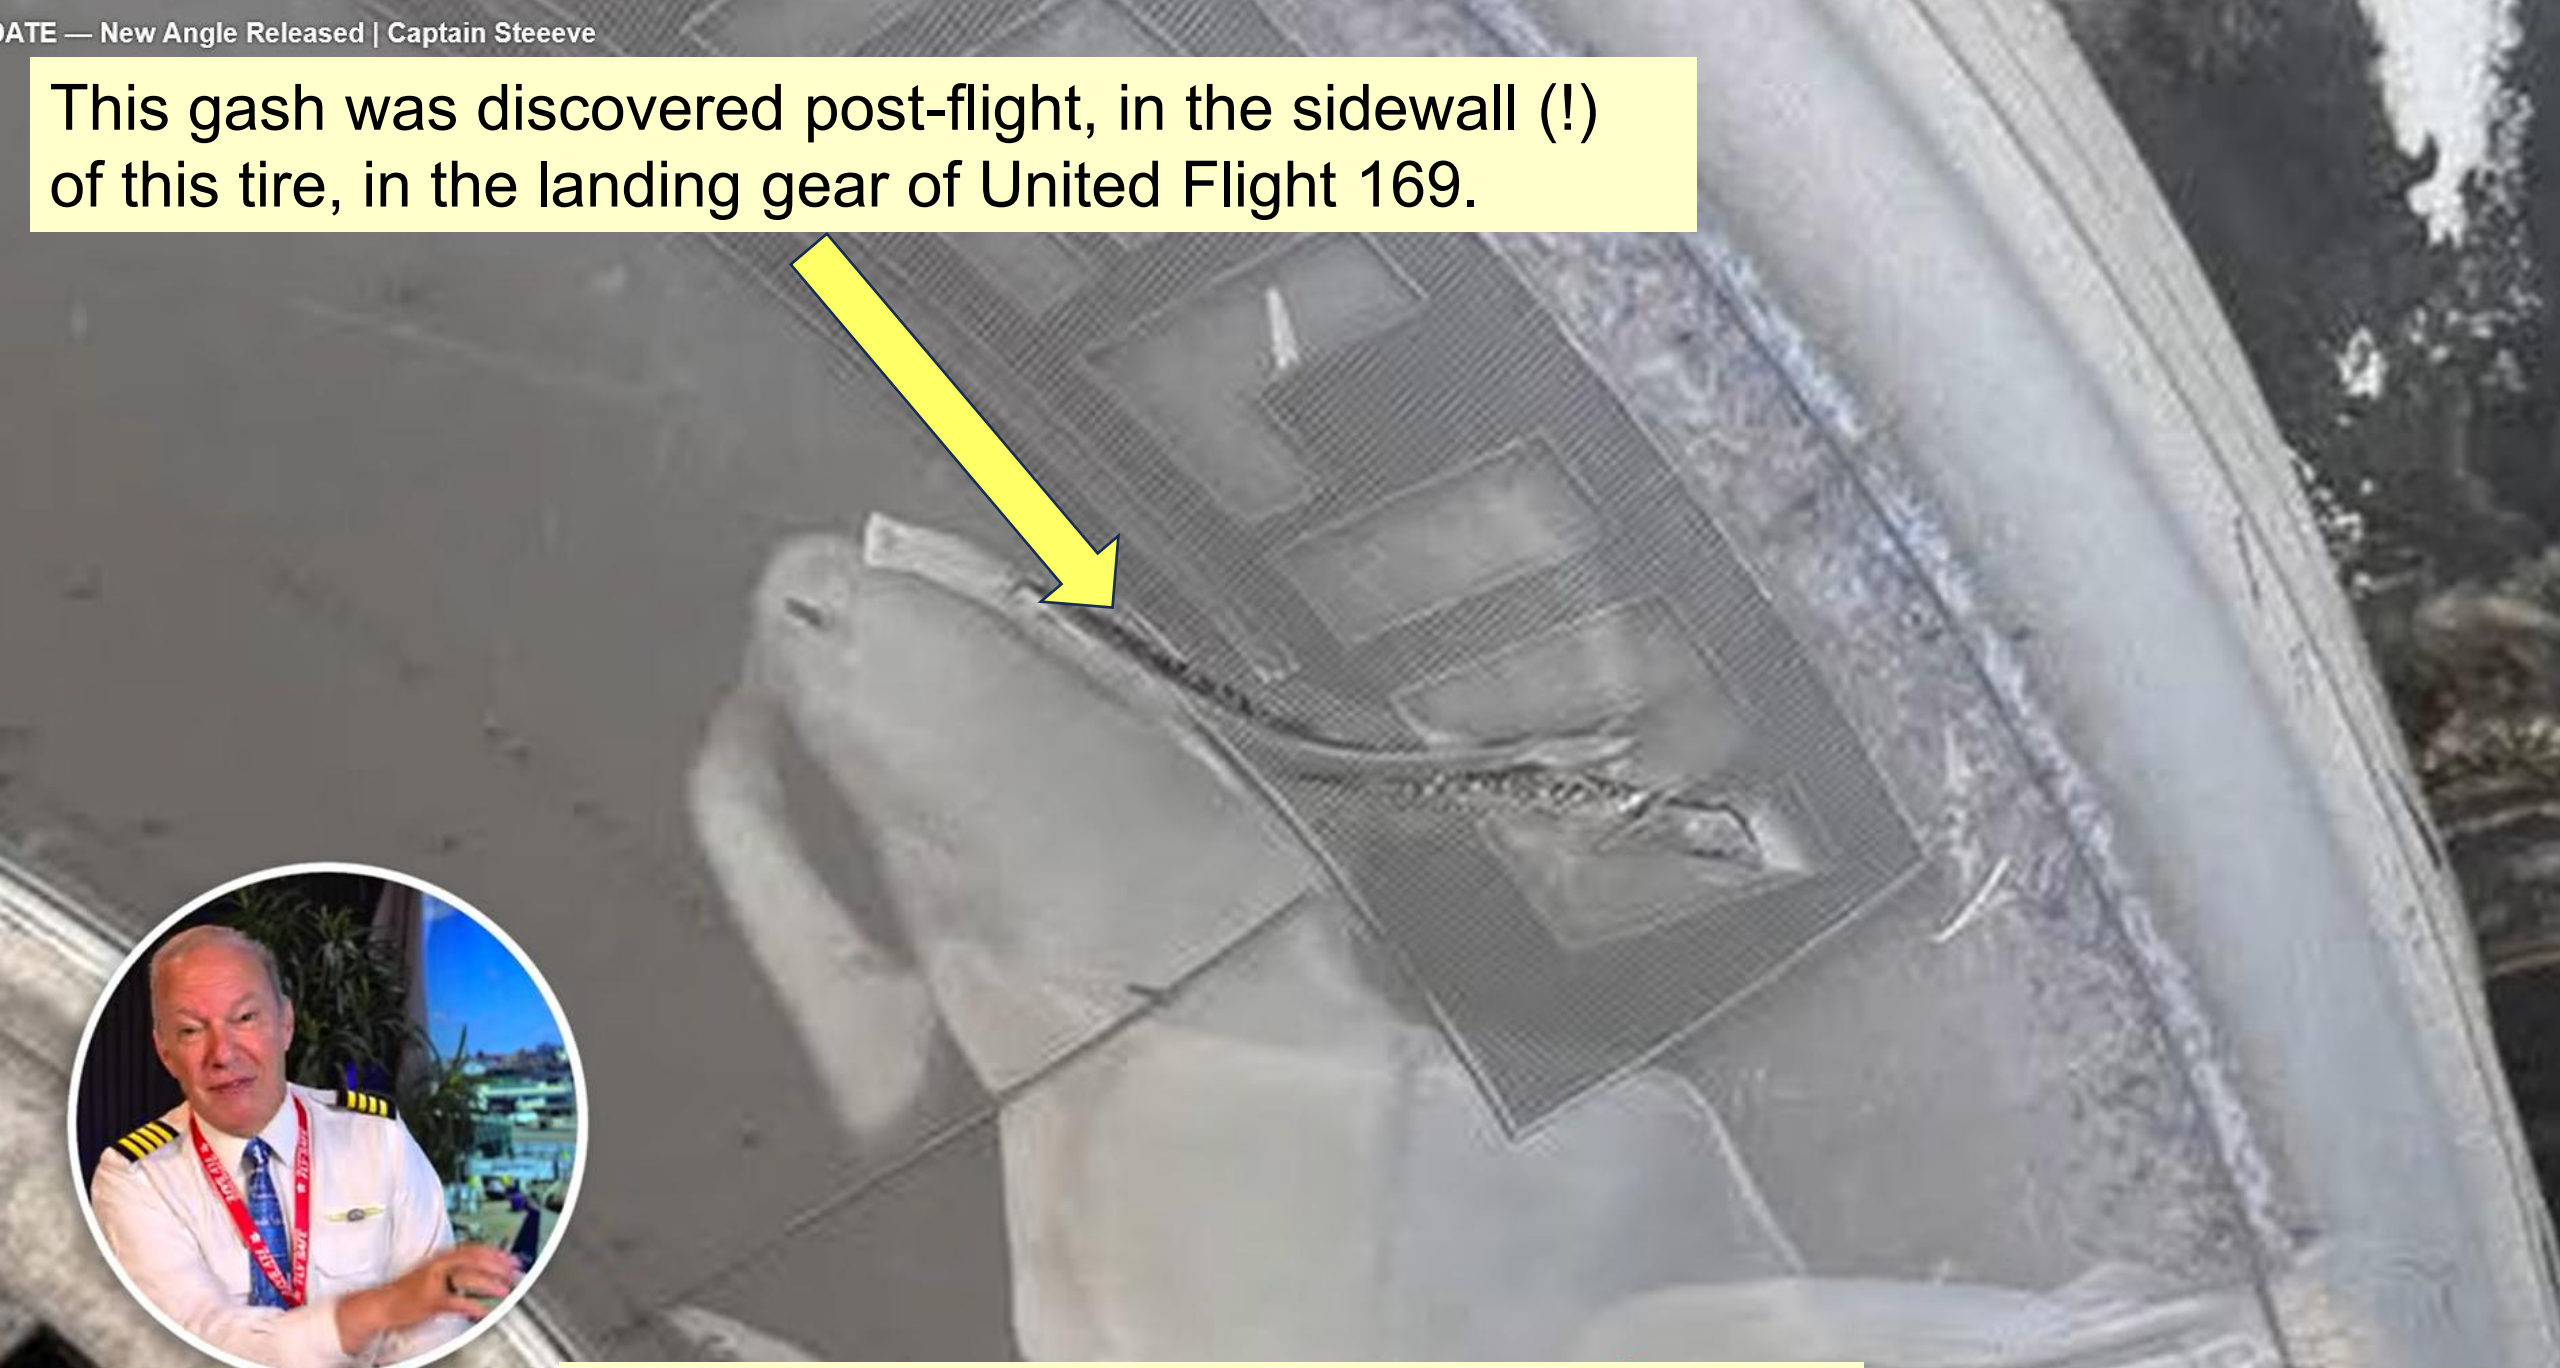
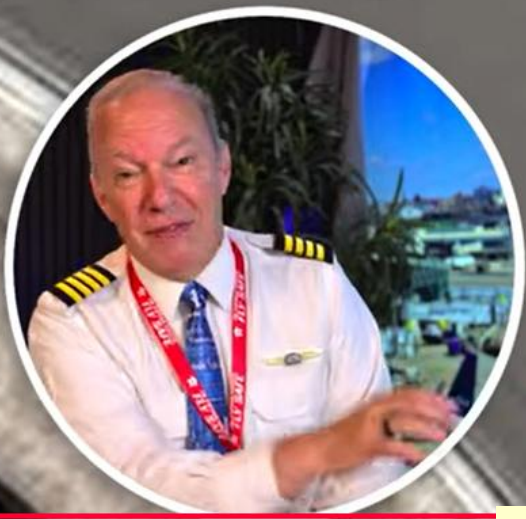
This gash was discovered post-flight, in the sidewall (!) of this tire, in the landing gear of United Flight 169.

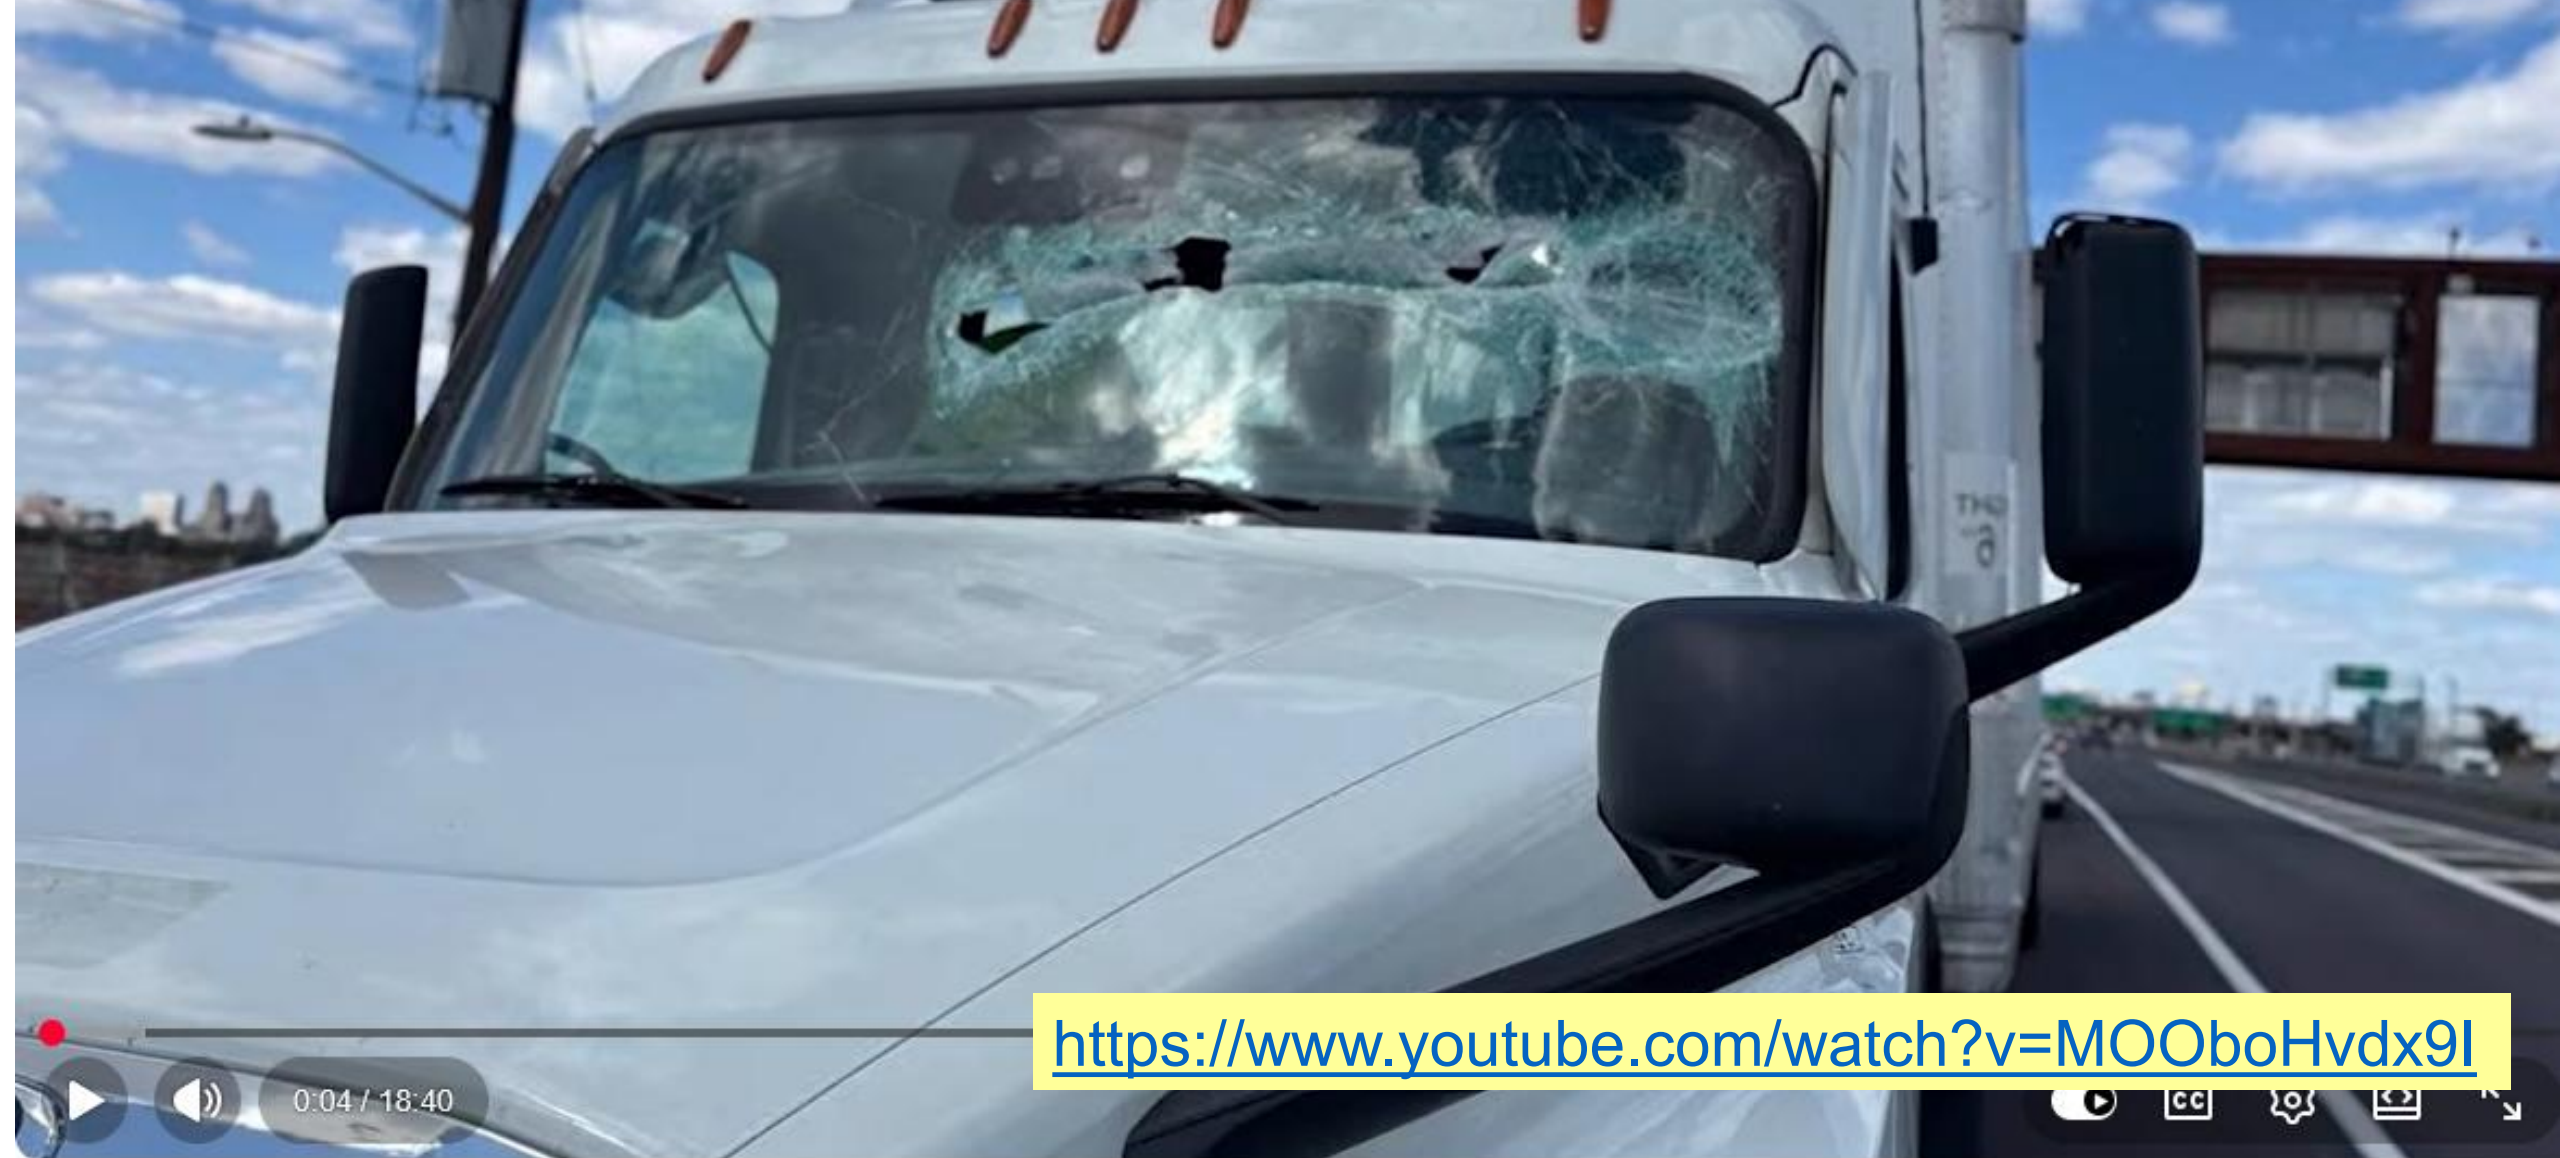
After United Flight 169 struck the light pole on the New Jersey Turnpike, did that pole also strike the Bakers Express semi-trailer, leaving this damage to the truck? Truck is parked to the side of the Exit Lane of the NJTP.

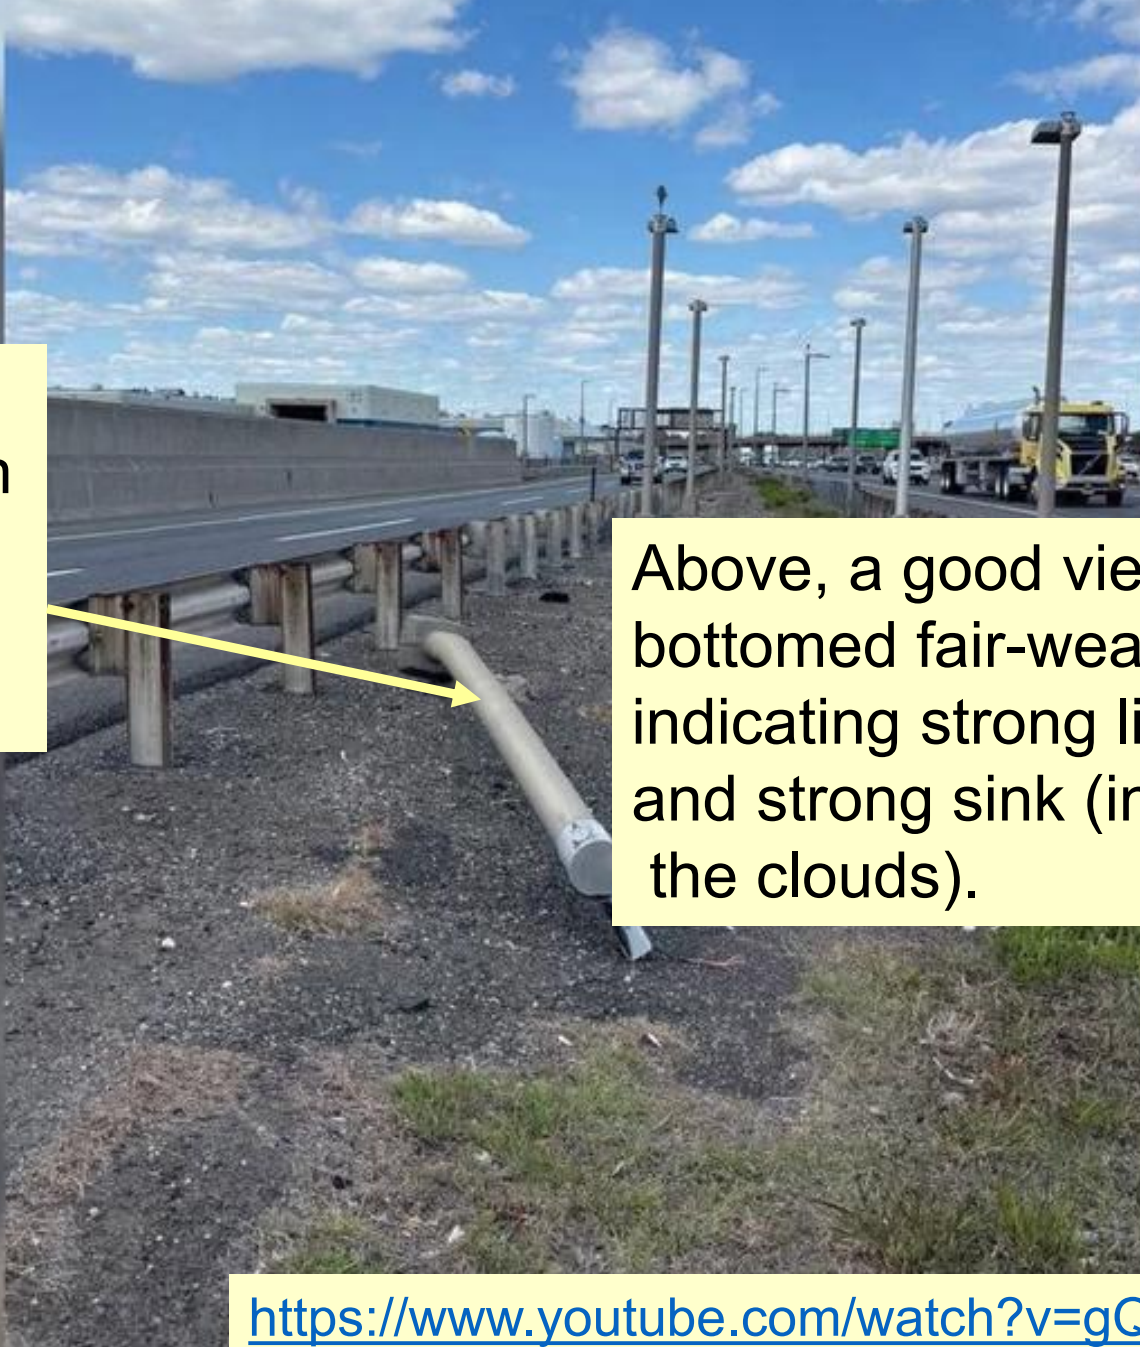
Looking North:
Broken light pole found in
exit lane divider of the
New Jersey Turnpike
after the accident.

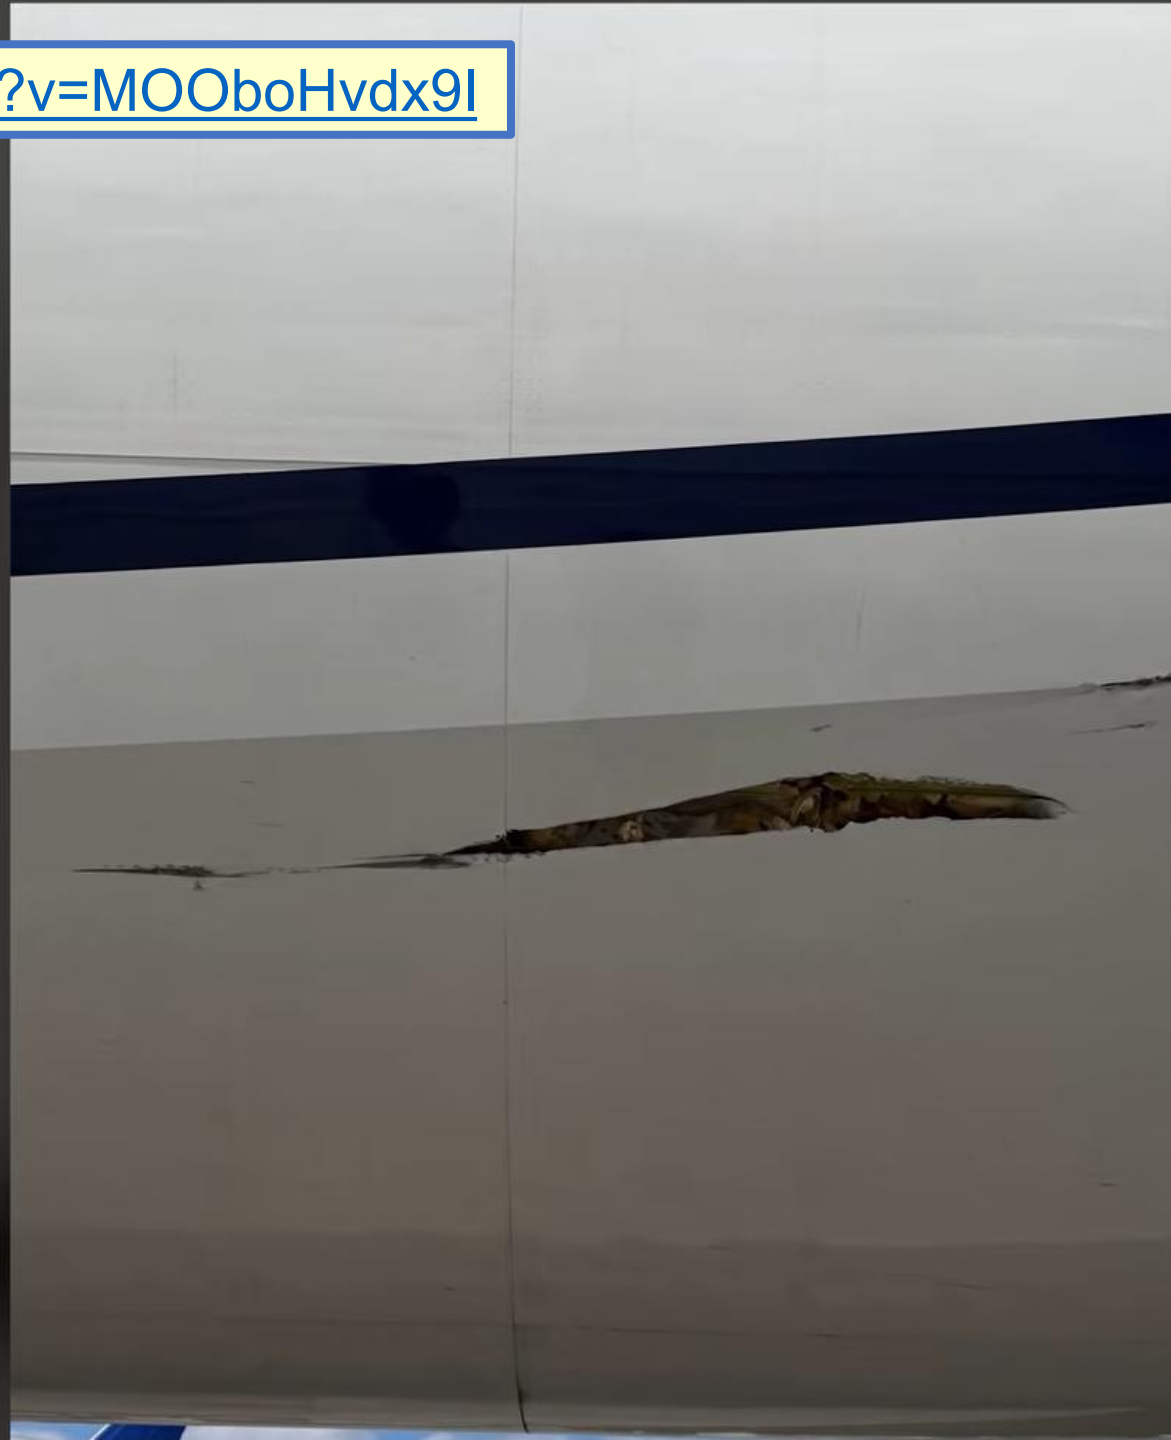
Gash in the side of the Boeing 767-400 ER found during the post-flight inspection of the aircraft, indicating it struck an object on the ground while landing at Newark.

Was this gash left by the aircraft striking part of the light pole?

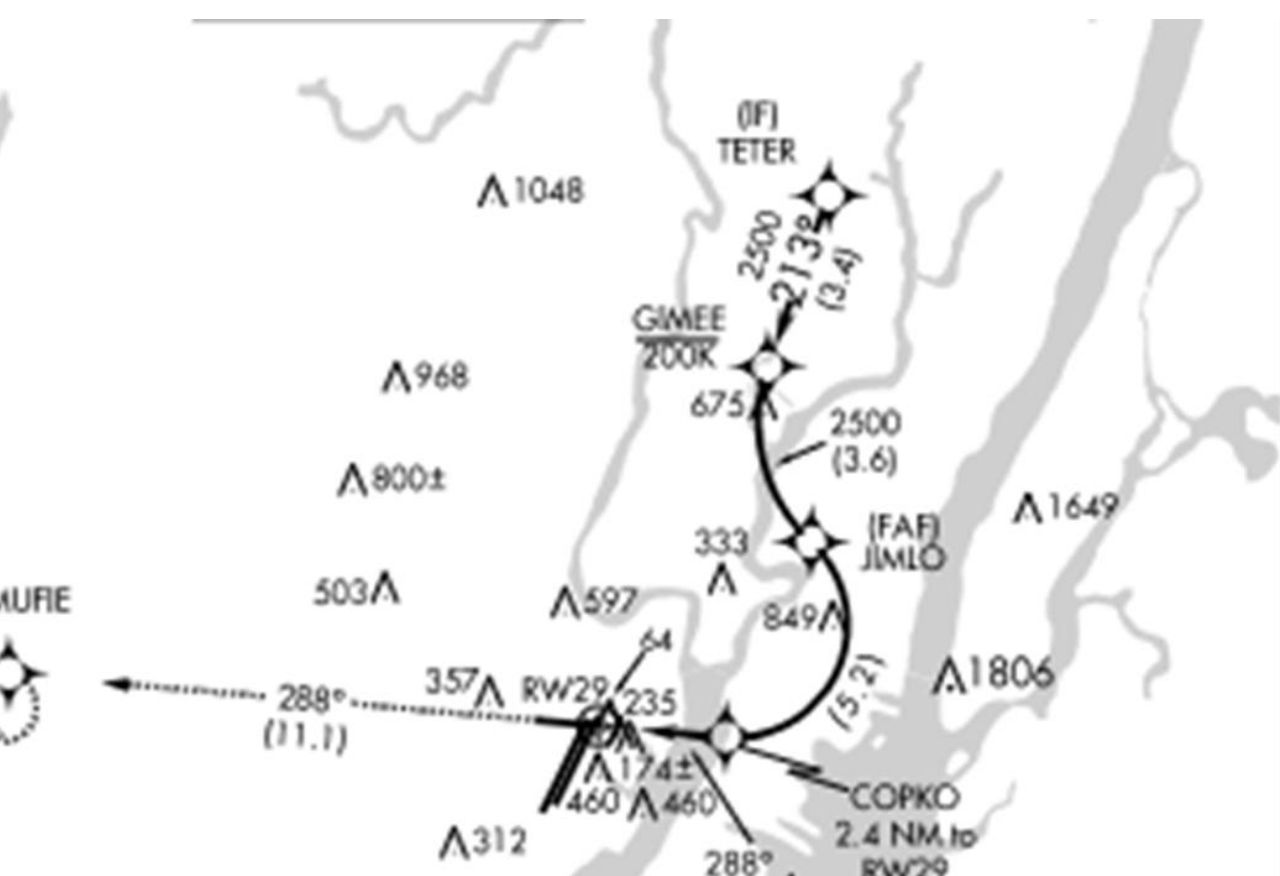
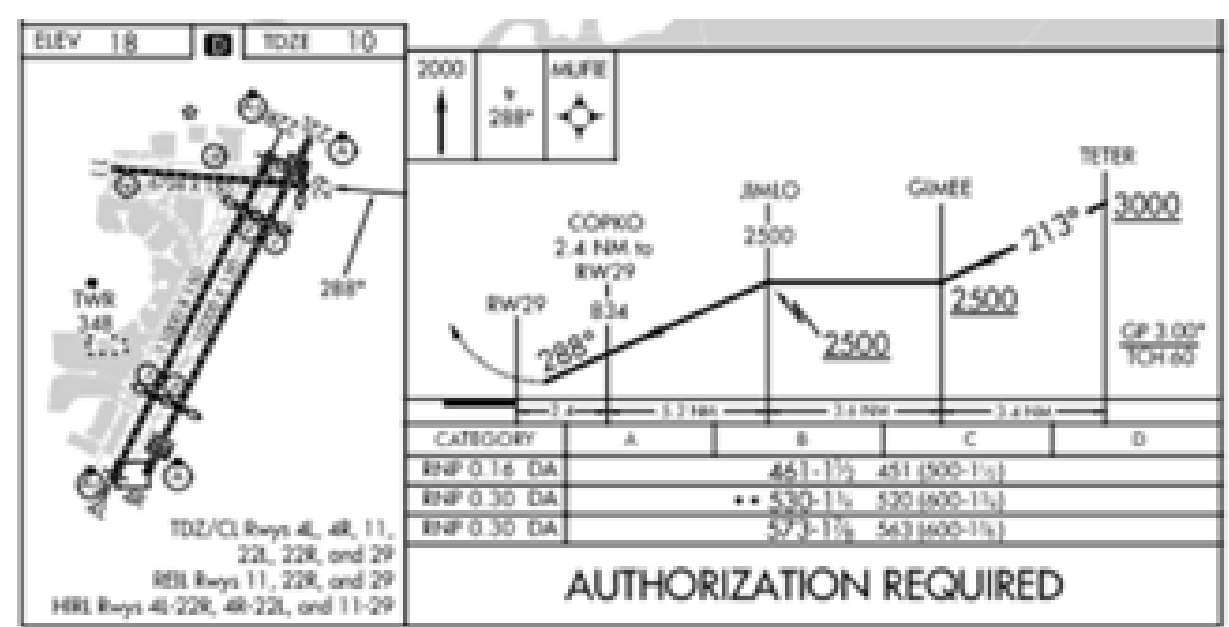
This is, to me, one clue that the strong sink was present as he crossed Newark Bay.

Here are the updrafts and downdrafts, the sinking air I posited at the beginning.

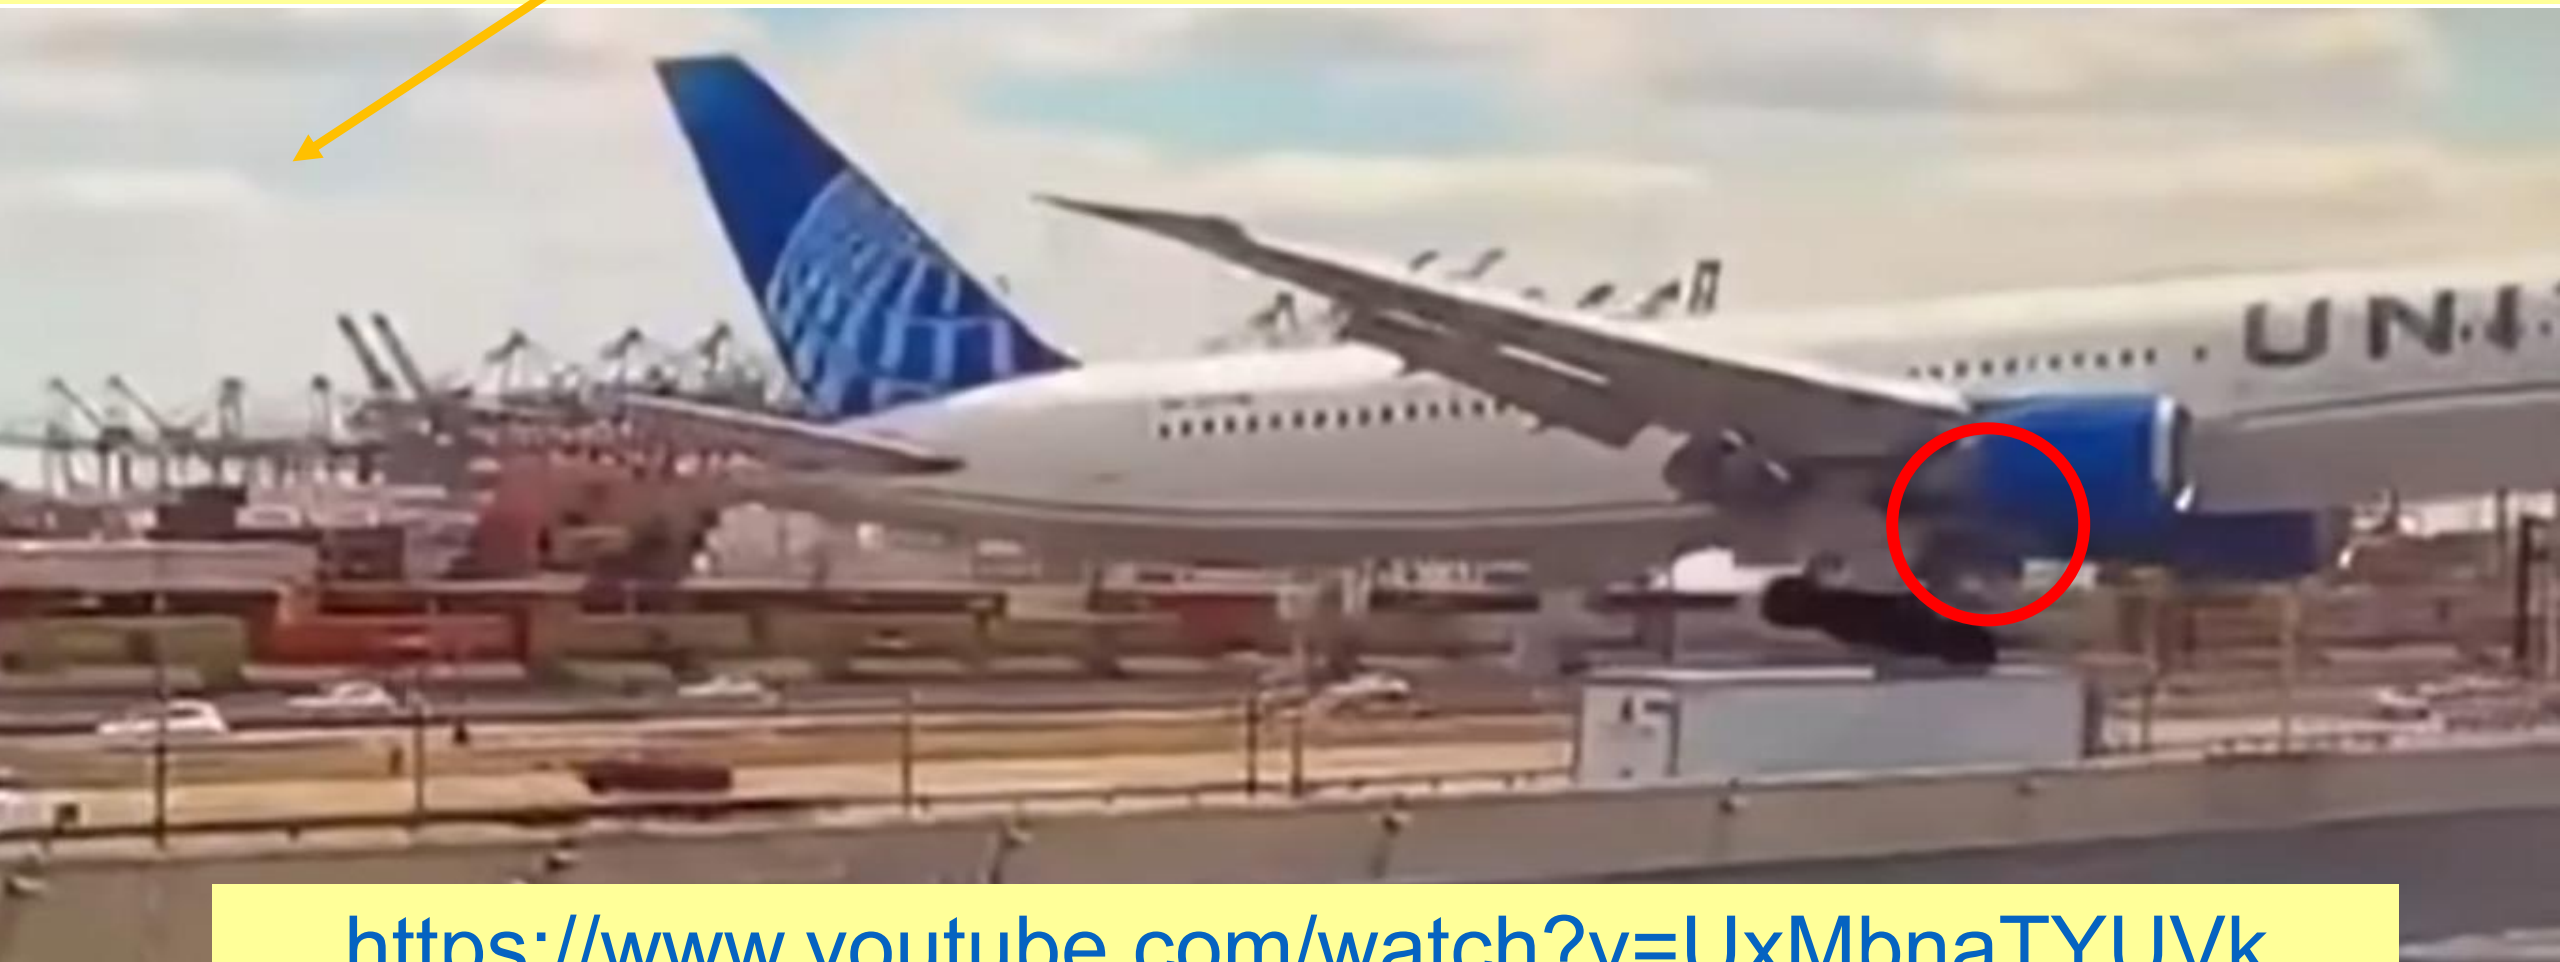
Observe these cumulus clouds on the afternoon of 3 May 2026. To me they indicate weak convection **over the water**, with “soft” cloud bases, sides and tops, indicative to me of weak convection which developed over Newark Bay, New Jersey’s Meadowlands and other nearby water surfaces.

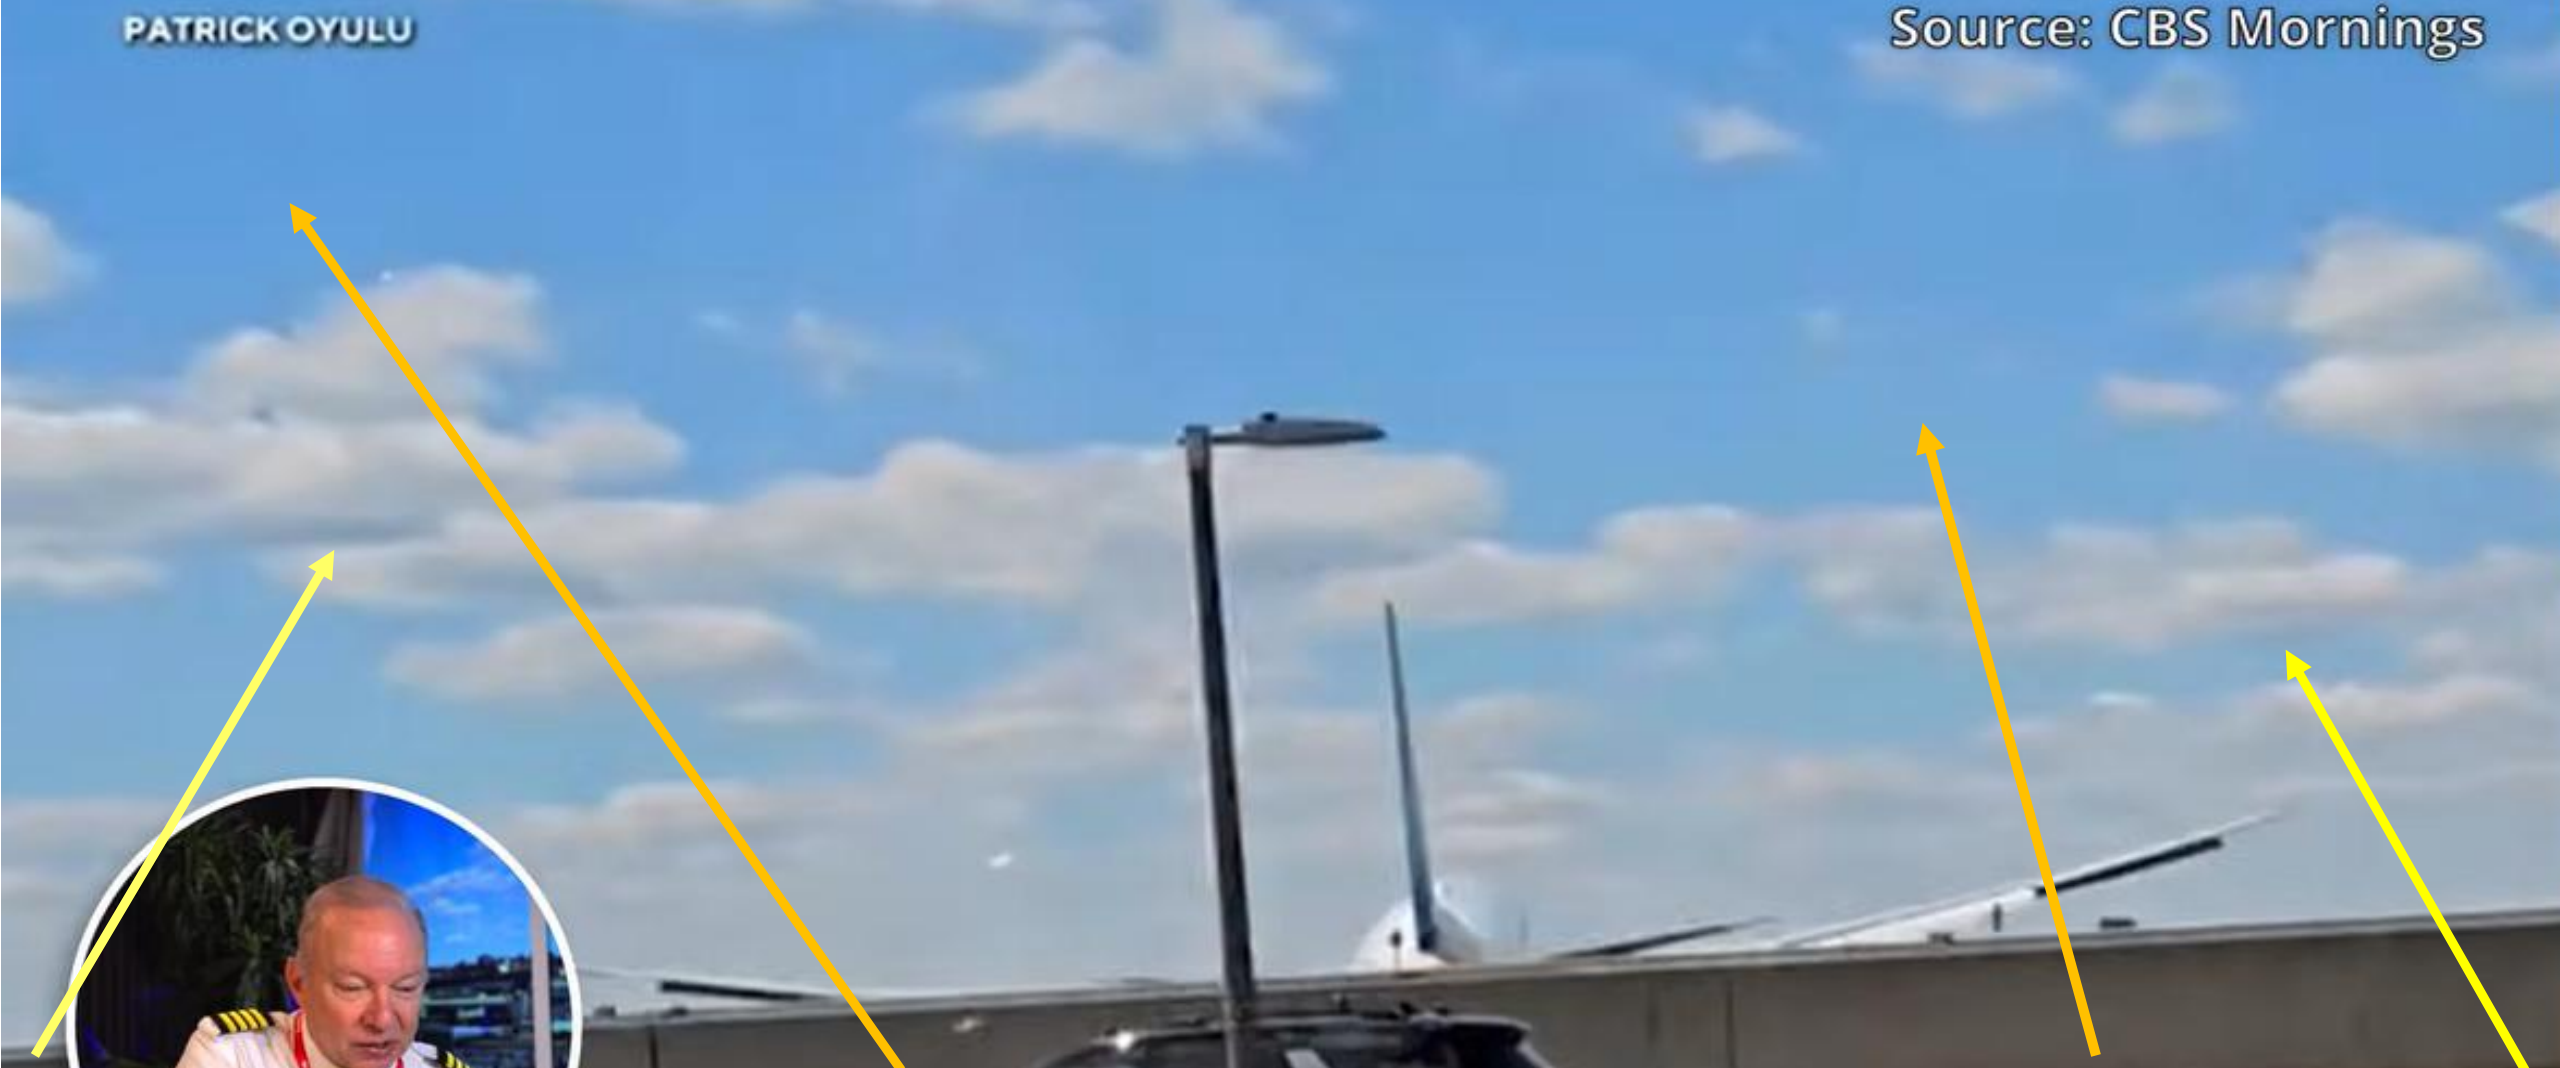
Notice at least three things in this image, to the west, over solid land at, and west of, Newark Liberty International Airport as Flight 169 landed. **ONE**: Cloud bases of the darker-bottom cumulus clouds are flat-bottomed, indicates much stronger lift and sink (Yellow Arrows). **TWO**: These clouds are scattered, not broken. **THREE**: Indications of a “Blue Hole” (Orange Arrows) over land, near the airport.
