Climatology and Weather Effects in the early Ground War in Russia's Invasion of Ukraine

Bob Endlich

Cruces Atmospheric Sciences Forum

19 March 2022

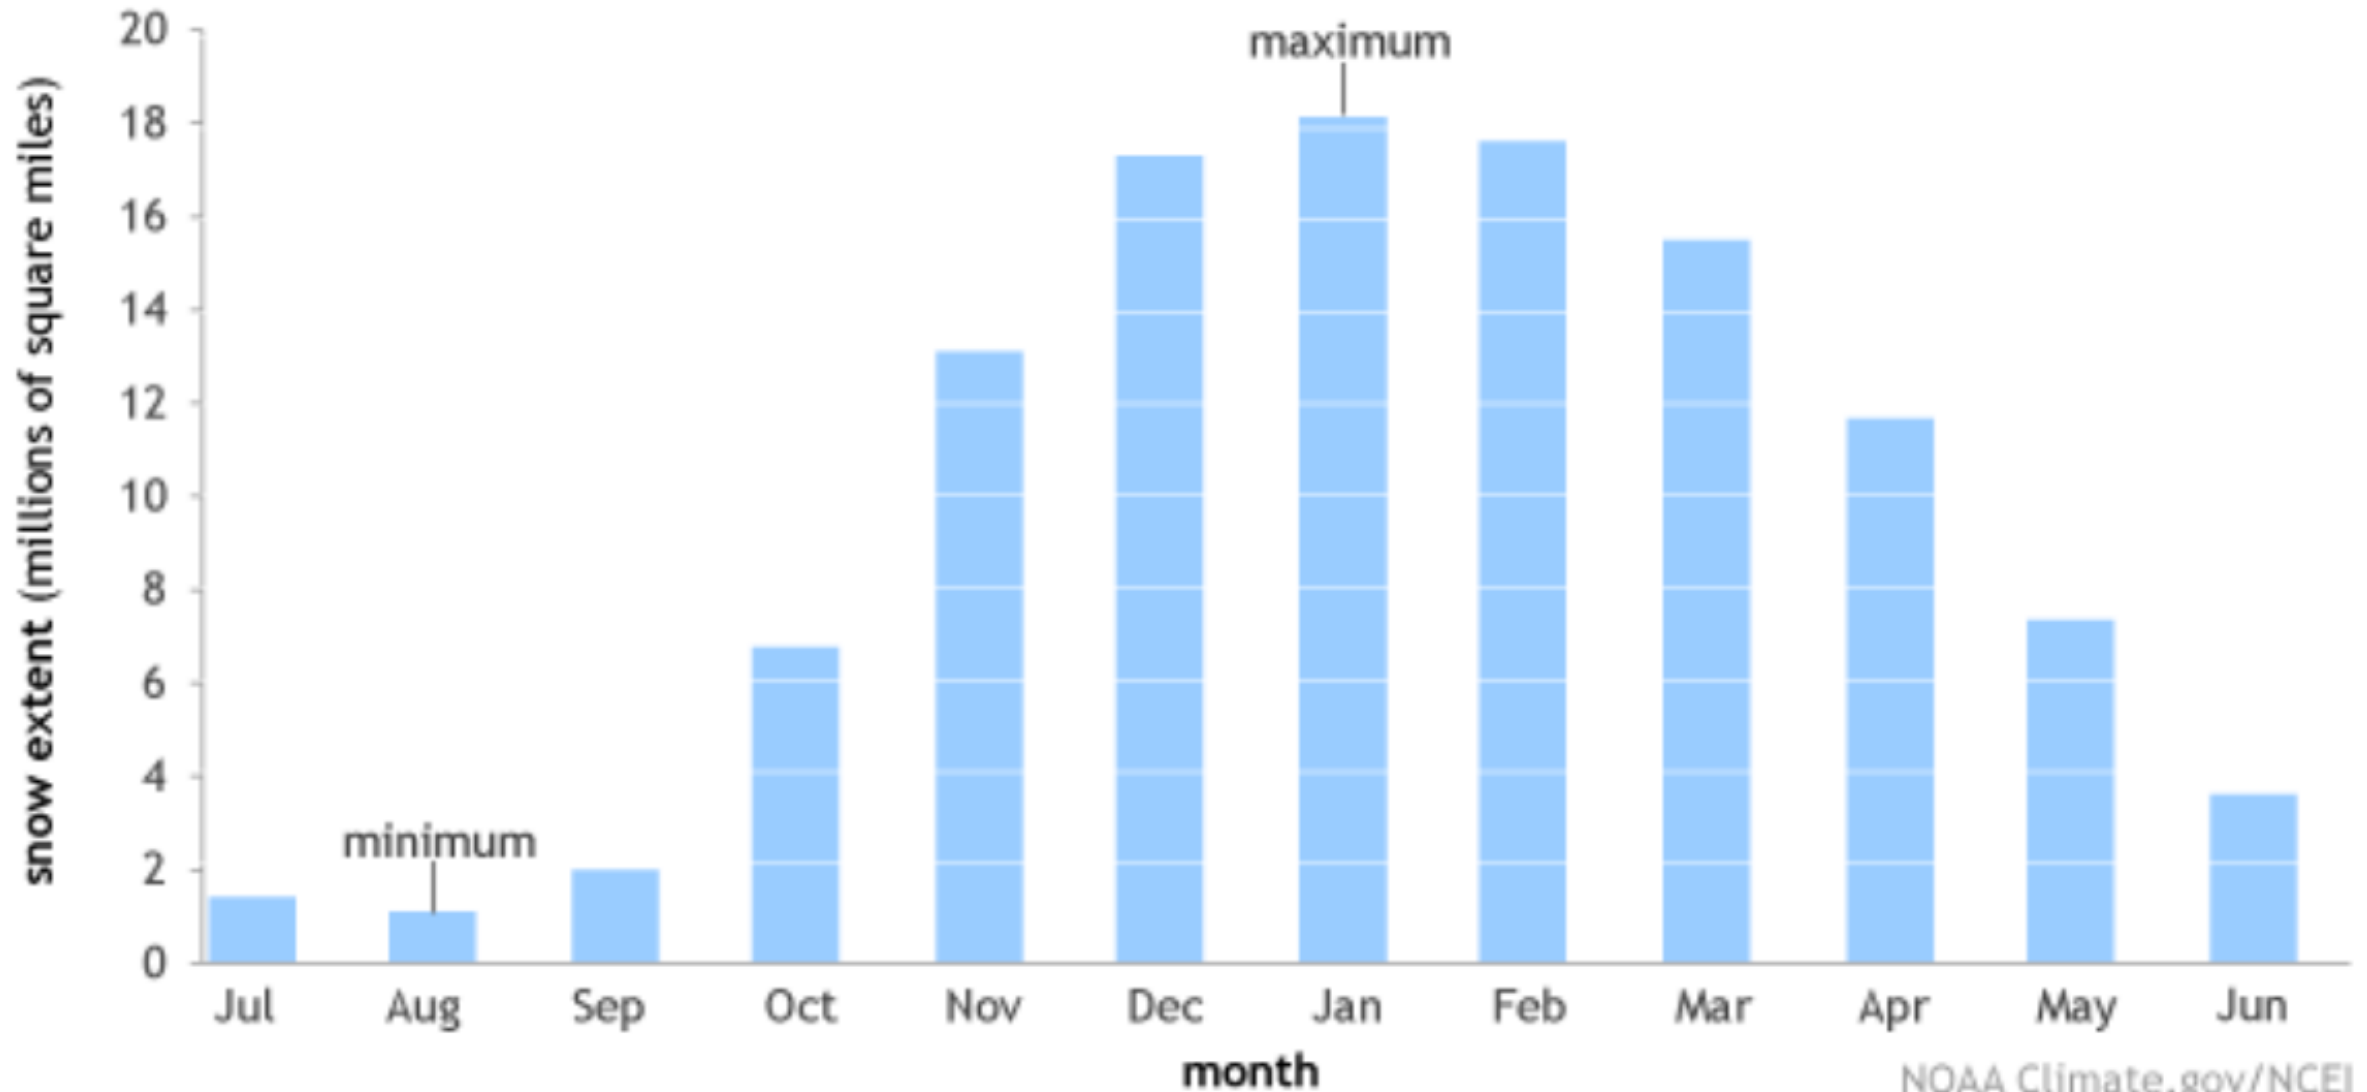
Average snow extent in Northern Hemisphere

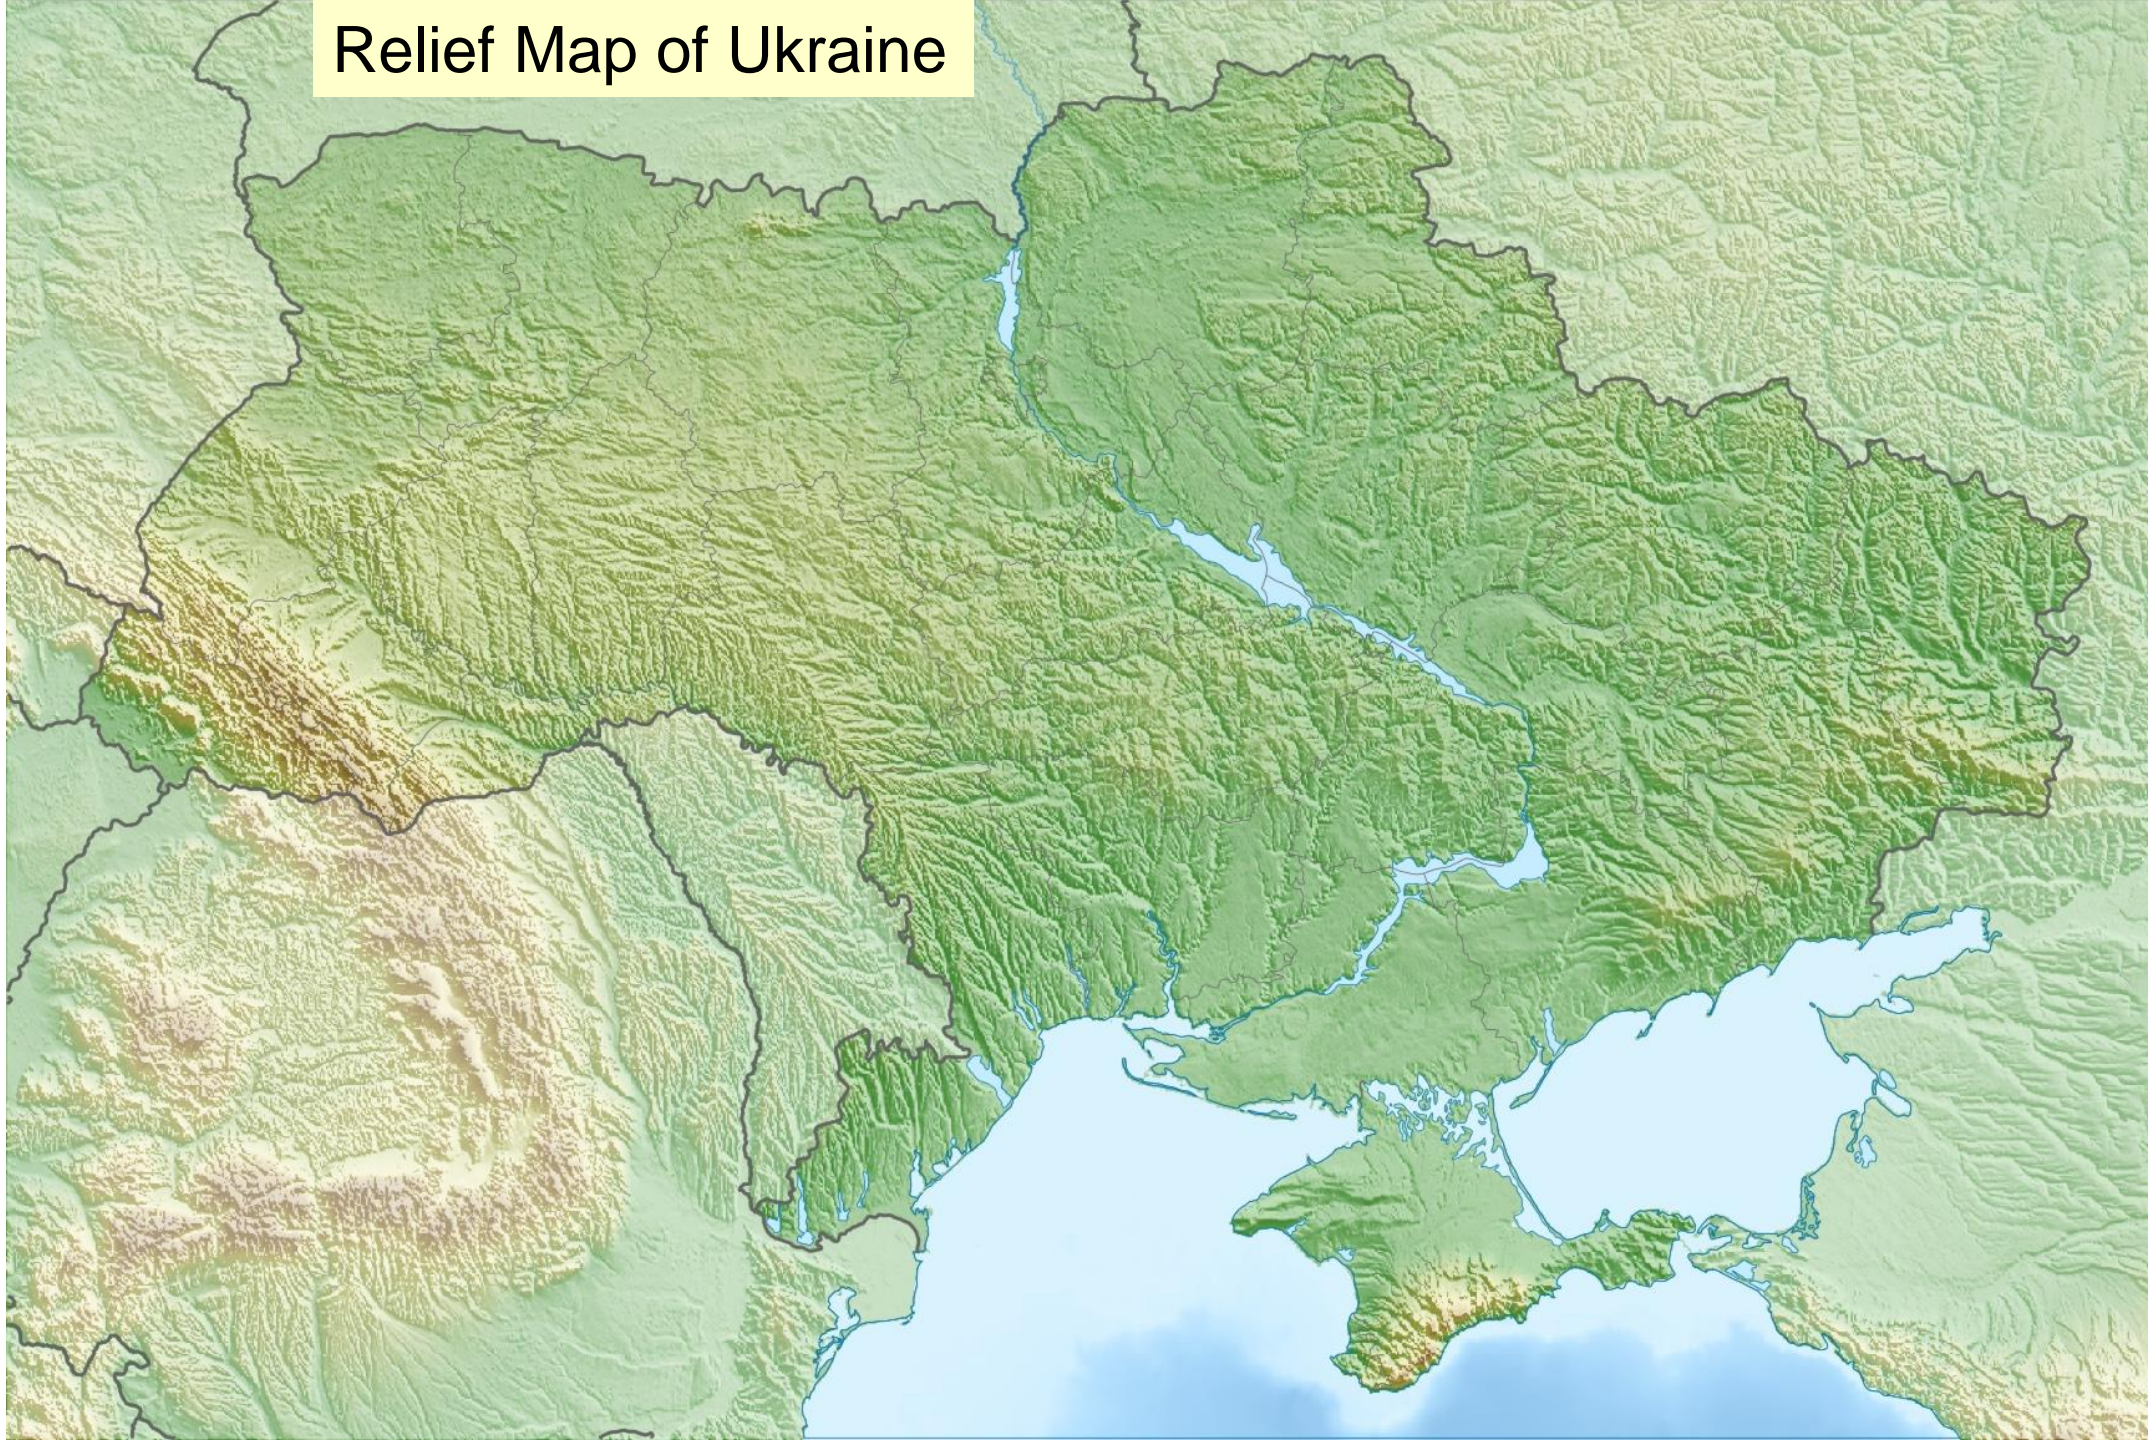
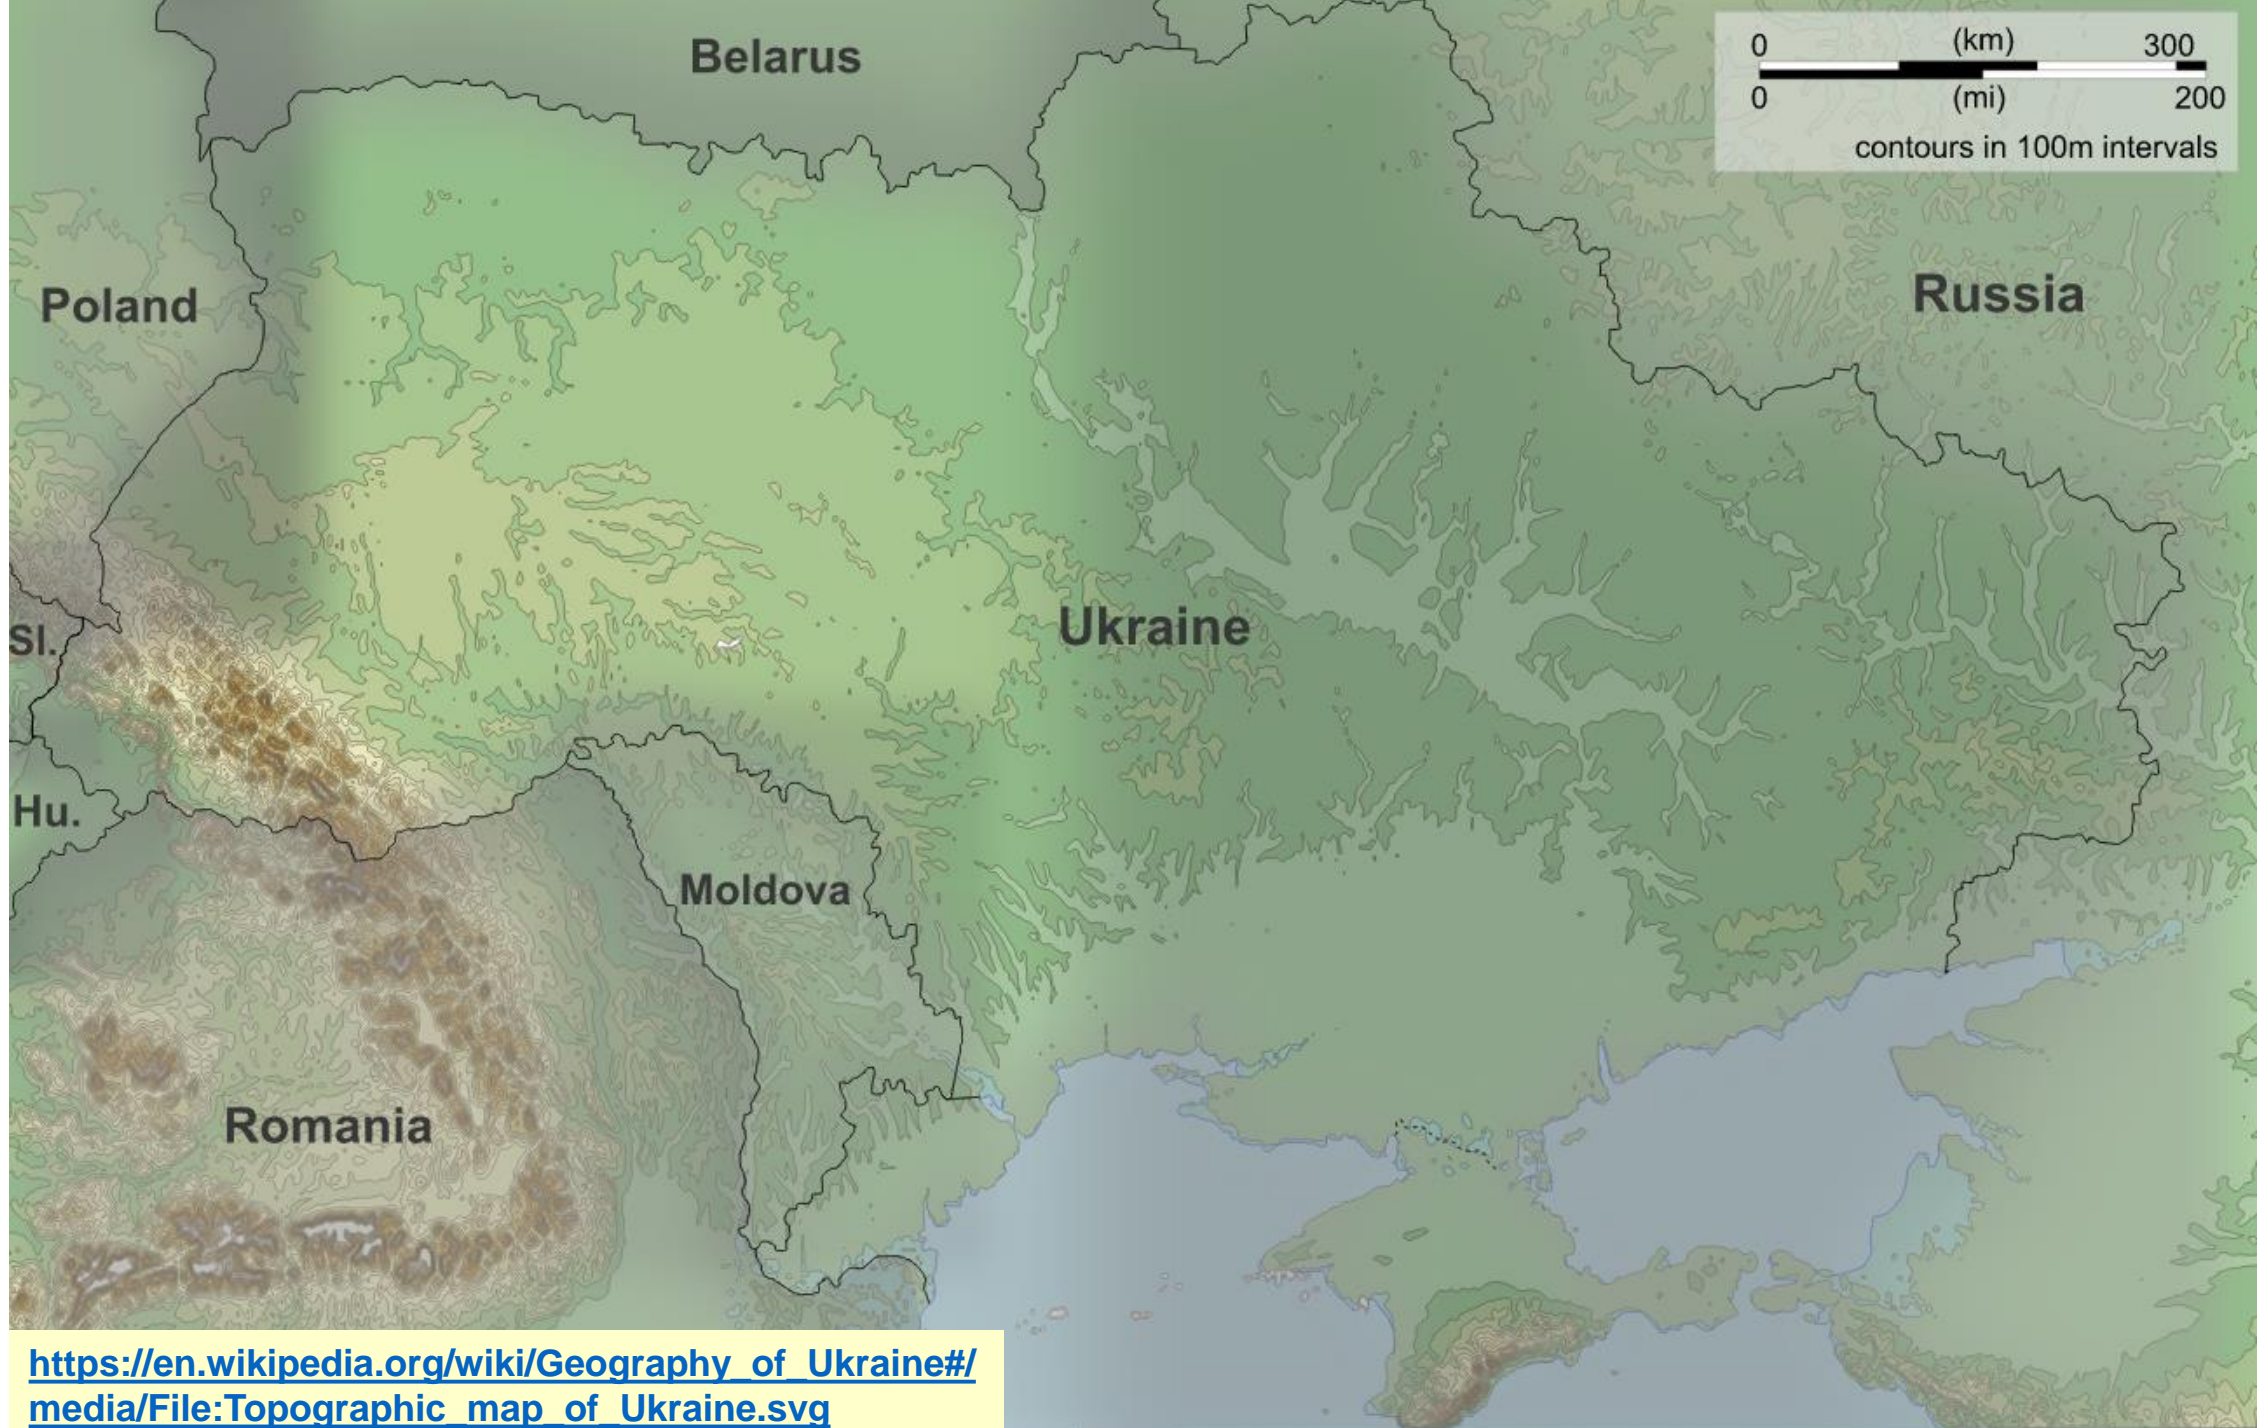
Relief Map of Ukraine

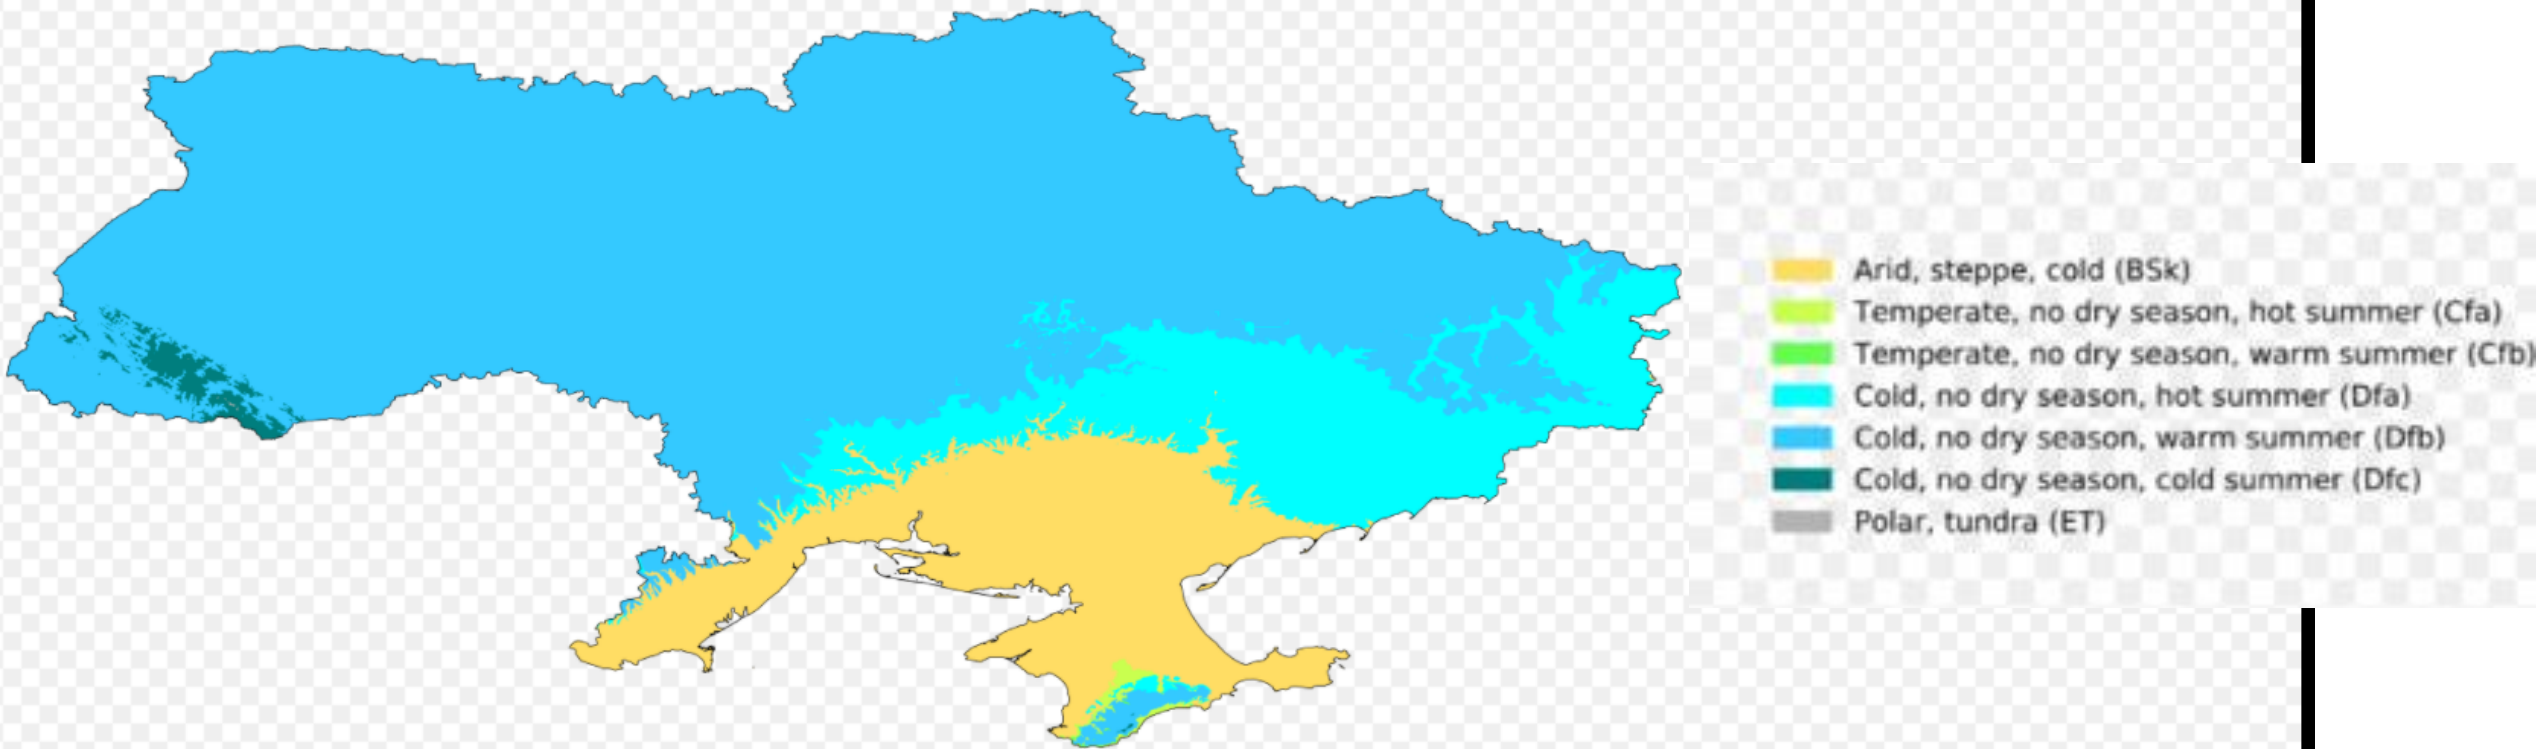
Köppen-Geiger climate classification map for Ukraine (1980-2016)

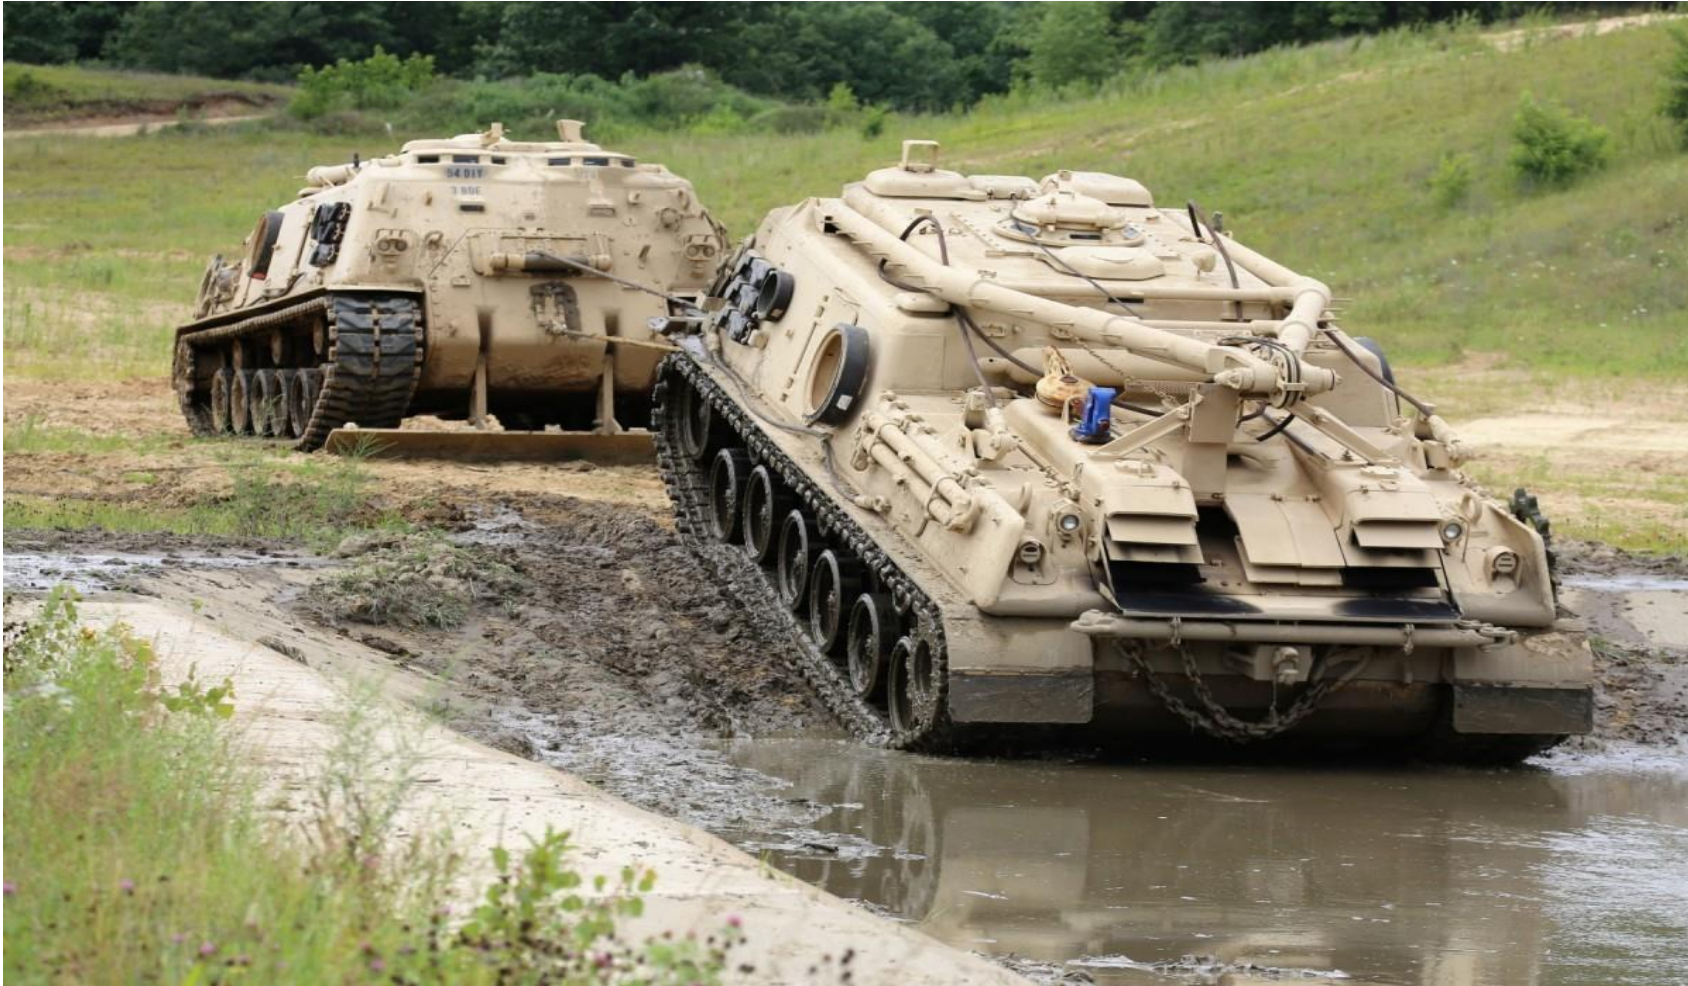
Students in the Regional Training Site (RTS)-Maintenance Tracked Vehicle Recovery Course hooked an M88A1 Medium-Tracked Recovery Vehicle to another M88A1 during course operations July 19, 2018, at a training area on North Post at Fort McCoy, Wis.

The M88A1 is a diesel-powered, full-tracked armored vehicle used to perform battlefield rescue and recovery missions. It performs hoisting, winching, and towing operations supporting recovery operations and evacuation of heavy tanks and other tracked combat vehicles.

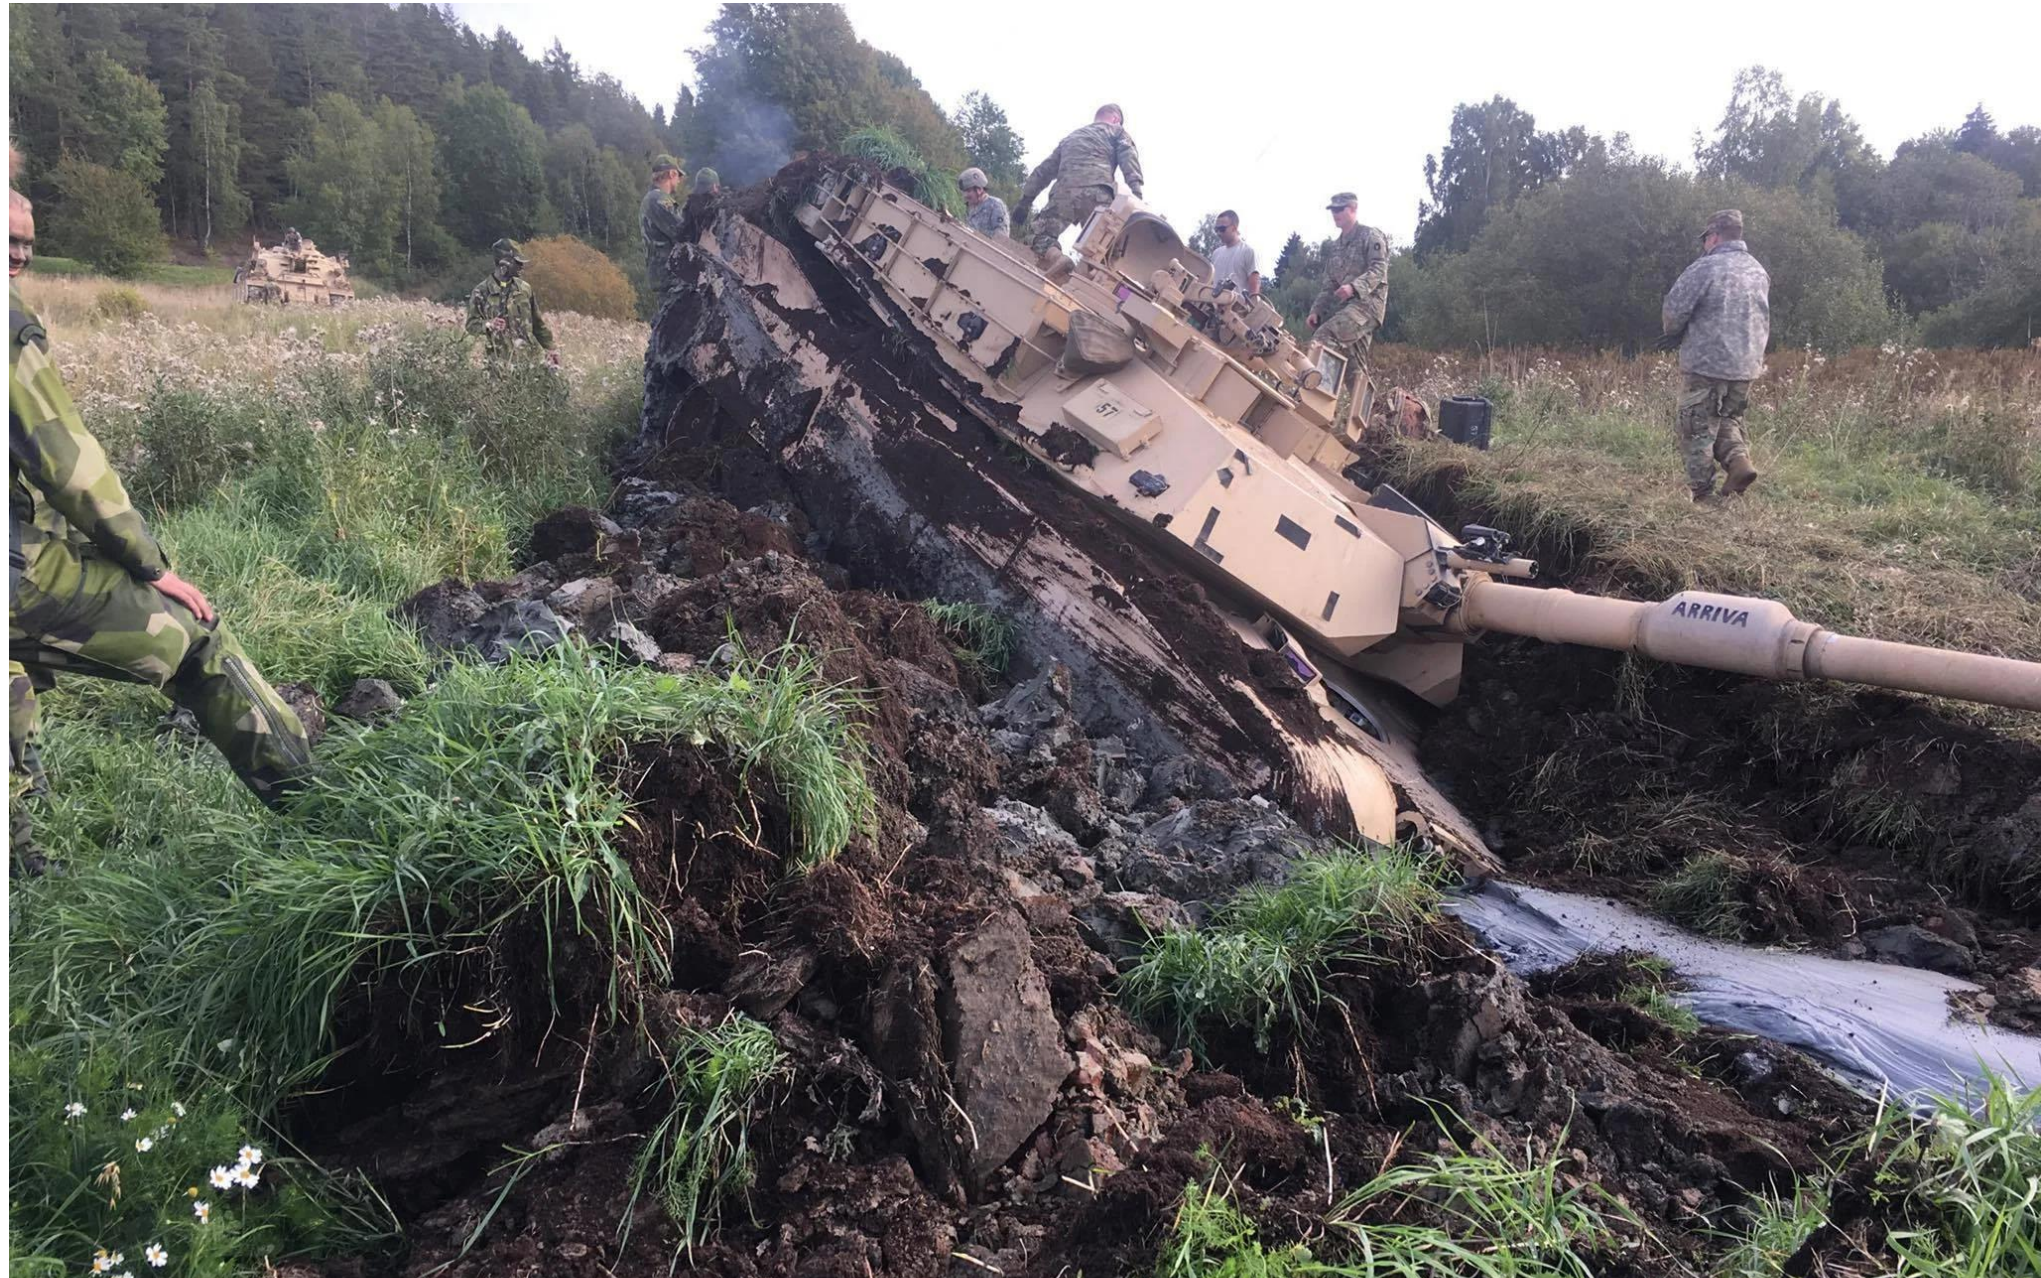
M1A1 Abrams stuck in the mud during exercise Aurora 17 in Sweden

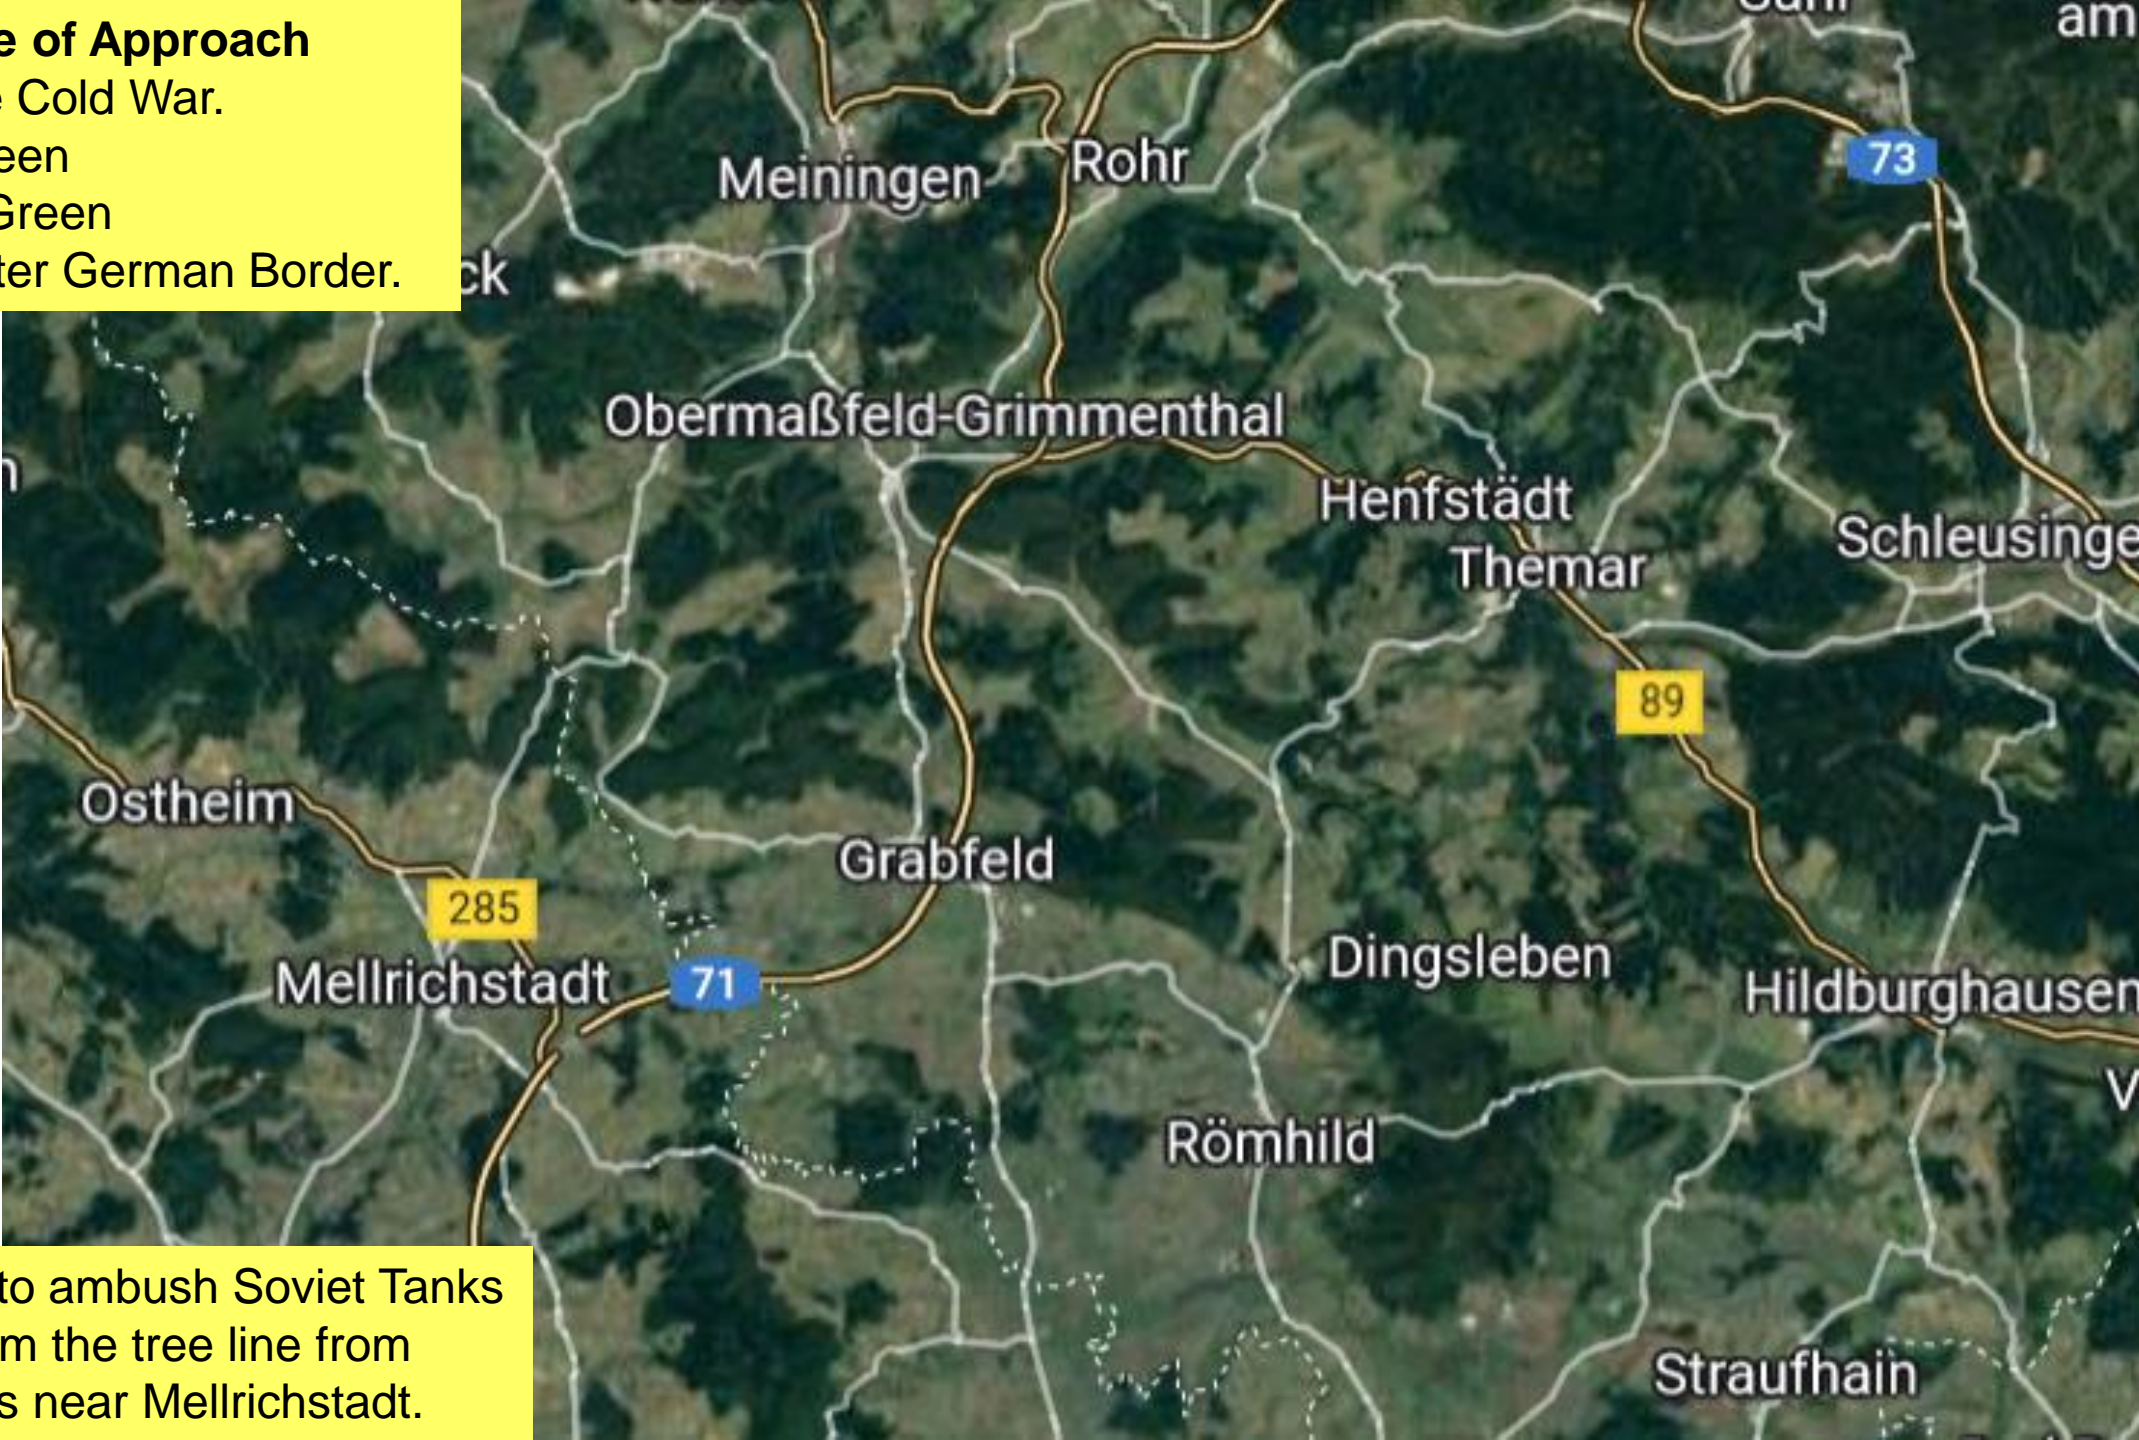
Meiningen Avenue of Approach
In our Sector in the Cold War.
Forests in Dark Green
Open areas Light Green
Dashed line Old Inter German Border.

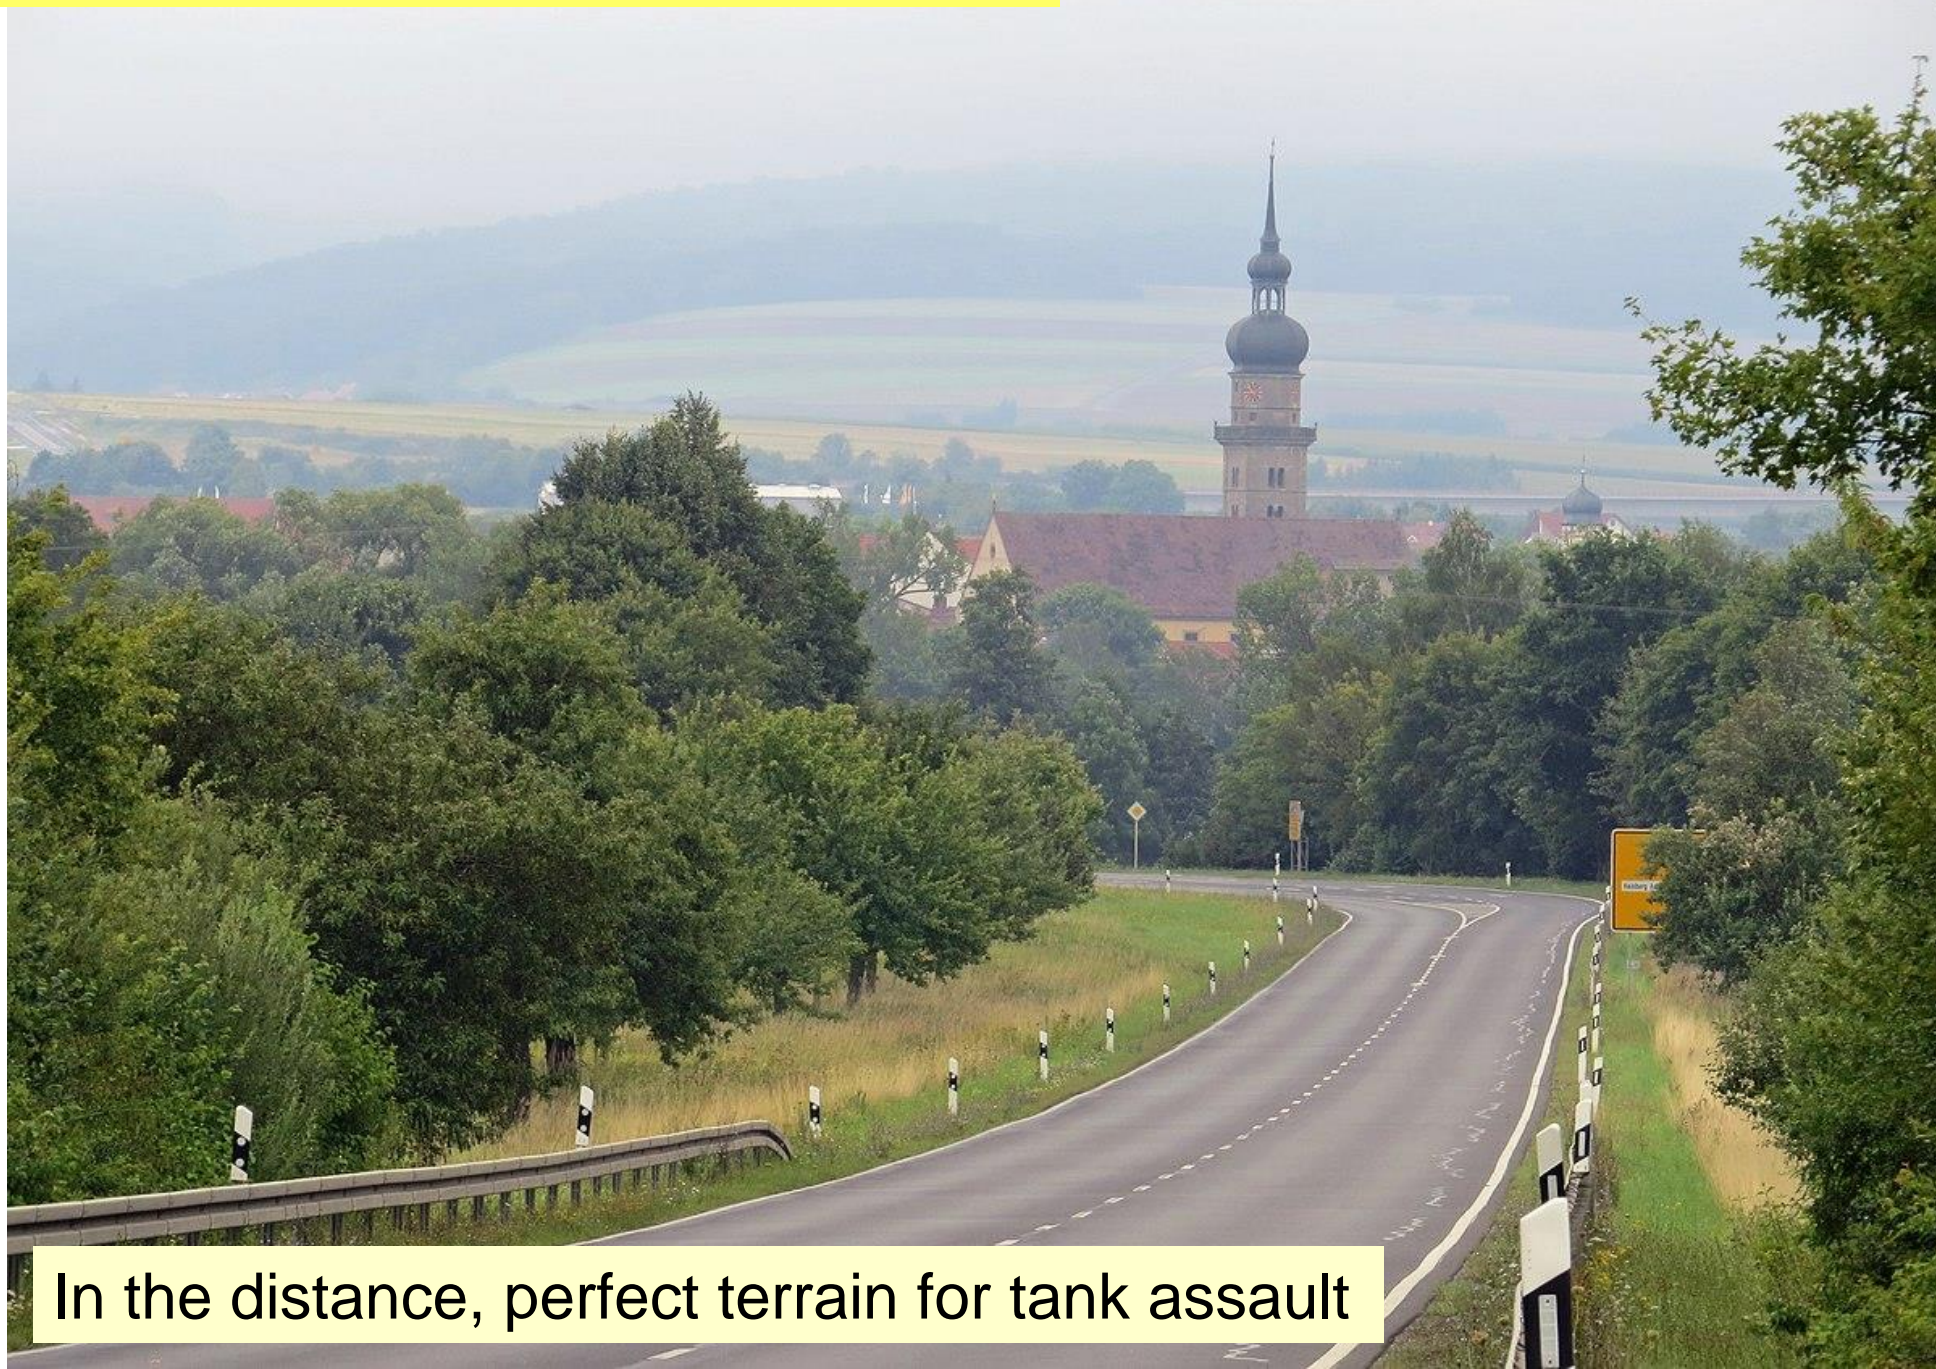
VII Corps planned to ambush Soviet Tanks if they emerged from the tree line from concealed positions near Mellrichstadt.
