Climatology and Weather Effects in the early Ground War in Russia's Invasion of Ukraine

Bob Endlich

Cruces Atmospheric Sciences Forum

19 March 2022

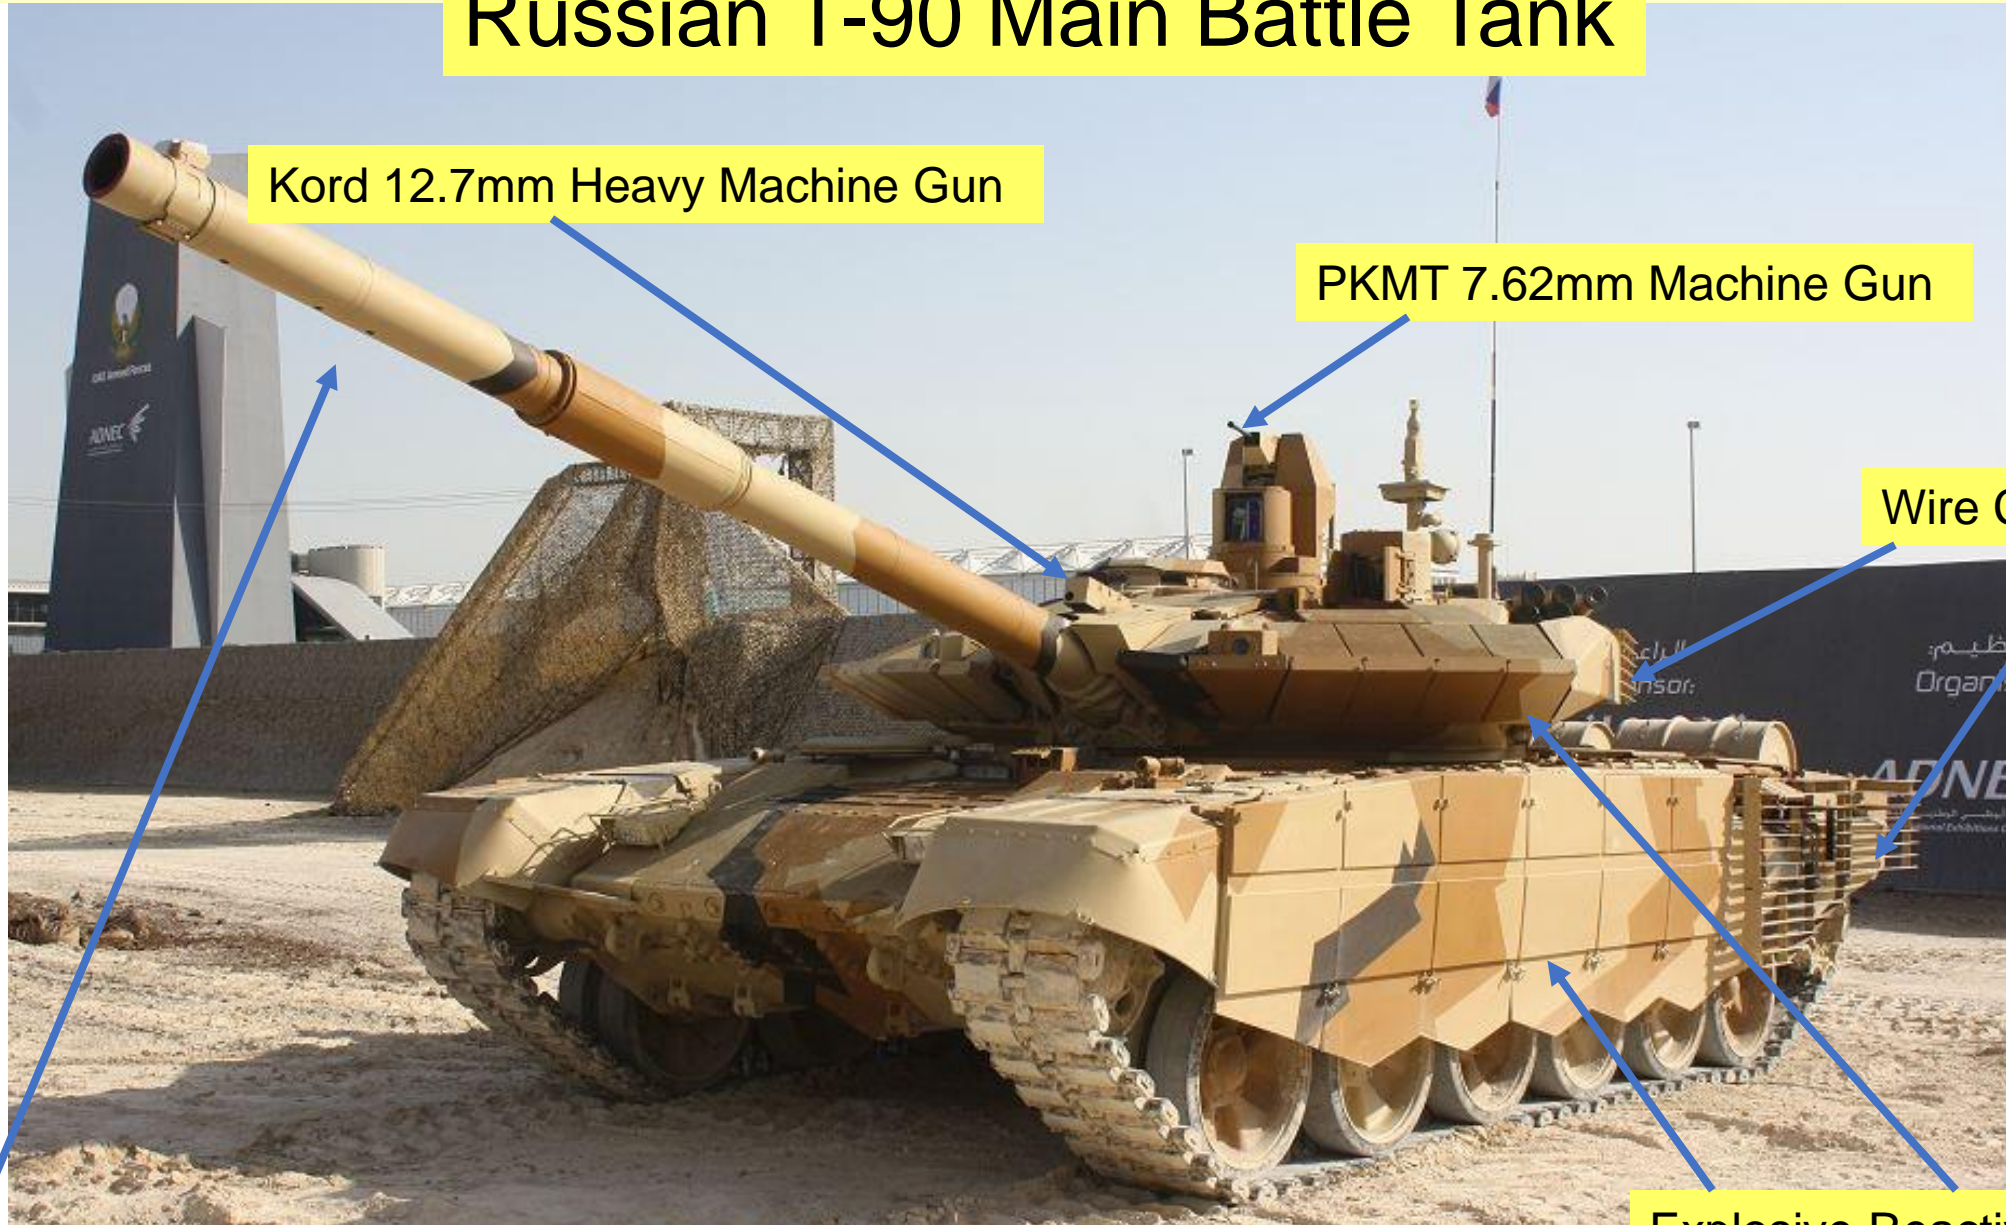
T-90 Armament

Russian T-90 Main Battle Tank

Kord 12.7mm Heavy Machine Gun

PKMT 7.62mm Machine Gun

Wire Cage Armor

Explosive Reactive Armor

125 mm (5-inch) Main Gun fires missile with range of 6 km (3.7 mi)

The T-90 tank's main tank gun, the 2A46M **125mm smoothbore tank gun**.

Can be replaced without dismantling the inner turret and is capable of firing:
armour-piercing fin-stabilised discarding sabot (APFSDS),
high-explosive anti-tank (HEAT-FS)
high explosive fragmentation (HE-FRAG) ammunition
9M119M Refleks anti-tank guided missiles.

Refleks missile has semi-automatic laser beam-riding guidance and a tandem hollow-charge HEAT warhead. **It has an effective range of 100 m to 6 km: takes 17.5 seconds to reach maximum range.** Refleks can penetrate ~ 950 millimetres (37 in) of steel armor. Can engage low-flying air targets such as helicopters.

Kord 12.7mm (12.7×108) remotely controlled anti-aircraft heavy machine gun can be operated from within the tank by the commander **has a range of 2 km.** Rate of fire of 700 rounds per minute with 300 rounds available.

PKMT 7.62mm (7.62×54mm) coaxial machine gun. <Range est. 1.5 km—Bob>

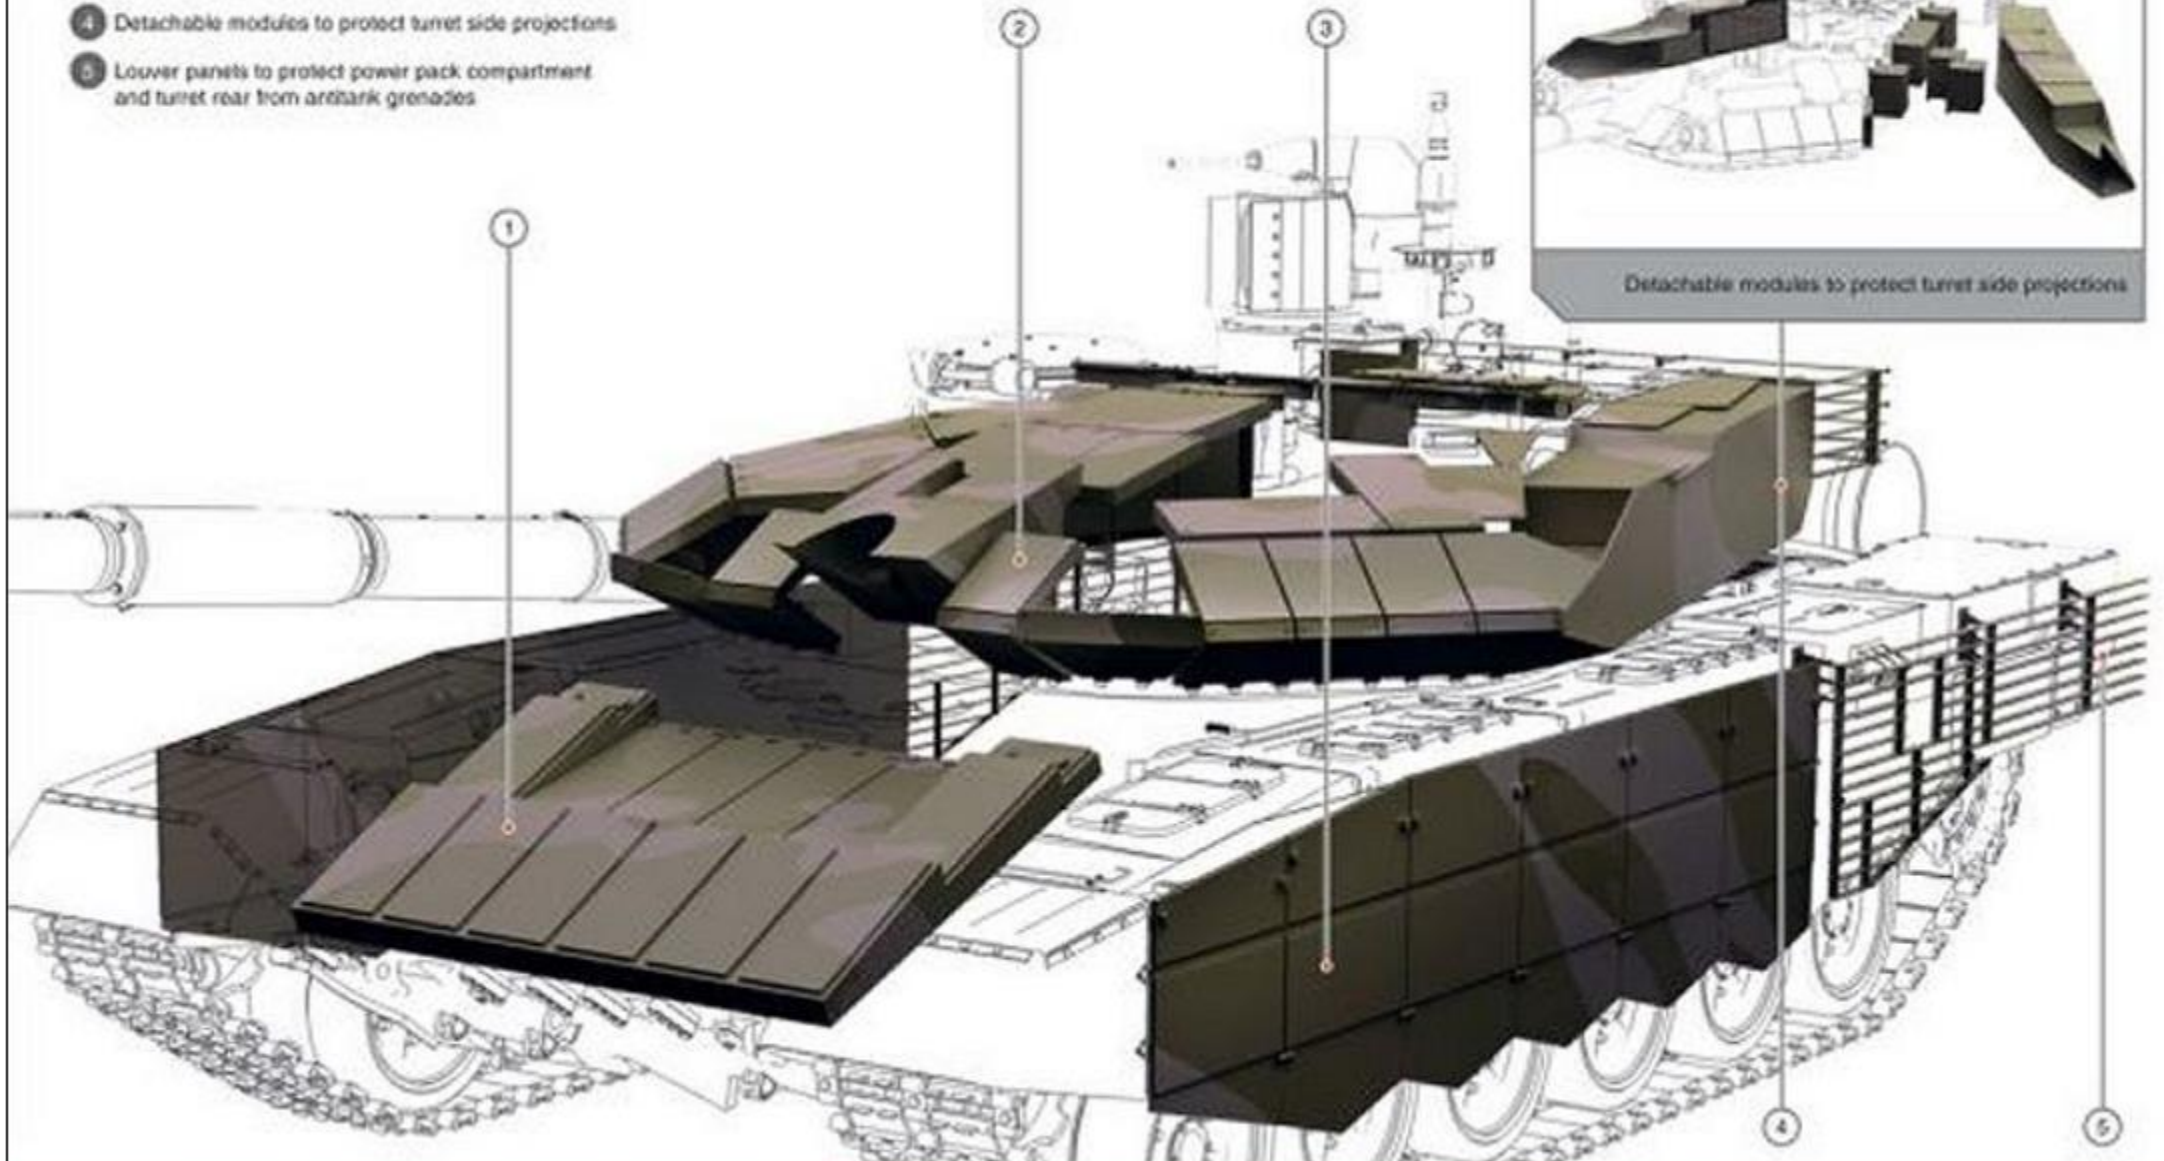
T-90 Explosive Reactive Armor and Wire Cage Armor

Arrangement of protection components

- 1 Detachable modules to protect hull front projections
- 2 Detachable modules to protect turret front projections
- 3 Detachable modules to protect hull side projections
- 4 Detachable modules to protect turret side projections
- 5 Louver panels to protect power pack compartment and turret rear from antitank grenades

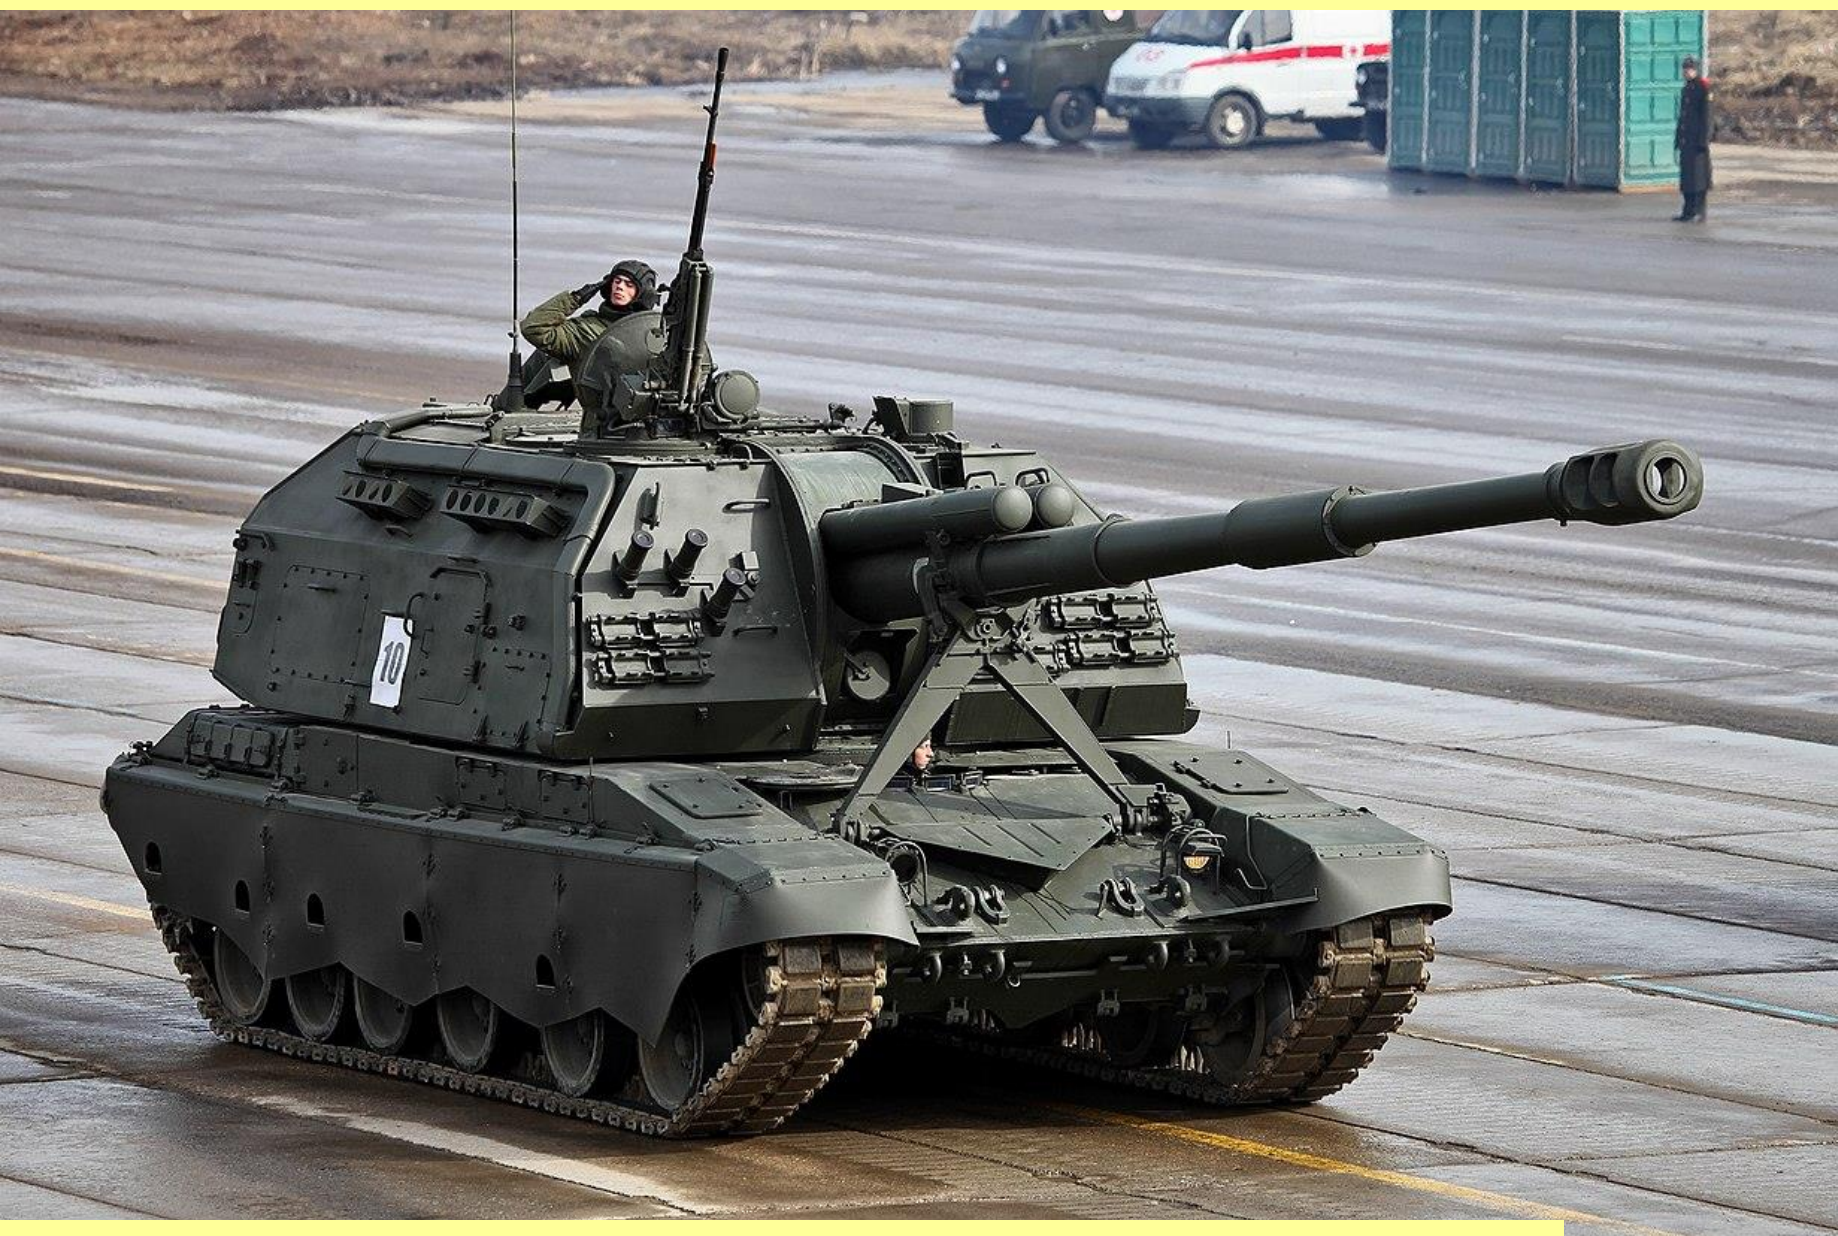
The hull and turret of the T-90MS are fitted with ERA (Explosive Reactive Armour) and wire cage armour.

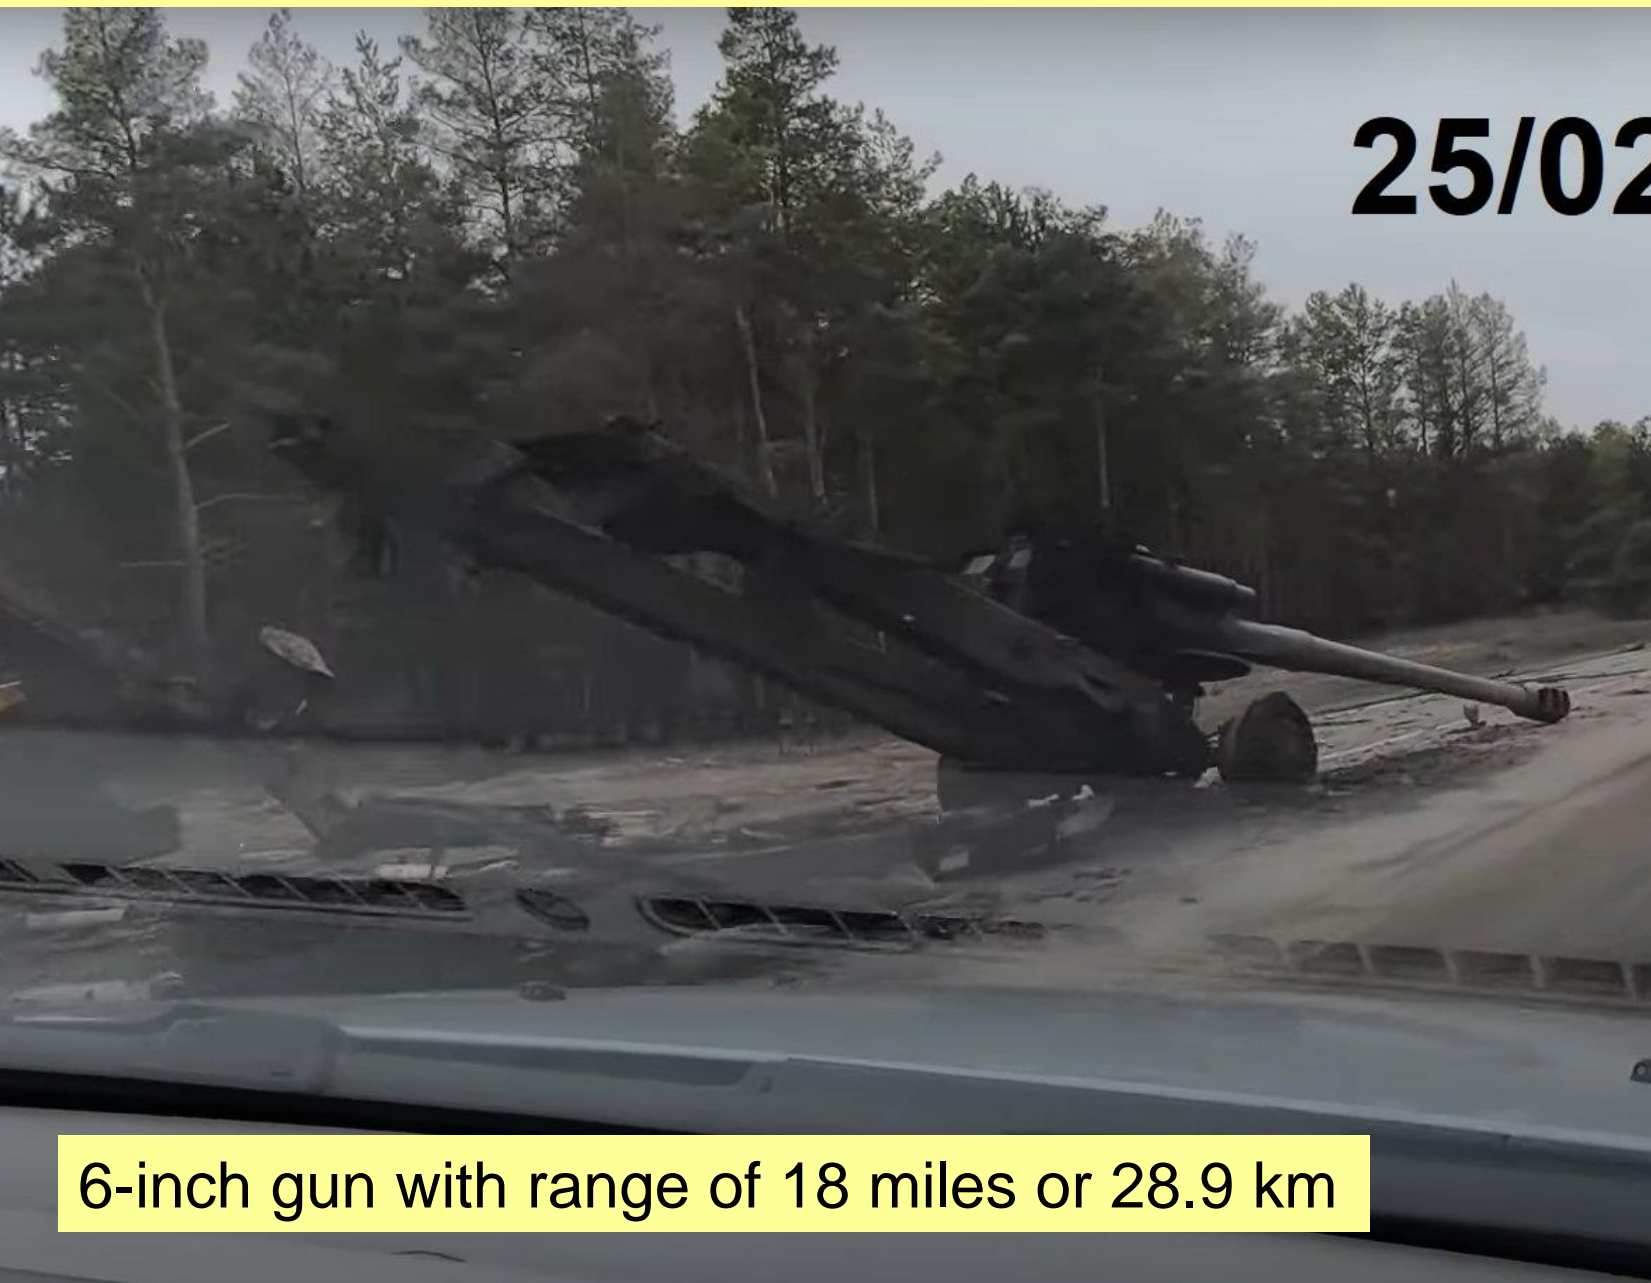
Specifications	
Mass	42 tonnes (93,000 lb)
Length	7.15 m (23 ft 5 in)
Width	3.38 m (11 ft 1 in)
Height	2.99 m (9 ft 10 in)
Crew	5
Elevation	-4° to +68°
Traverse	360°
Rate of fire	2S19: 6-8 rounds per minute 2S19M2: 10 rounds per minute
Maximum firing range	Base bleed: 25 km (16 mi) RAP: 28.9 km (18.0 mi)
Armor	Classified
Main armament	152.4 mm howitzer 2A65
Secondary armament	12.7 mm NSVT anti-aircraft machine gun
Engine	Diesel V-84A 840 hp (630 kW)
Power/weight	20 hp/tonne
Suspension	Torsion bar
Operational range	500 km (310 mi)
Maximum speed	60 km/h (37 mph)

Maximum Range: 25 km (16 mi) RAP Round 28.9 km (18 mi)

2S19 Msta (Russian: Мста, after the Msta River) **152.4 mm self-propelled howitzer** designed by the Soviet Union

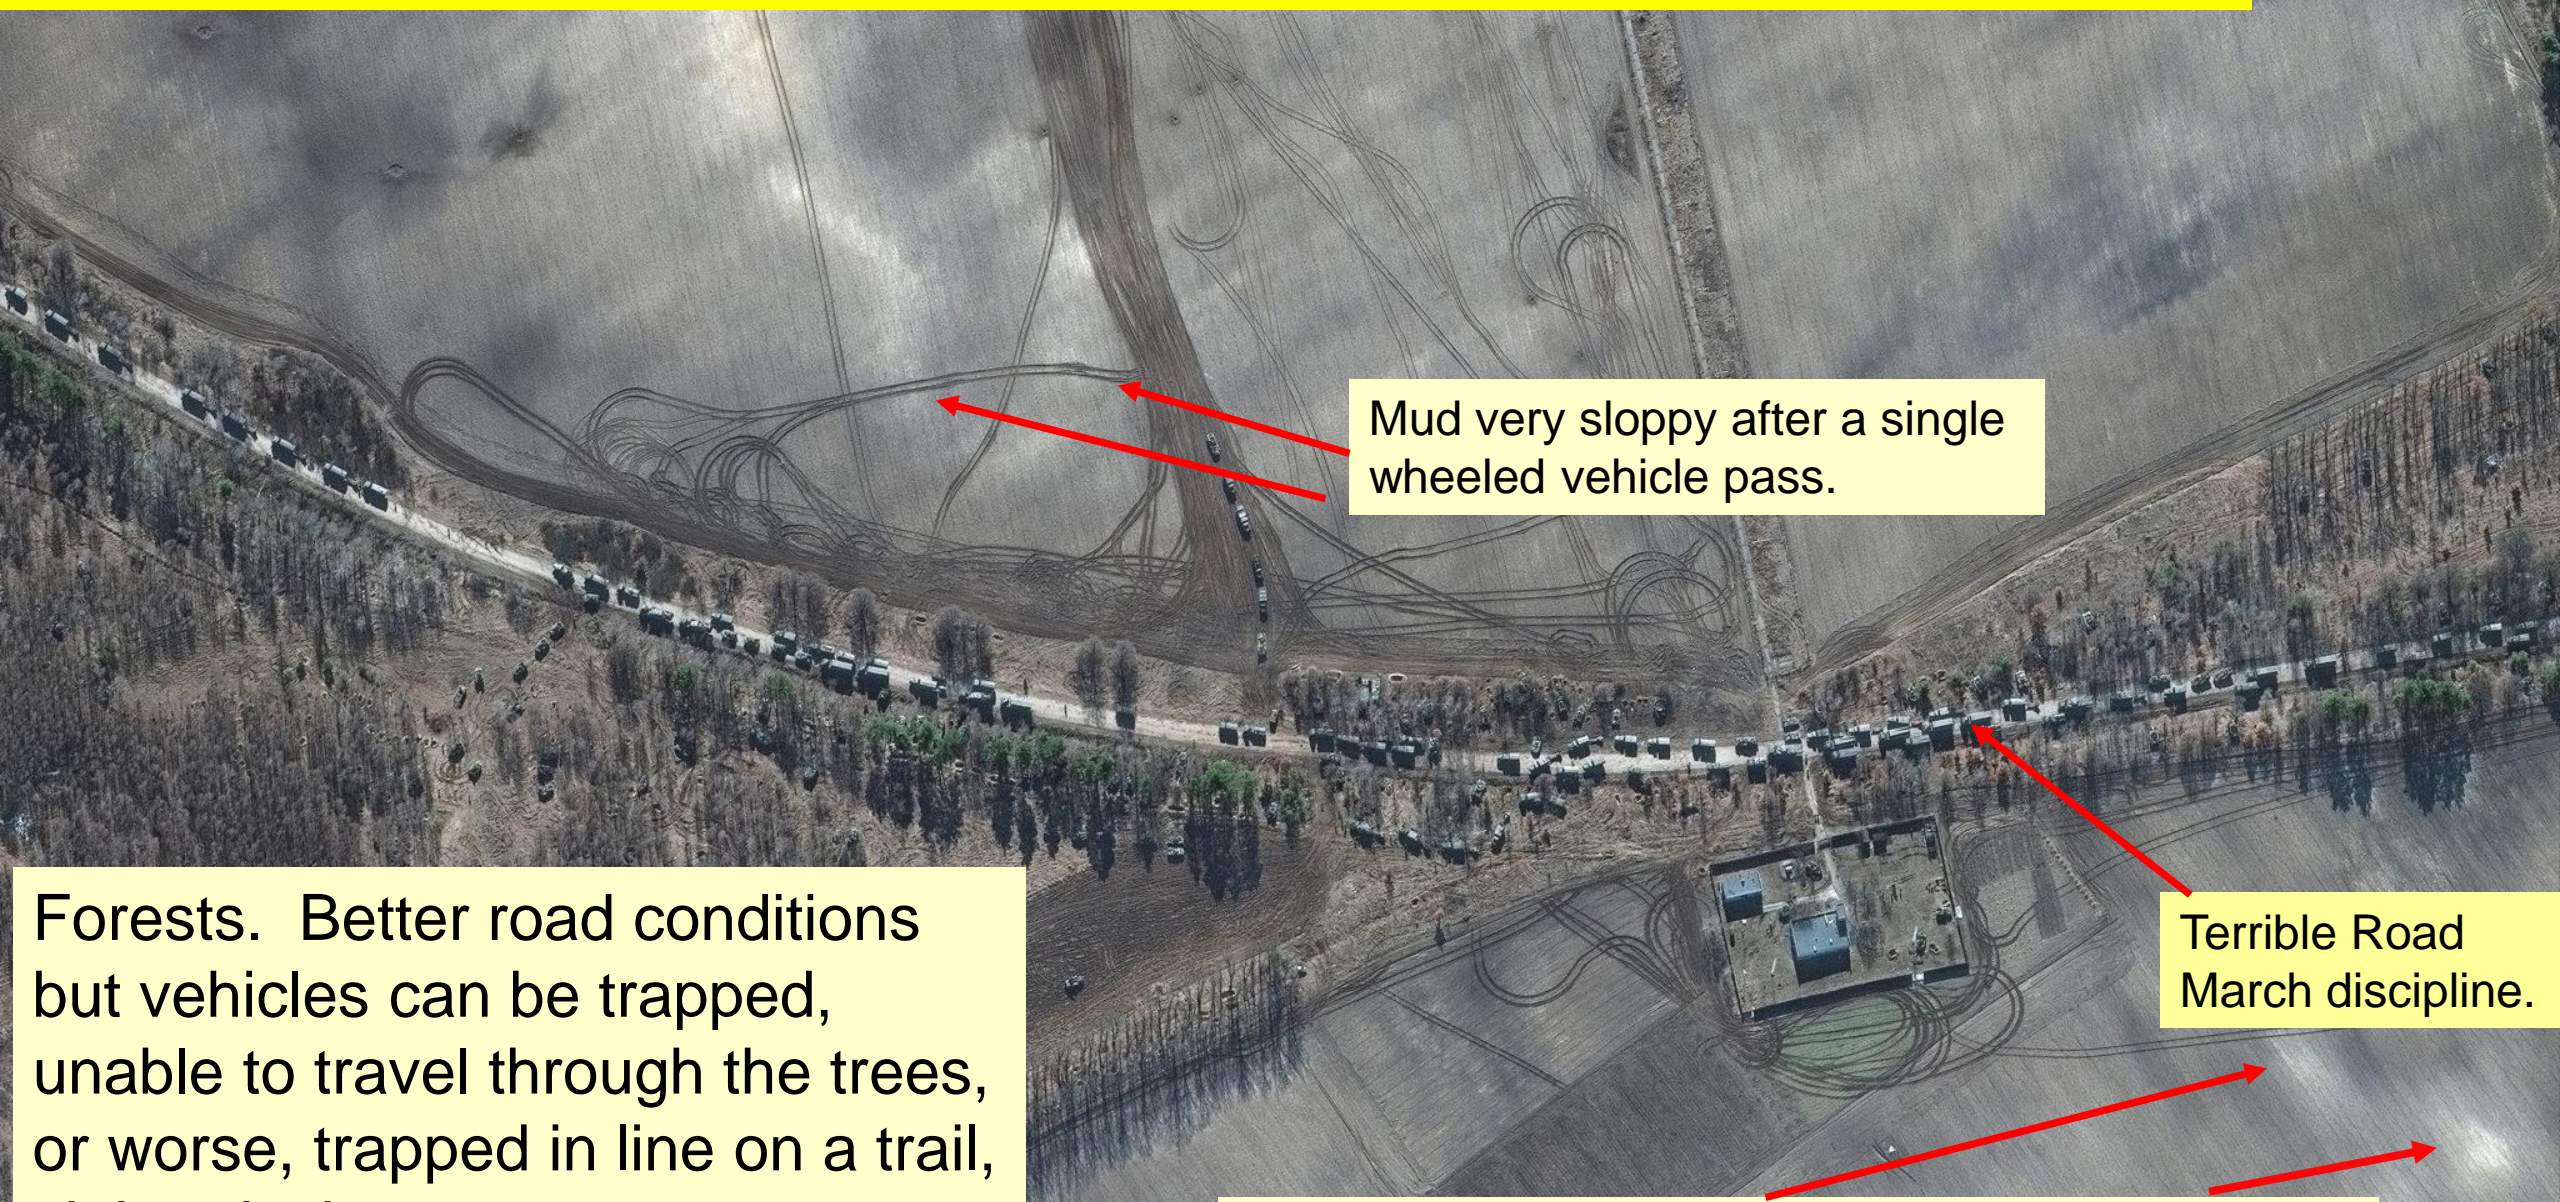
Wet Fields. Number of passes of vehicles goes to zero after multiple wheeled, tracked vehicle passes.

Mud very sloppy after a single wheeled vehicle pass.

Terrible Road March discipline.

Forests. Better road conditions but vehicles can be trapped, unable to travel through the trees, or worse, trapped in line on a trail, sitting ducks.

High sun reflectivity. Probably means standing water.

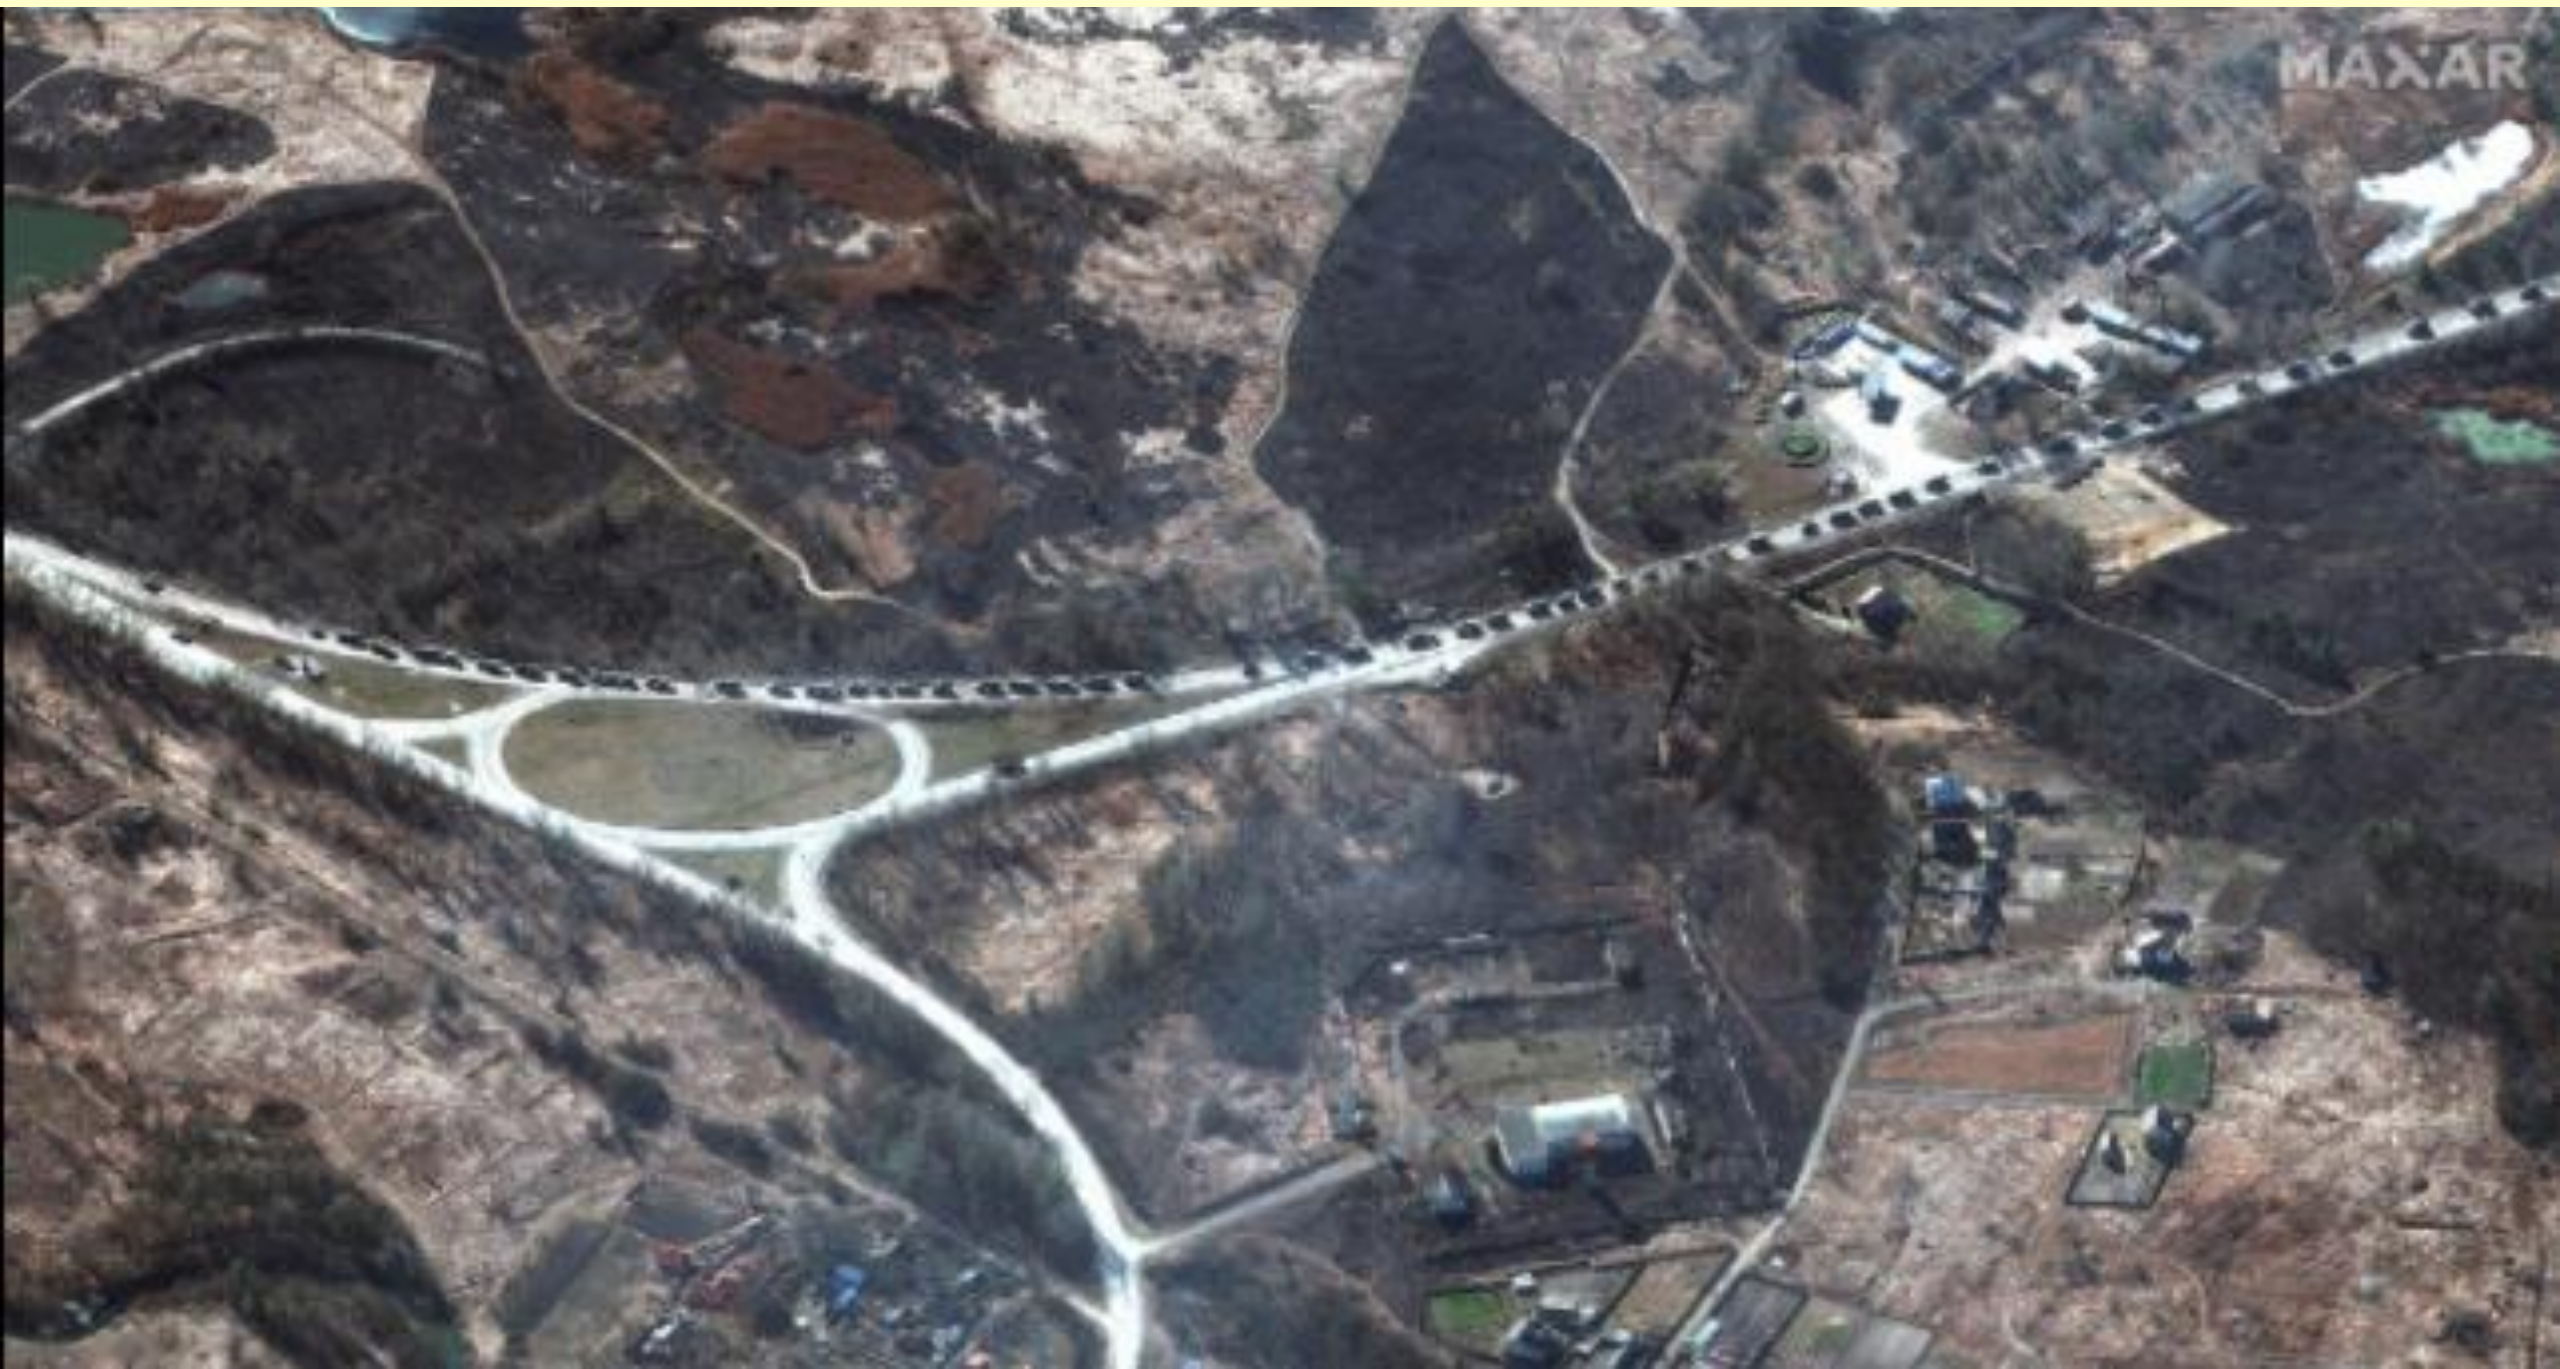
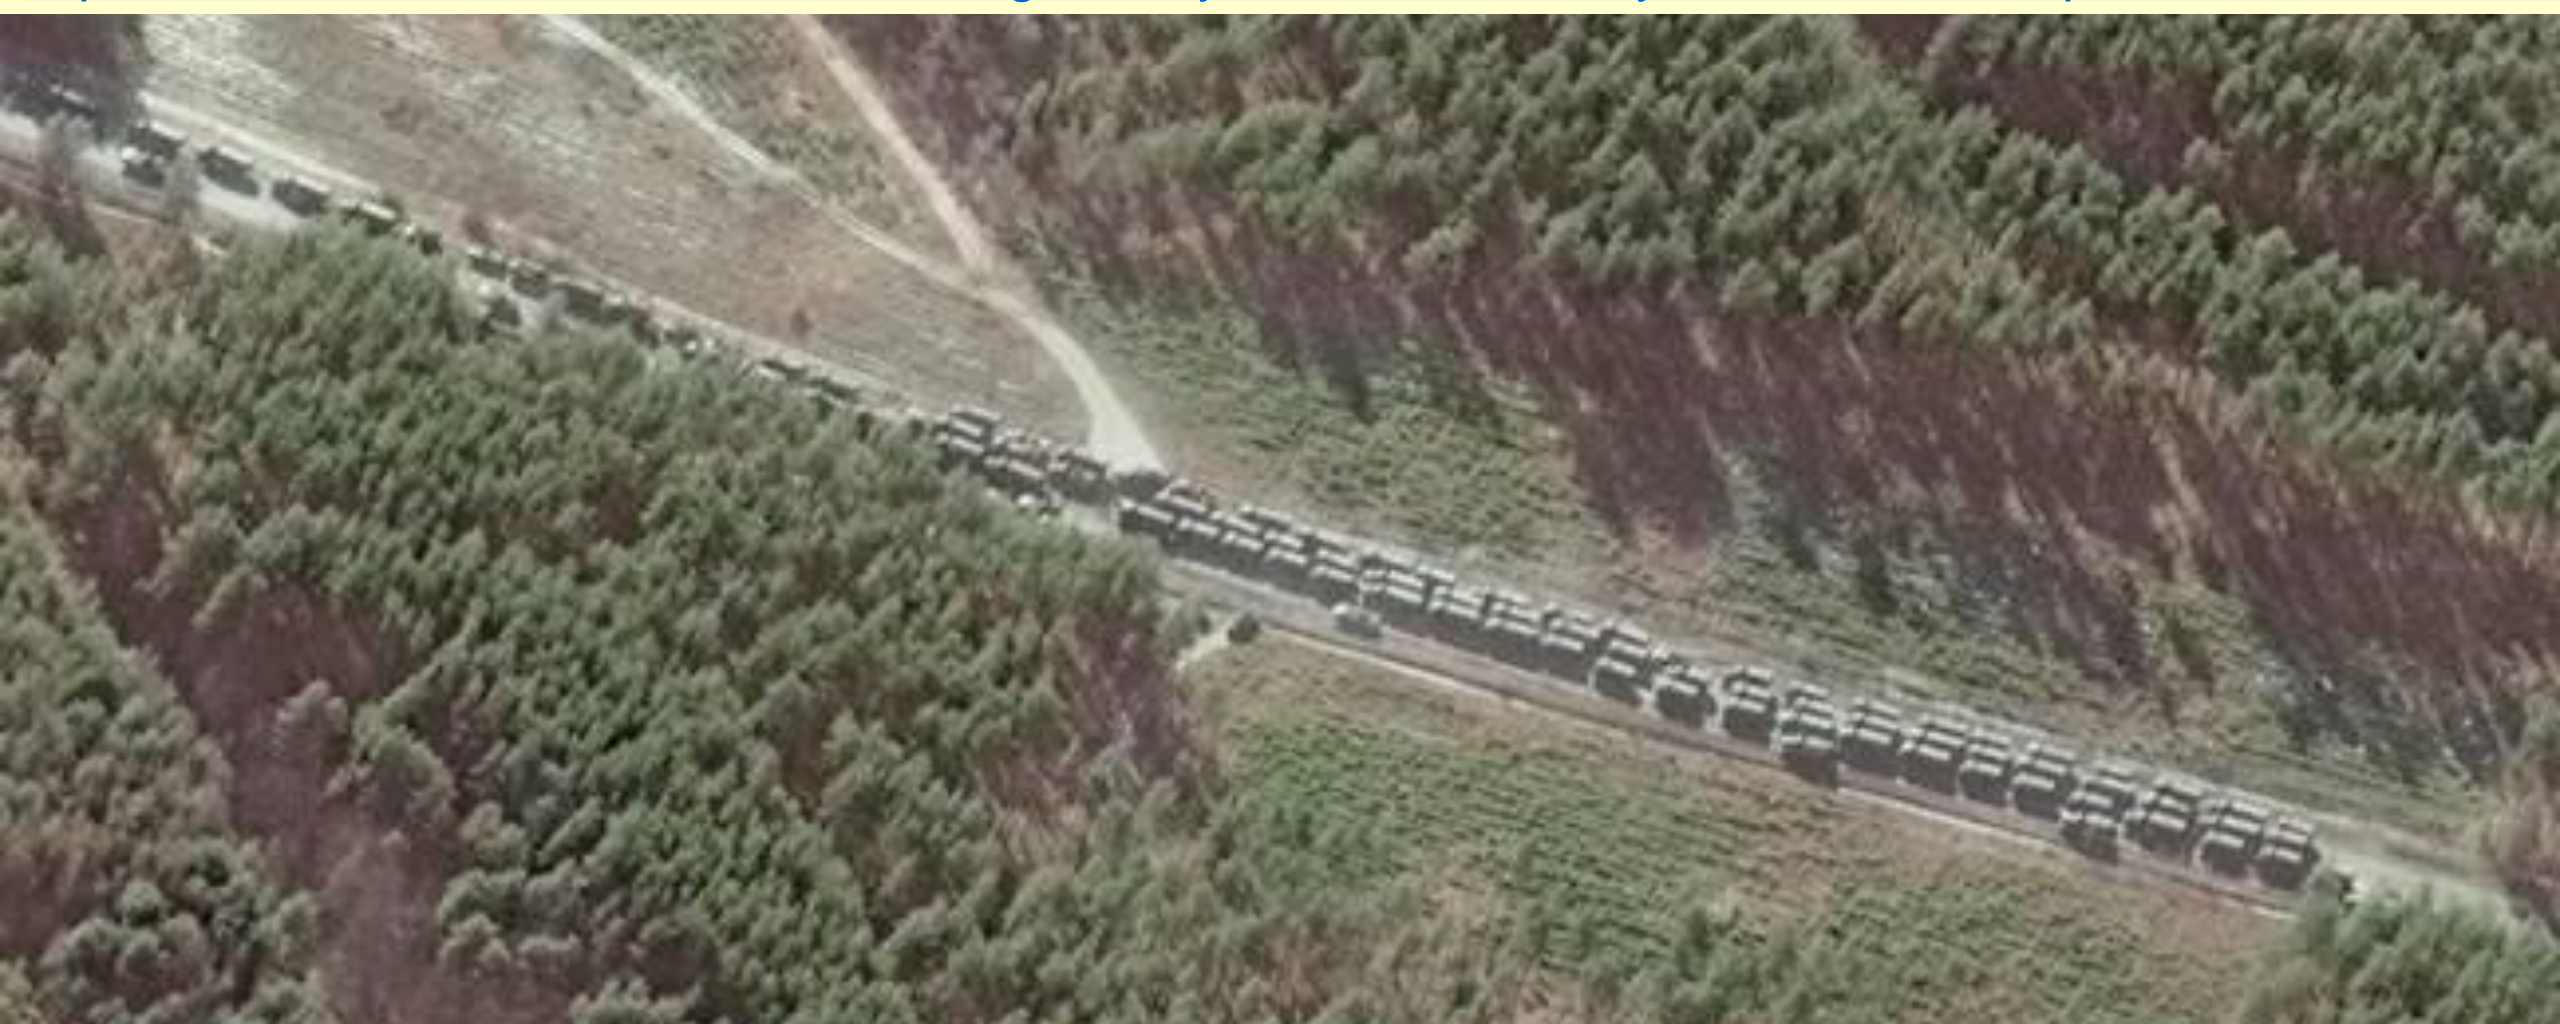
Russian vehicle convoy north of Kiev.
The vehicles can not travel through the forest.
Apparent terrible road discipline, with 3-abreast vehicles preventing refueling, resupply, or on-road / off-road maneuver.
