A Likely Weather Factor in the United Flight 169 Accident, Newark Liberty International Airport, 3 May 2026

Cruces Atmospheric Sciences Forum
16 May 2026

Bottom Line Up Front:

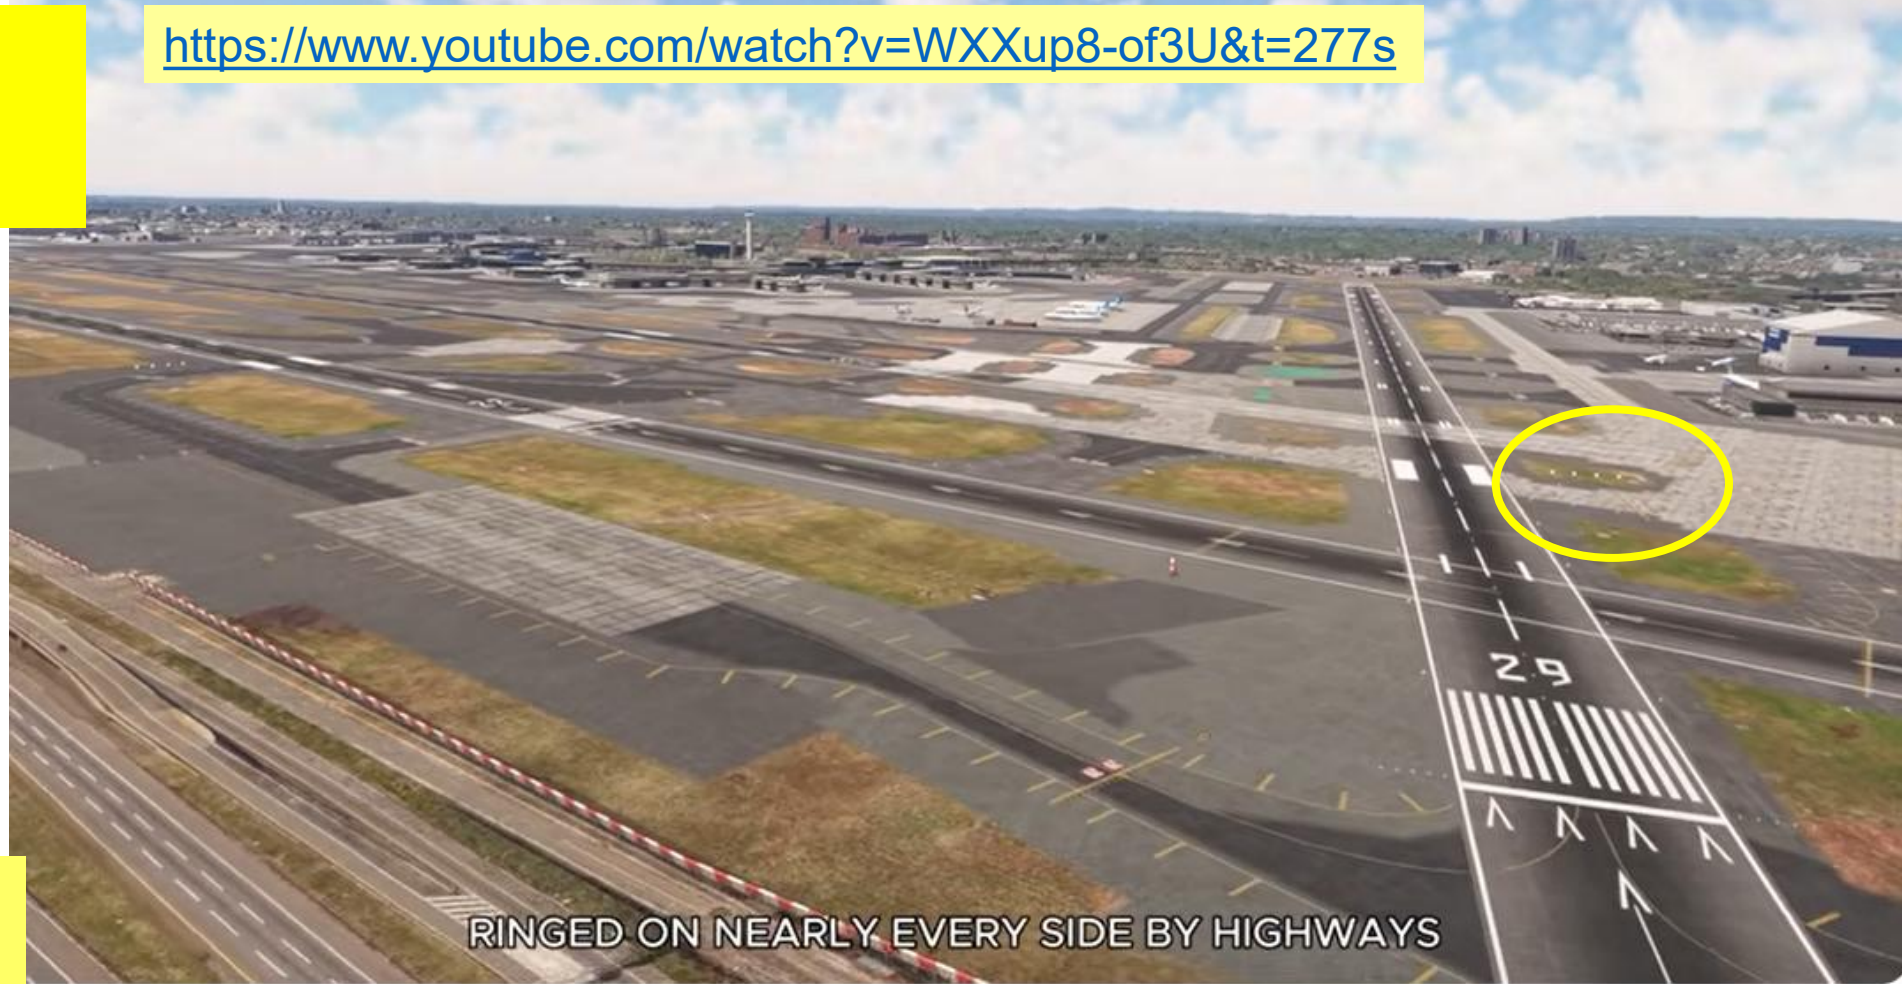
Yellow Oval shows PAPI Lights.

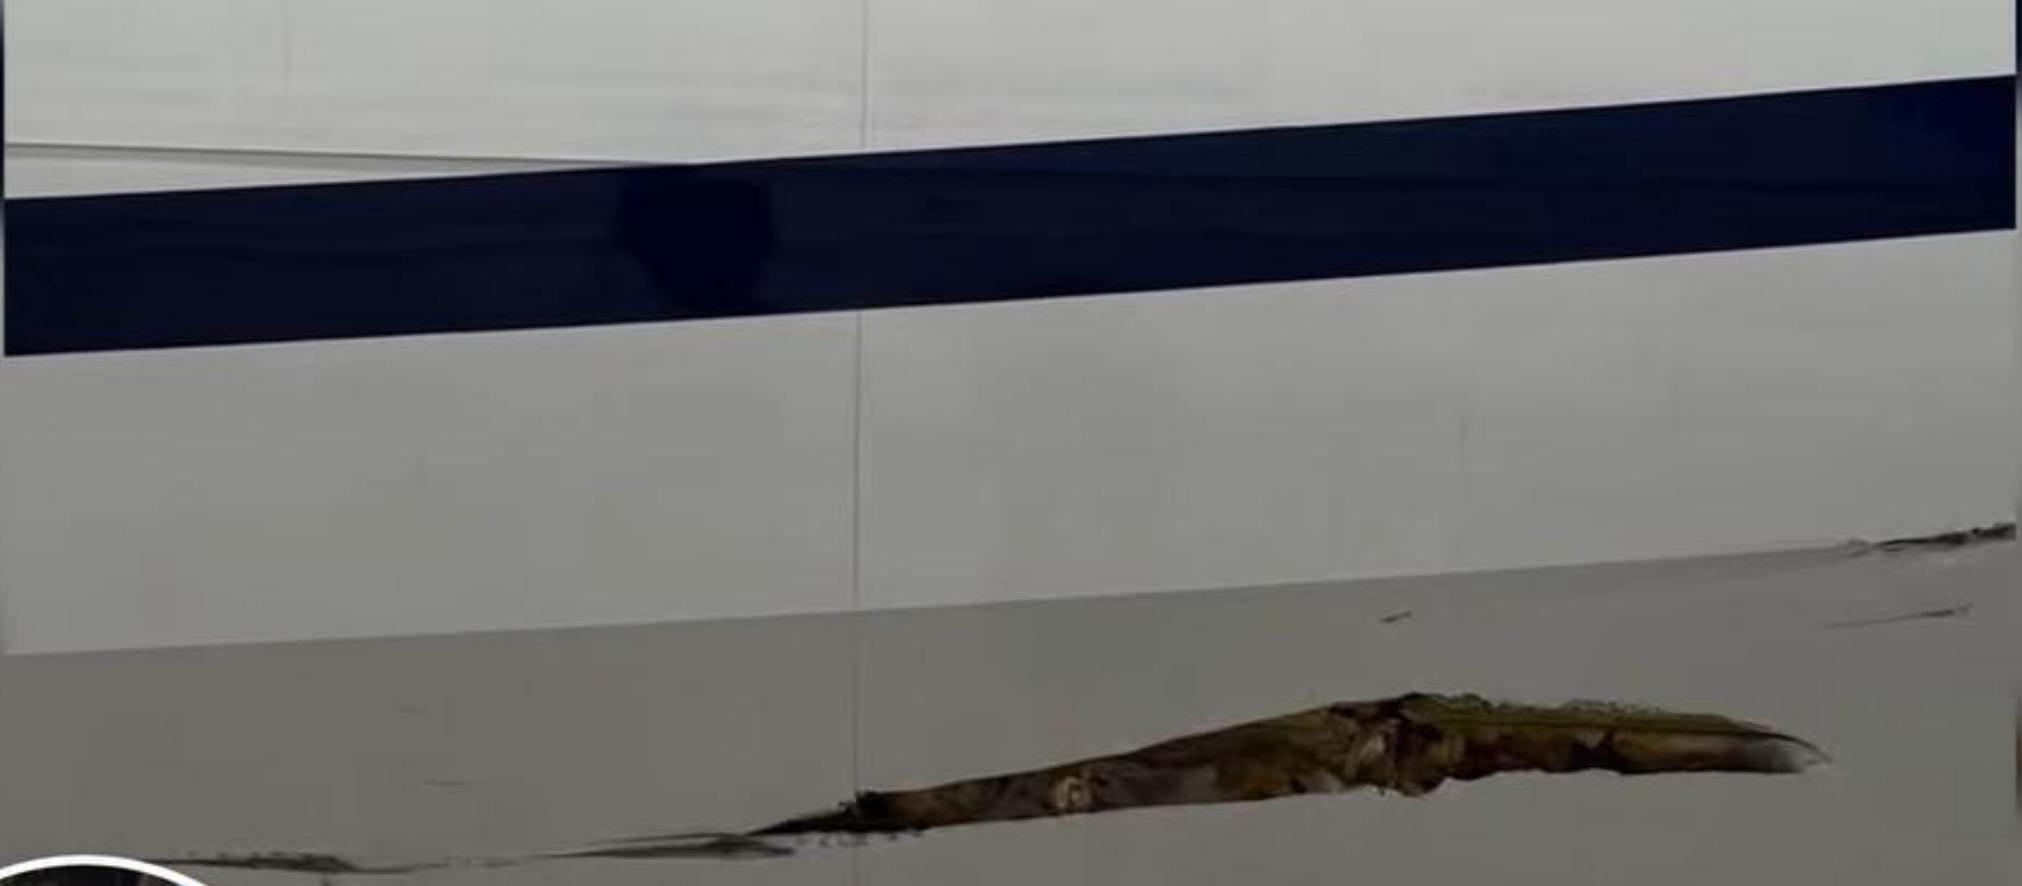
Gash in the side of the Boeing 767-400 ER found during the post-flight inspection of the aircraft, indicating it struck an object on the ground while landing at Newark.

Was this gash left by the aircraft striking part of the light pole?

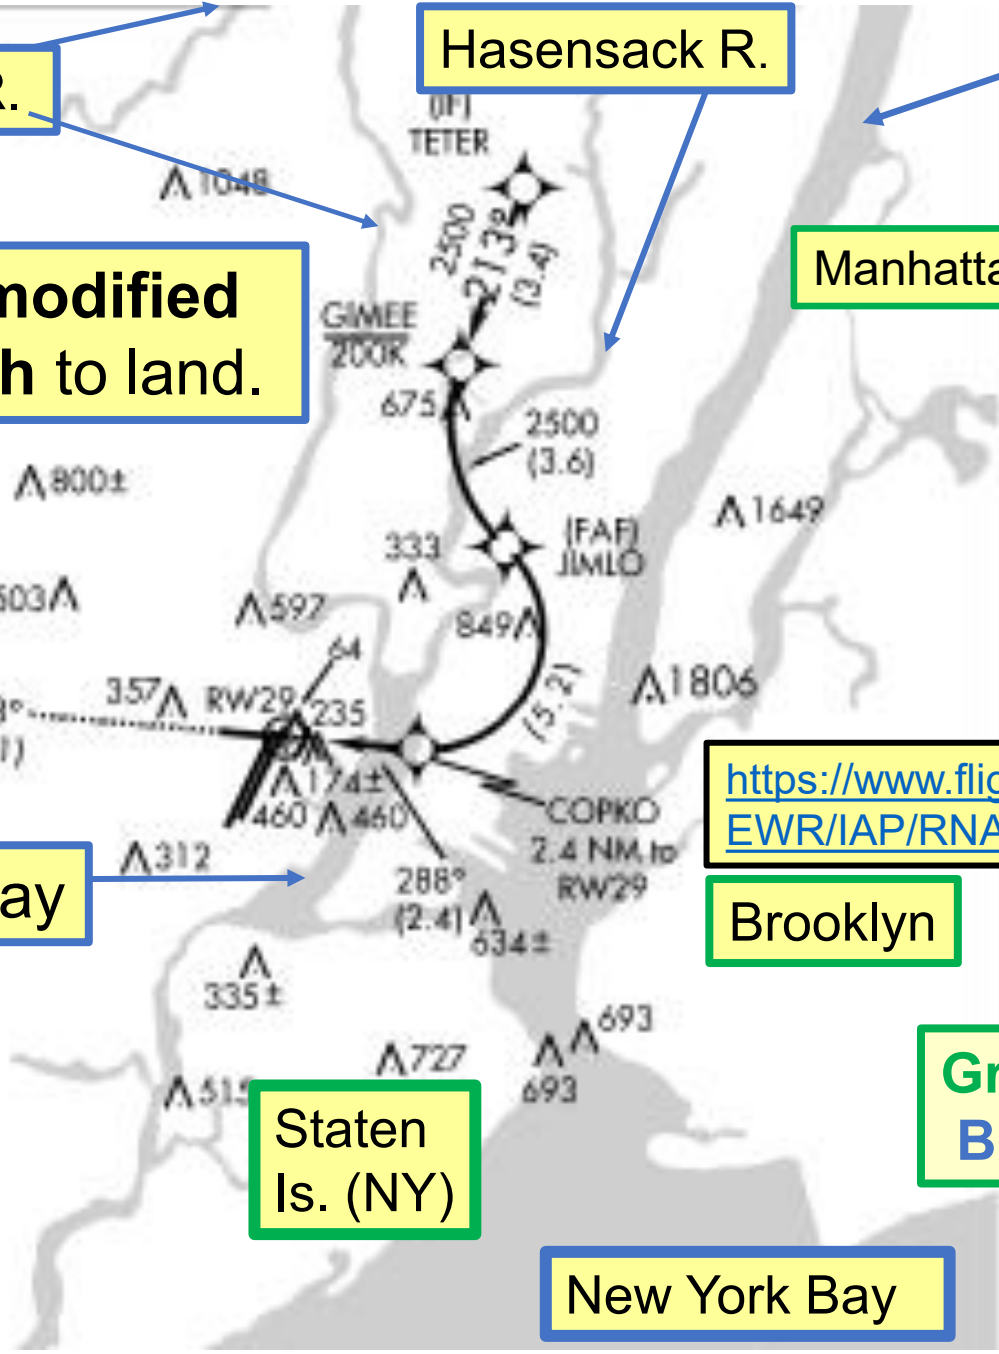
RNAV APPROACH
RUNWAY 29
NEWARK LIBERTY
INTERNATIONAL AIRPORT
(EWR)

Published Visual Flight Rules **modified** right turn "circling" approach to land.

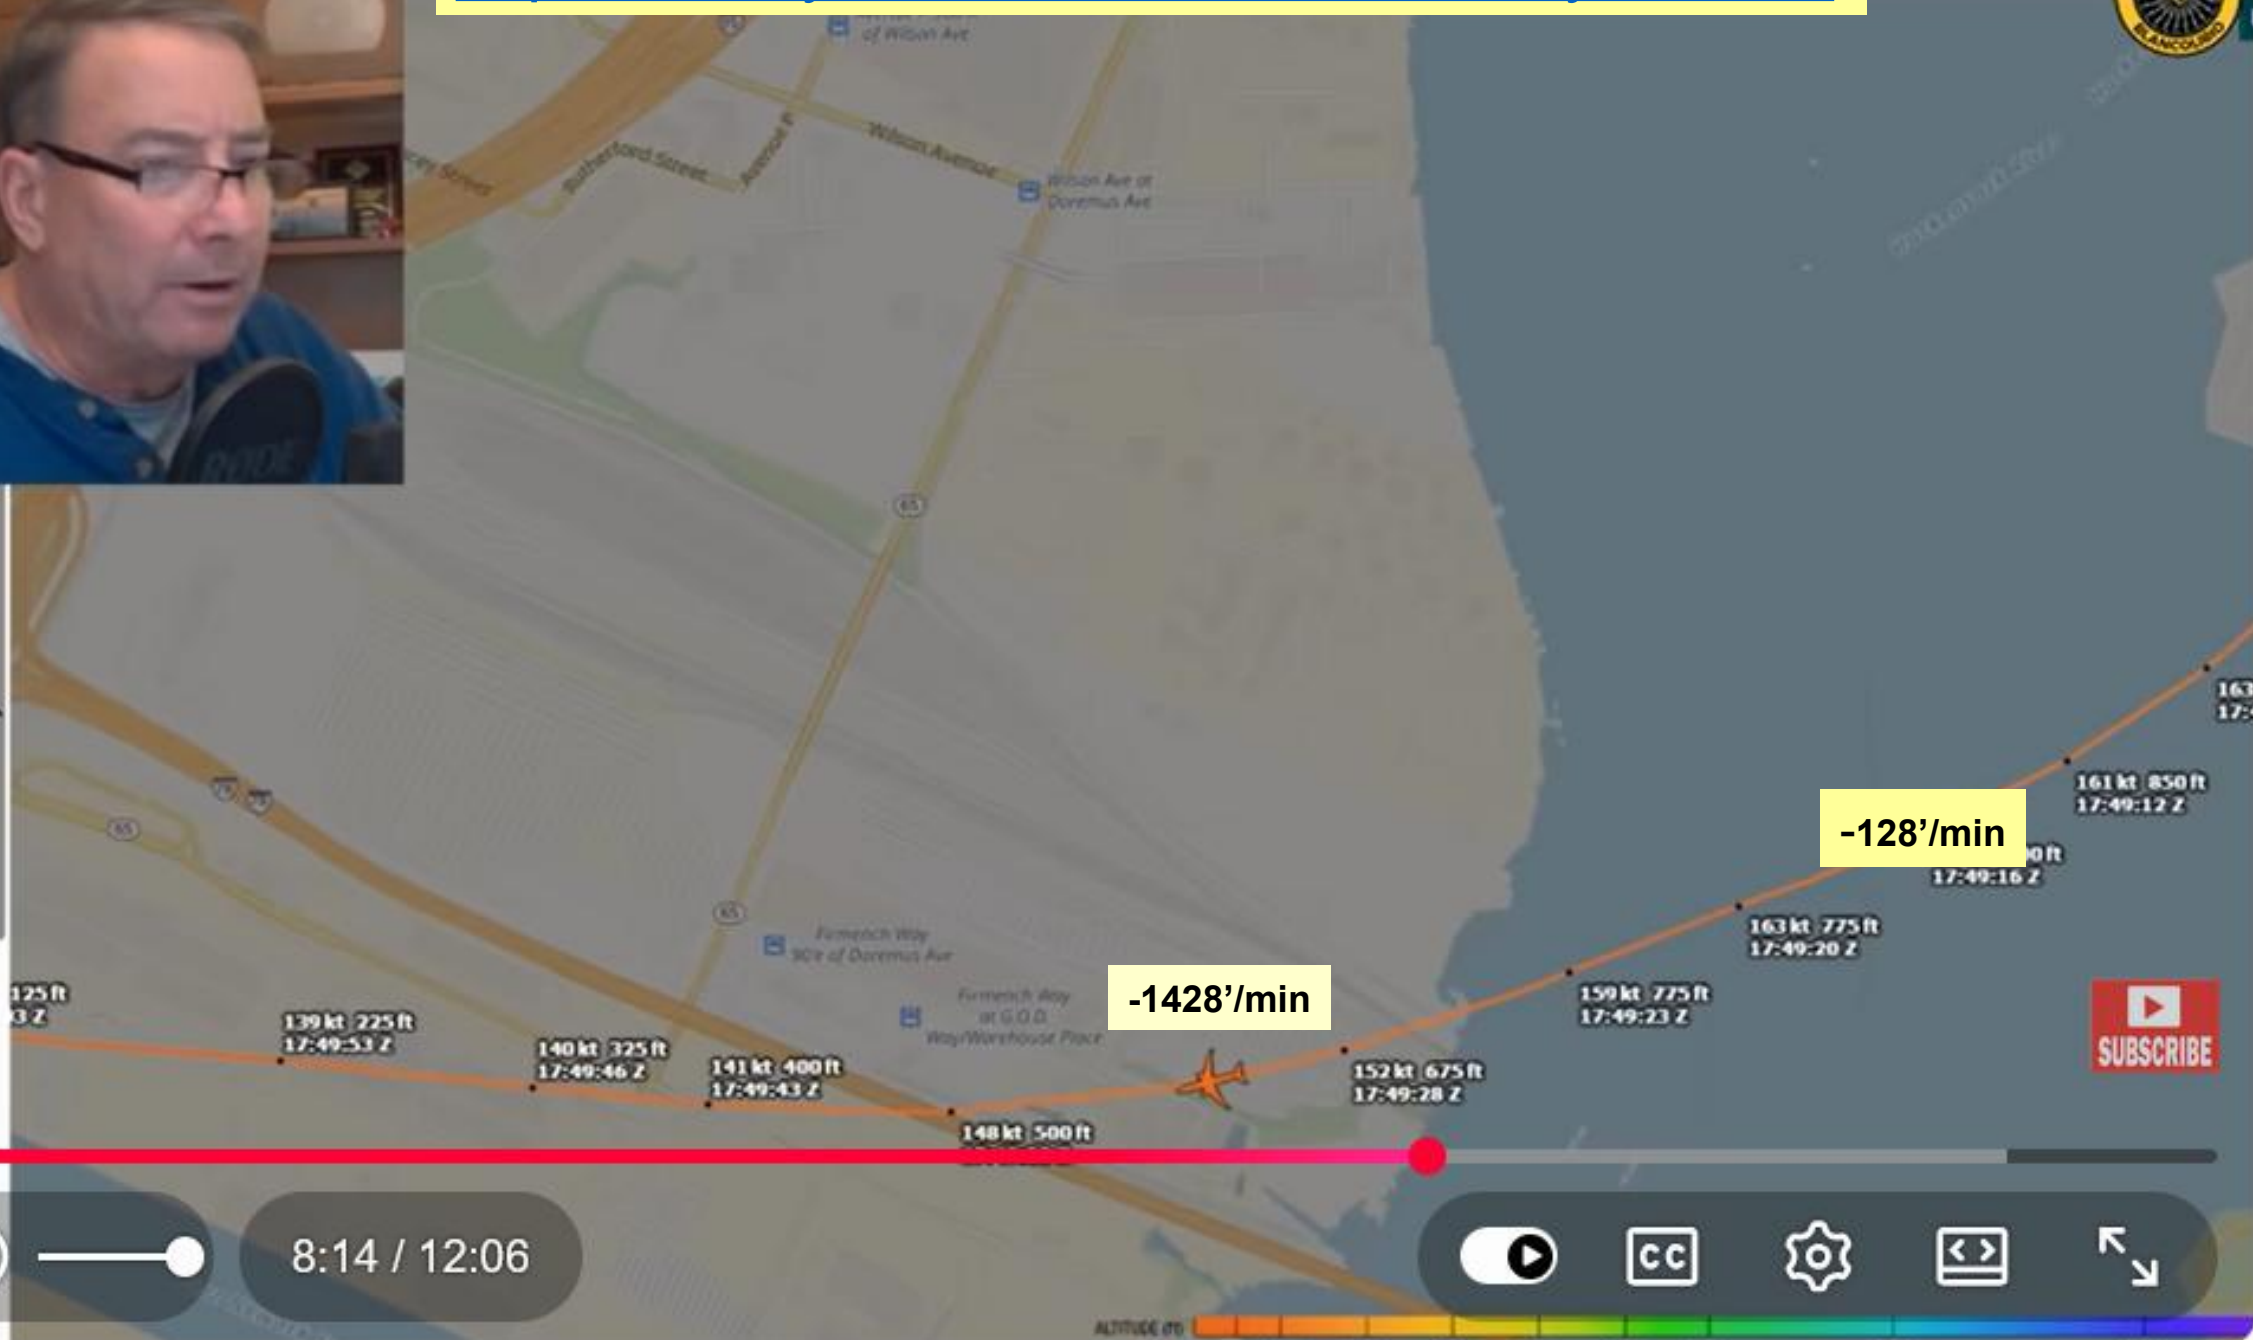
This is, to me, one clue that the strong sink was present as he crossed Newark Bay.

-128'/min

-1428'/min

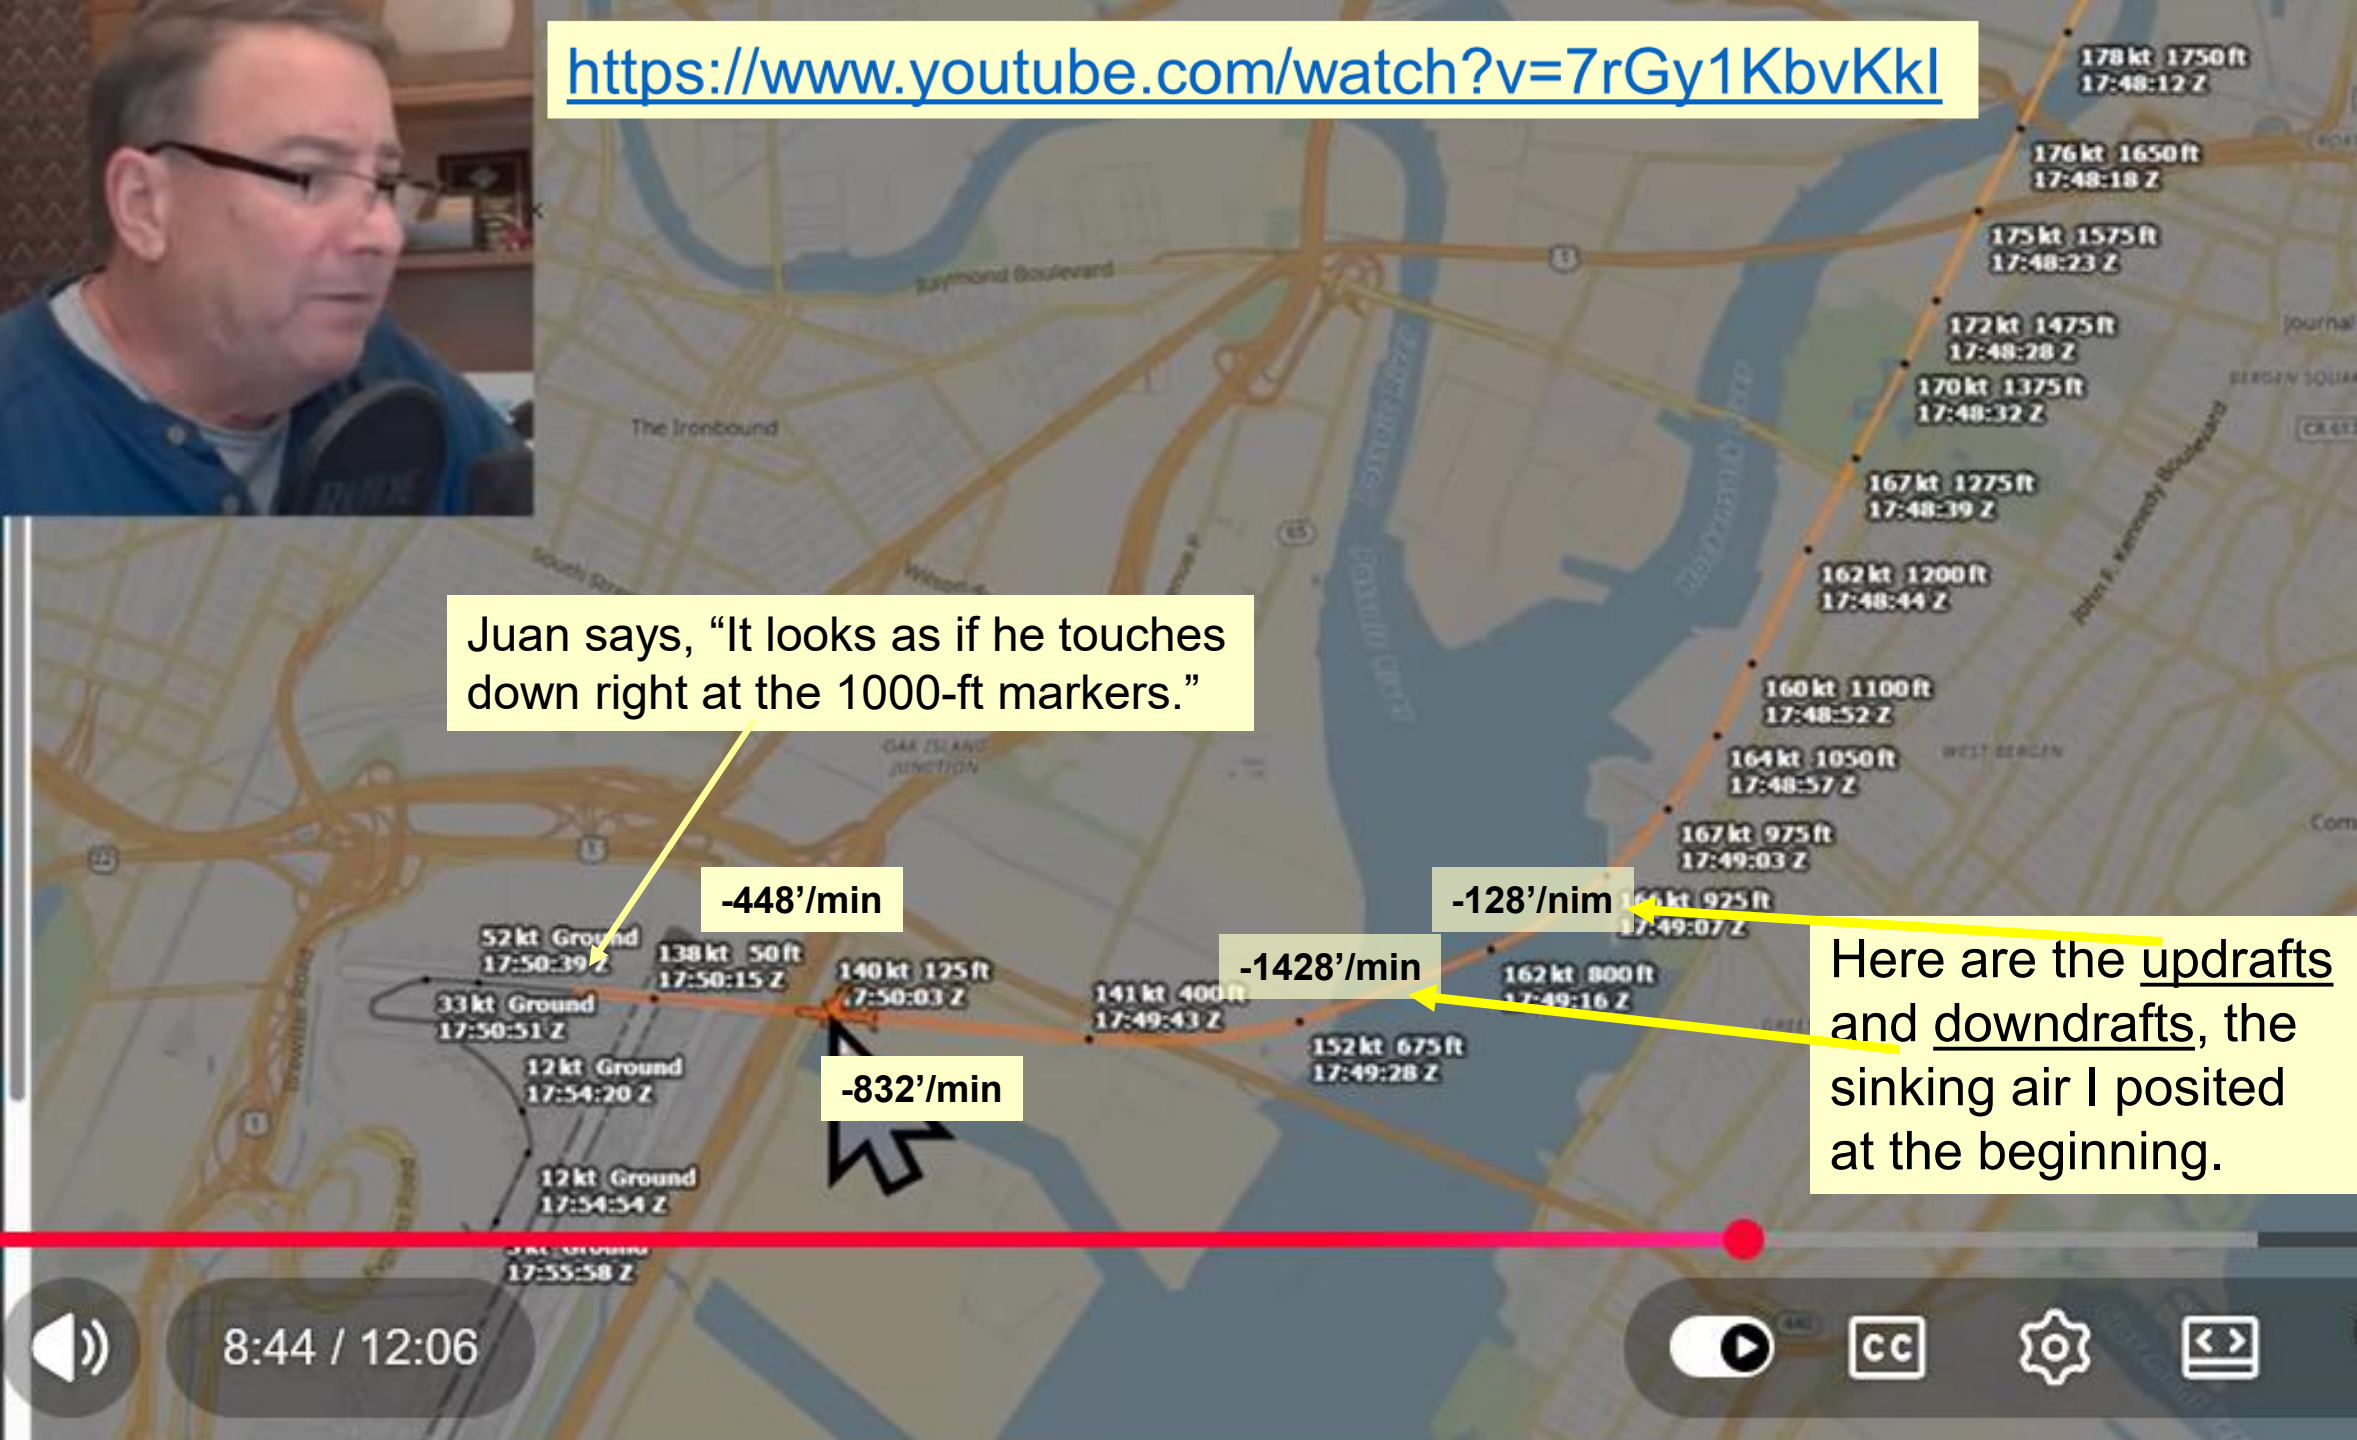
Juan says, "It looks as if he touches down right at the 1000-ft markers."

Here are the updrafts and downdrafts, the sinking air I posited at the beginning.

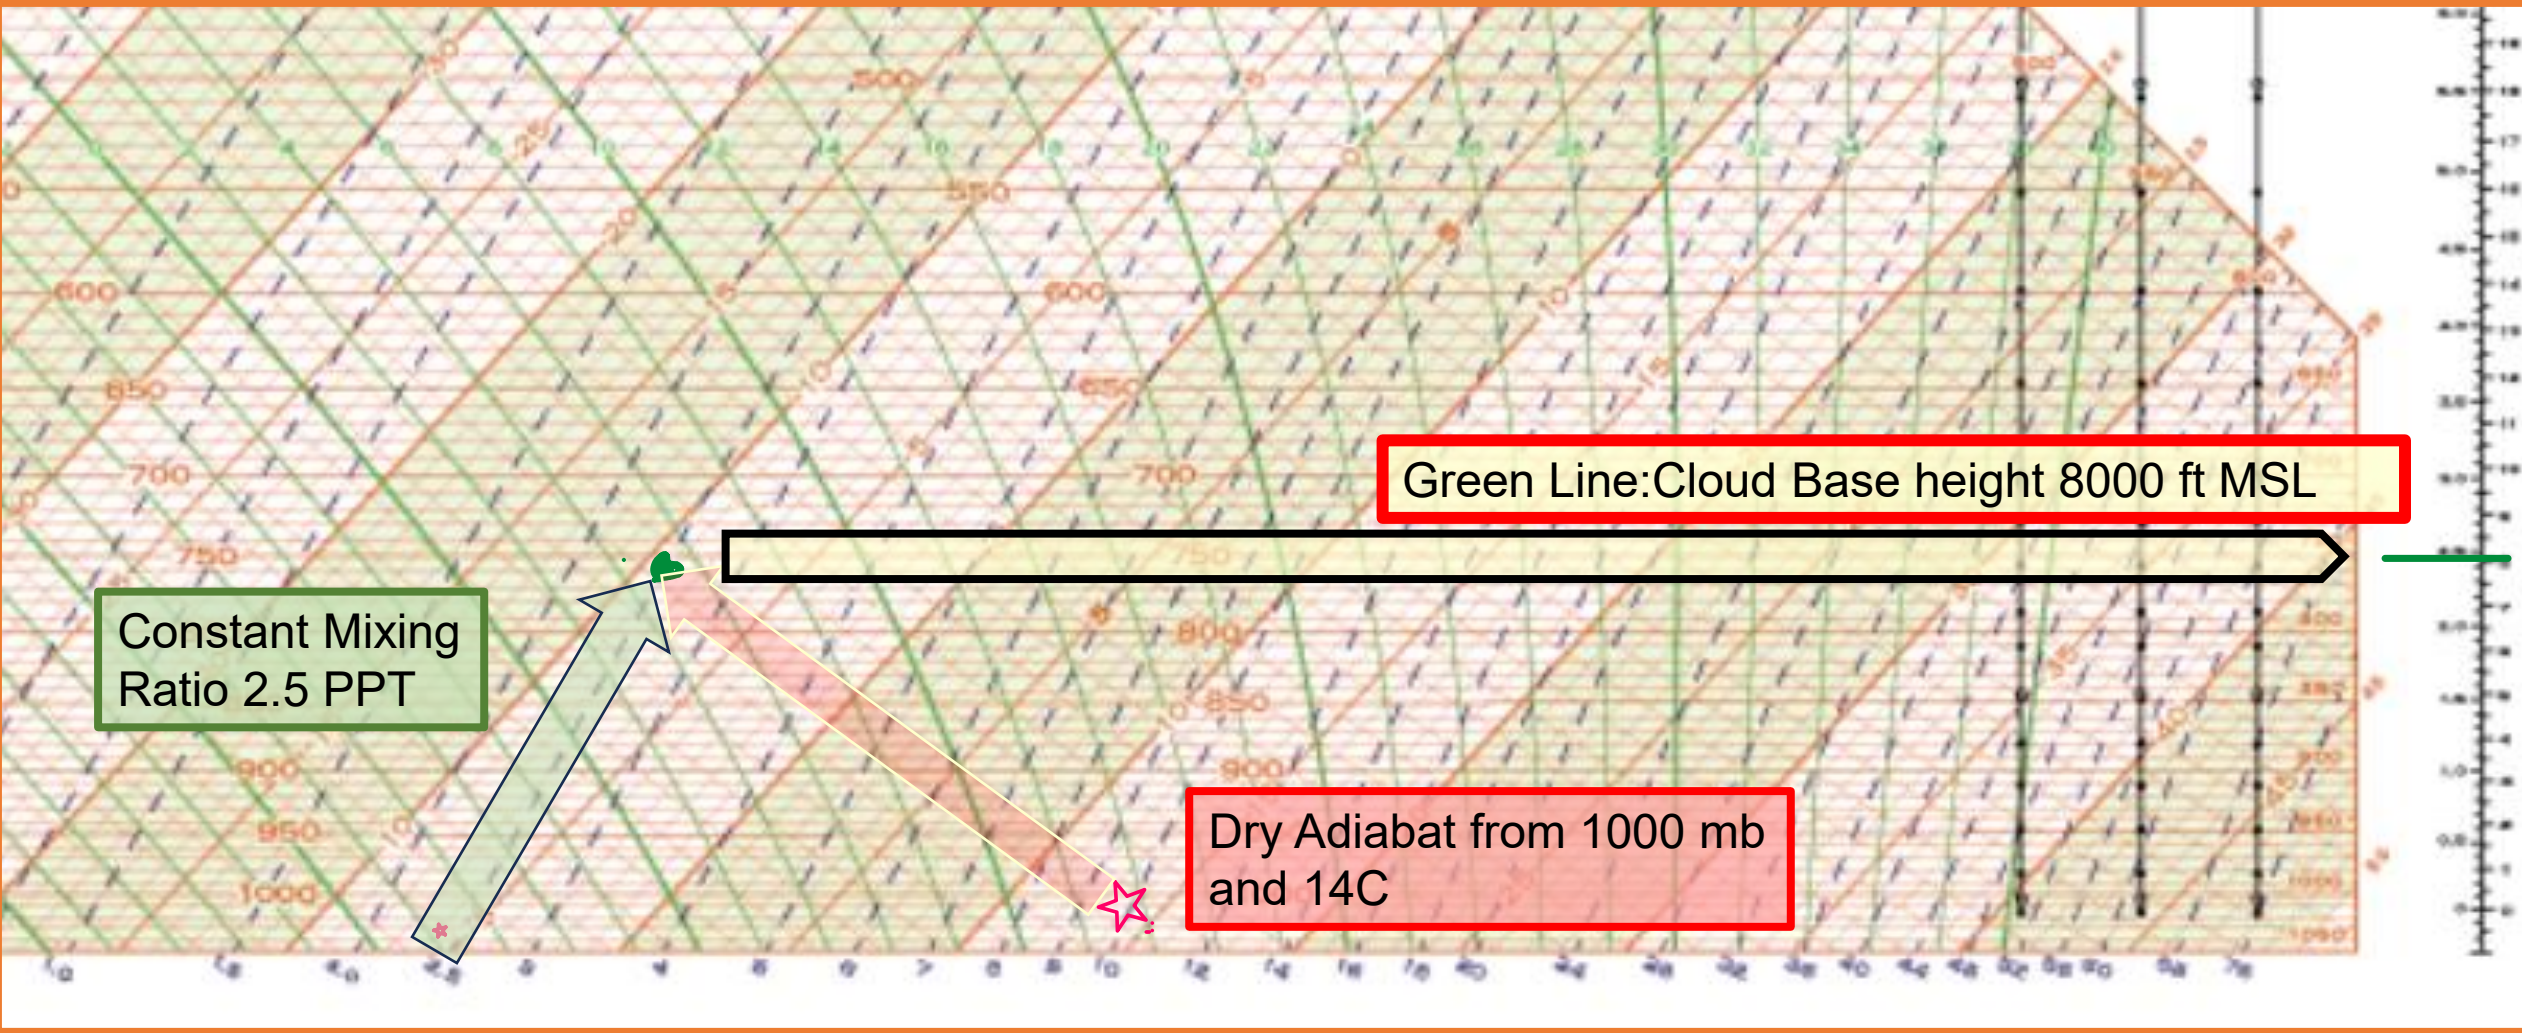
Lifting Condensation Level on Skew-T Log P diagram

Using Temperature 14C, Dewpoint -6C, I get base of cumulus 8000 ft MSL, METAR report was 7500 BKN.

Green Line: Cloud Base height 8000 ft MSL

Note the 1751Z observation reported the low clouds **BROKEN**; I think they were **scattered**, not broken.

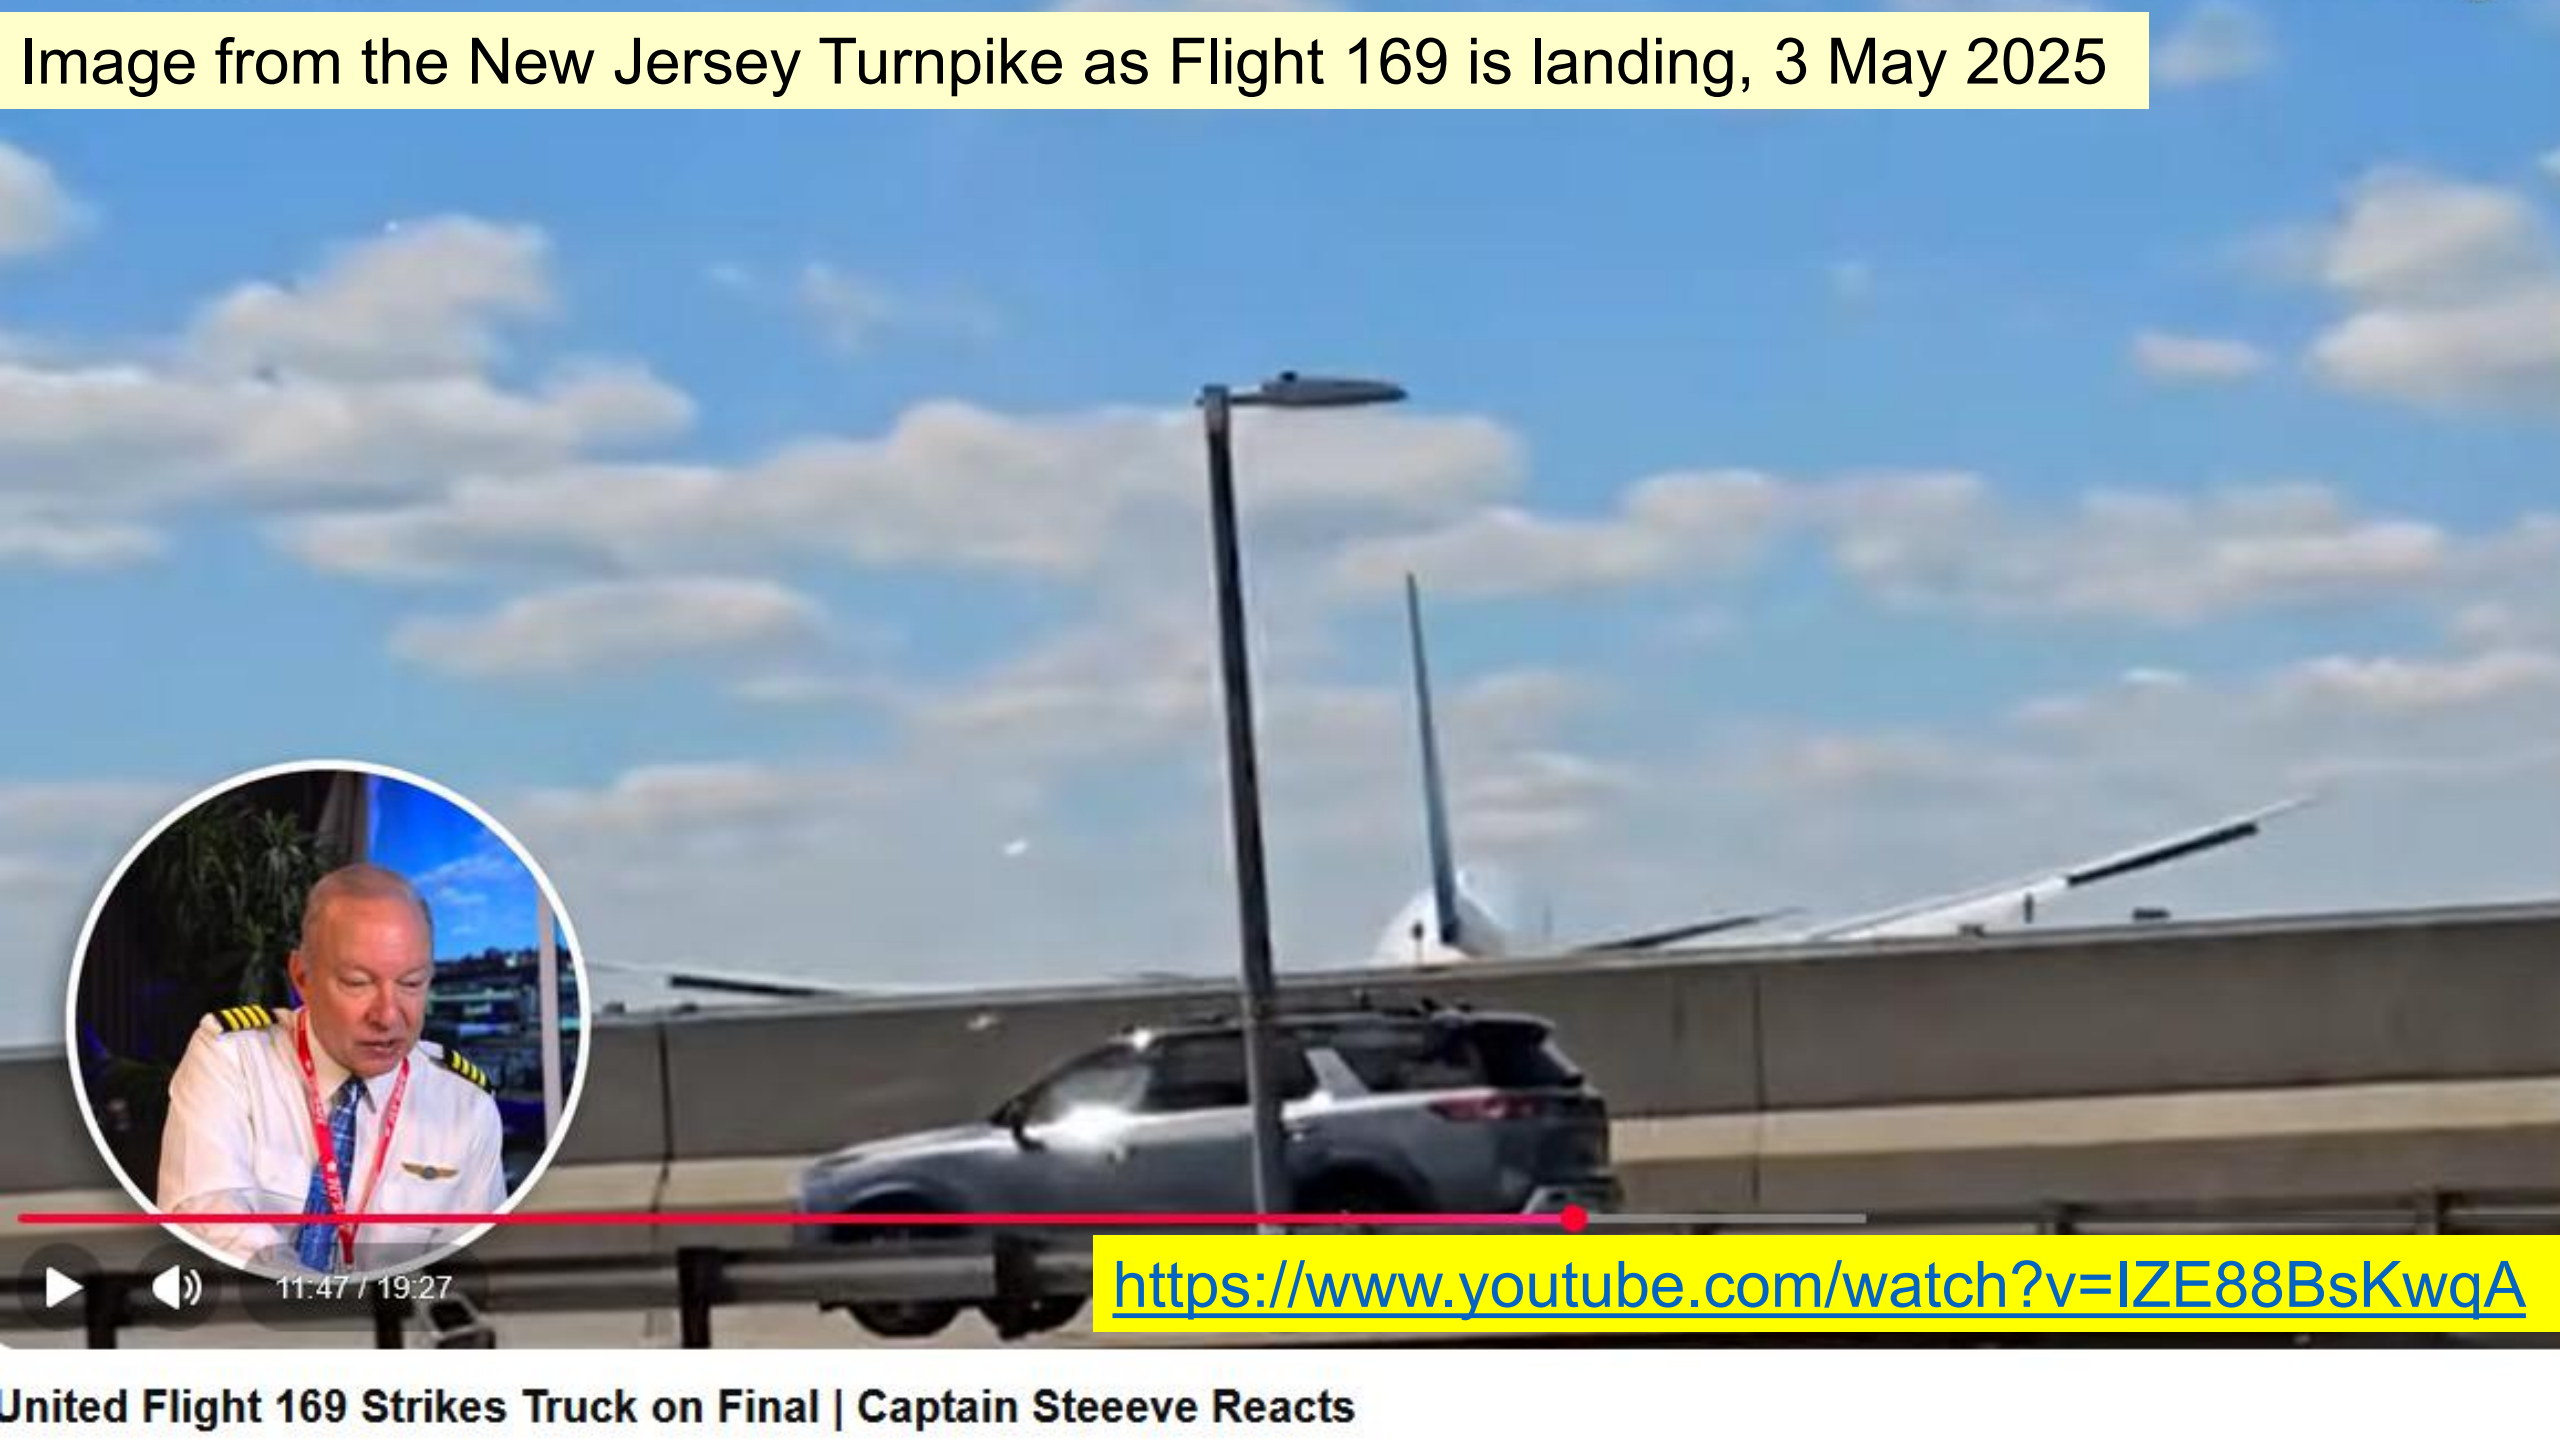
Image from the New Jersey Turnpike as Flight 169 is landing, 3 May 2025

Notice at least three things in this image, to the west, over solid land at, and west of, Newark Liberty International Airport as Flight 169 landed. **ONE**: Cloud bases of the darker-bottom cumulus clouds are flat-bottomed, indicates much stronger lift and sink (Yellow Arrows). **TWO**: These clouds are scattered, not broken. **THREE**: Indications of a “Blue Hole” (Orange Arrows) over land, near the airport.

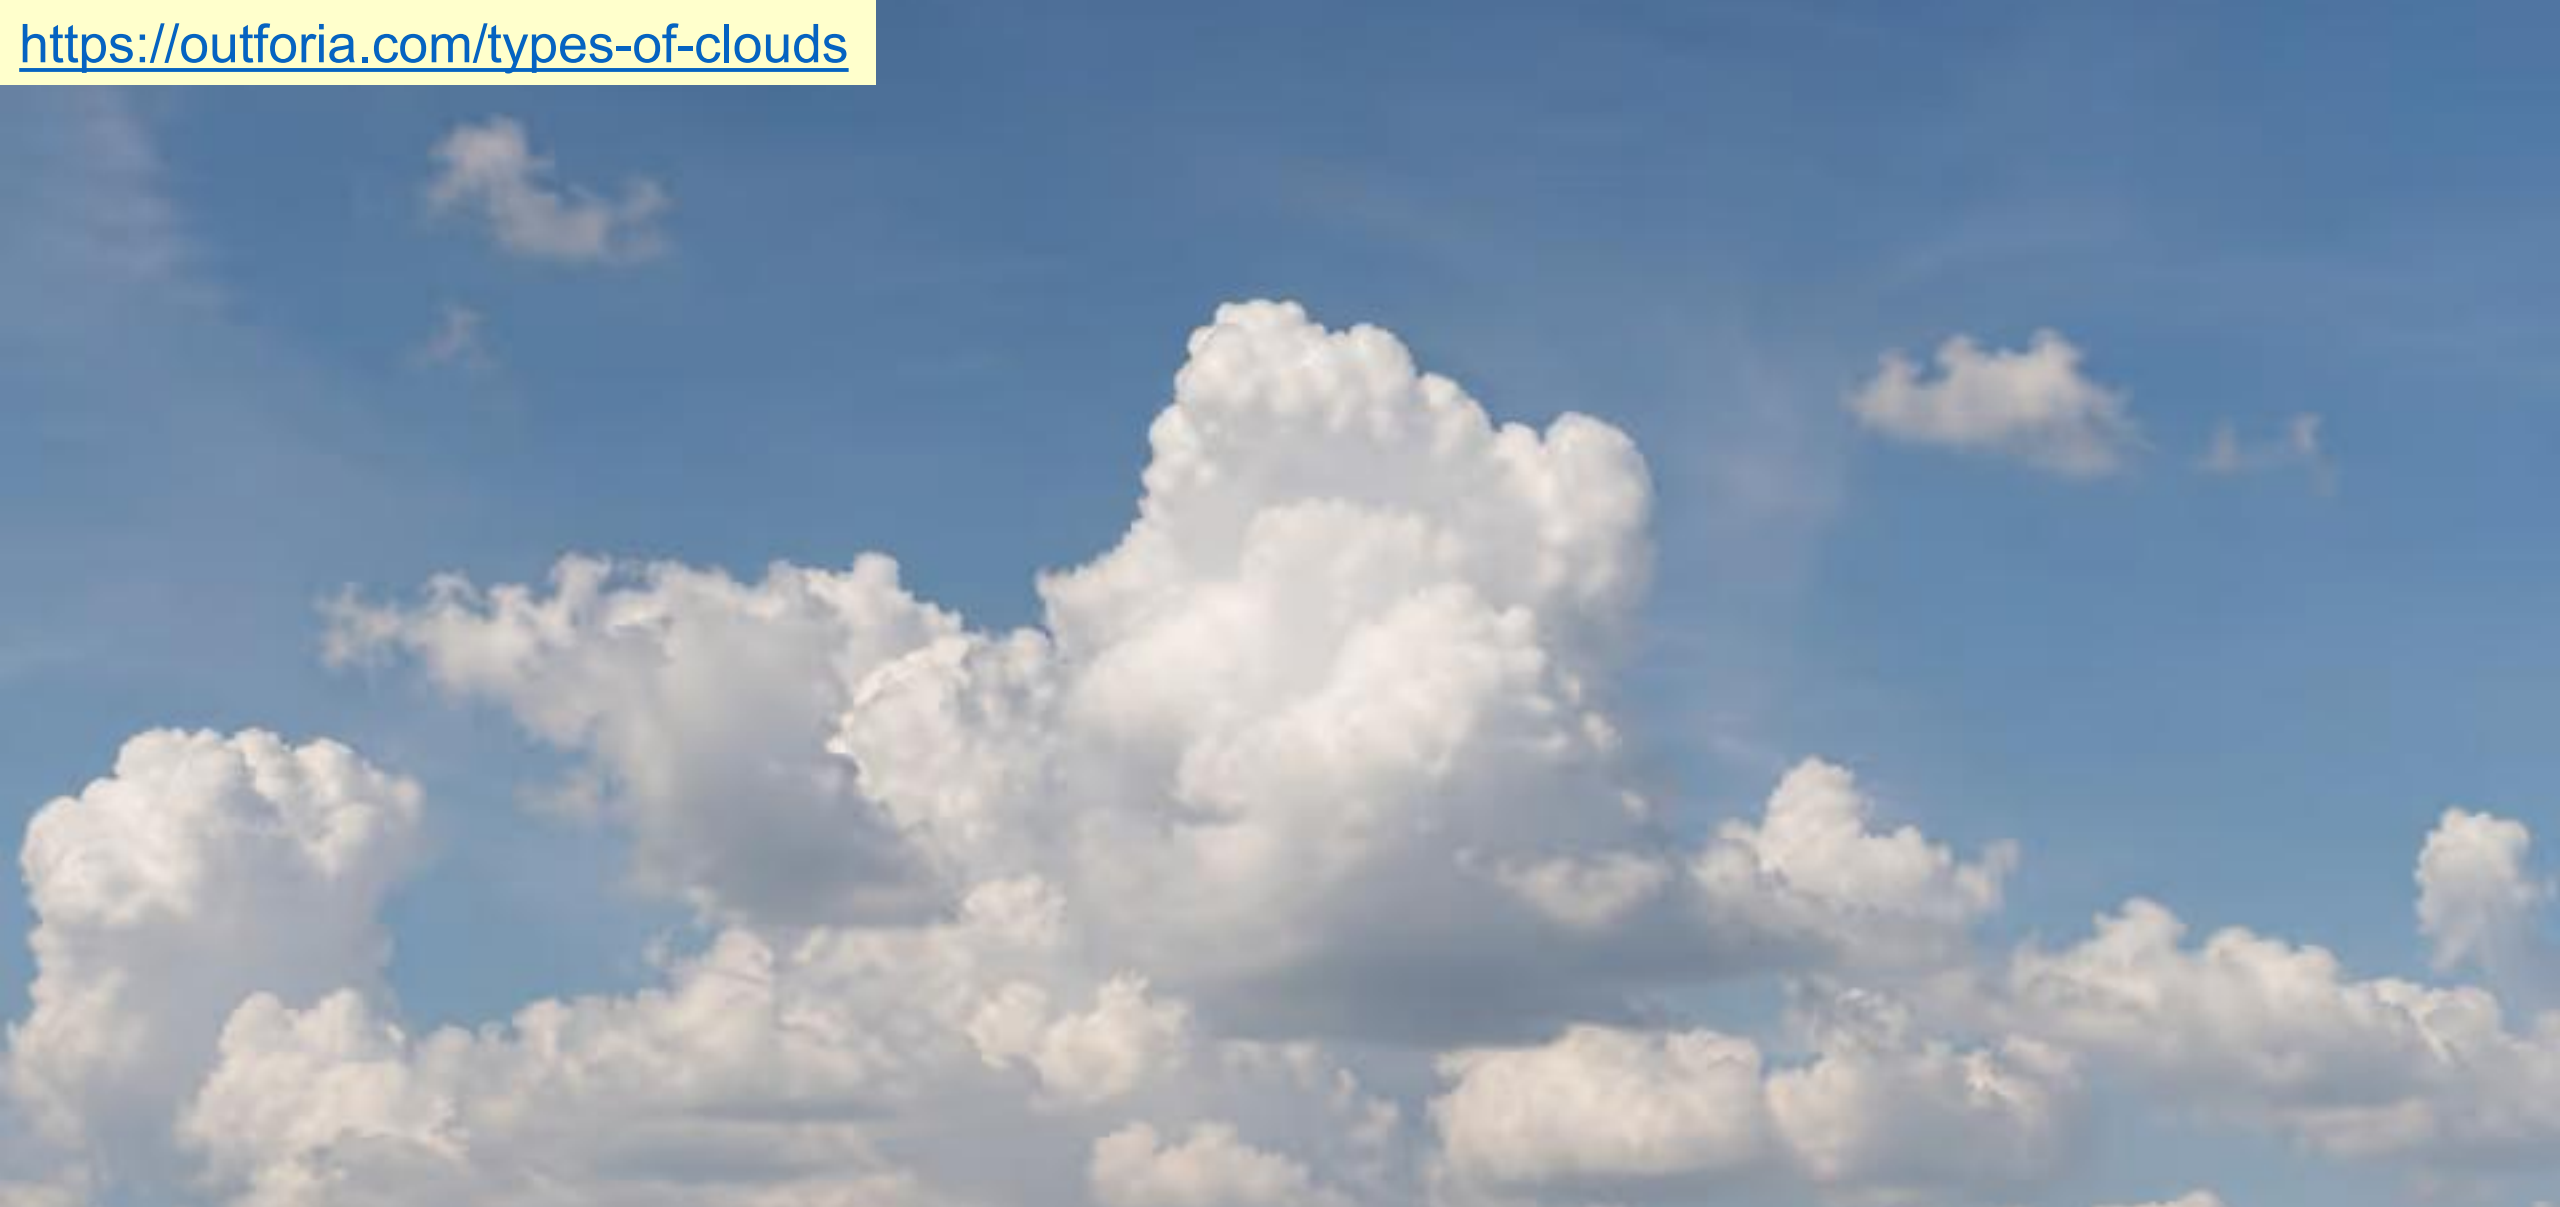
Here is a planetary boundary layer with what appears to be a good field of fair-weather cumulus clouds, usually a good day for soaring. Many of the flat-bottomed clouds have good lift. *Fractus* clouds, no lift at all. Blue Sky means sink!

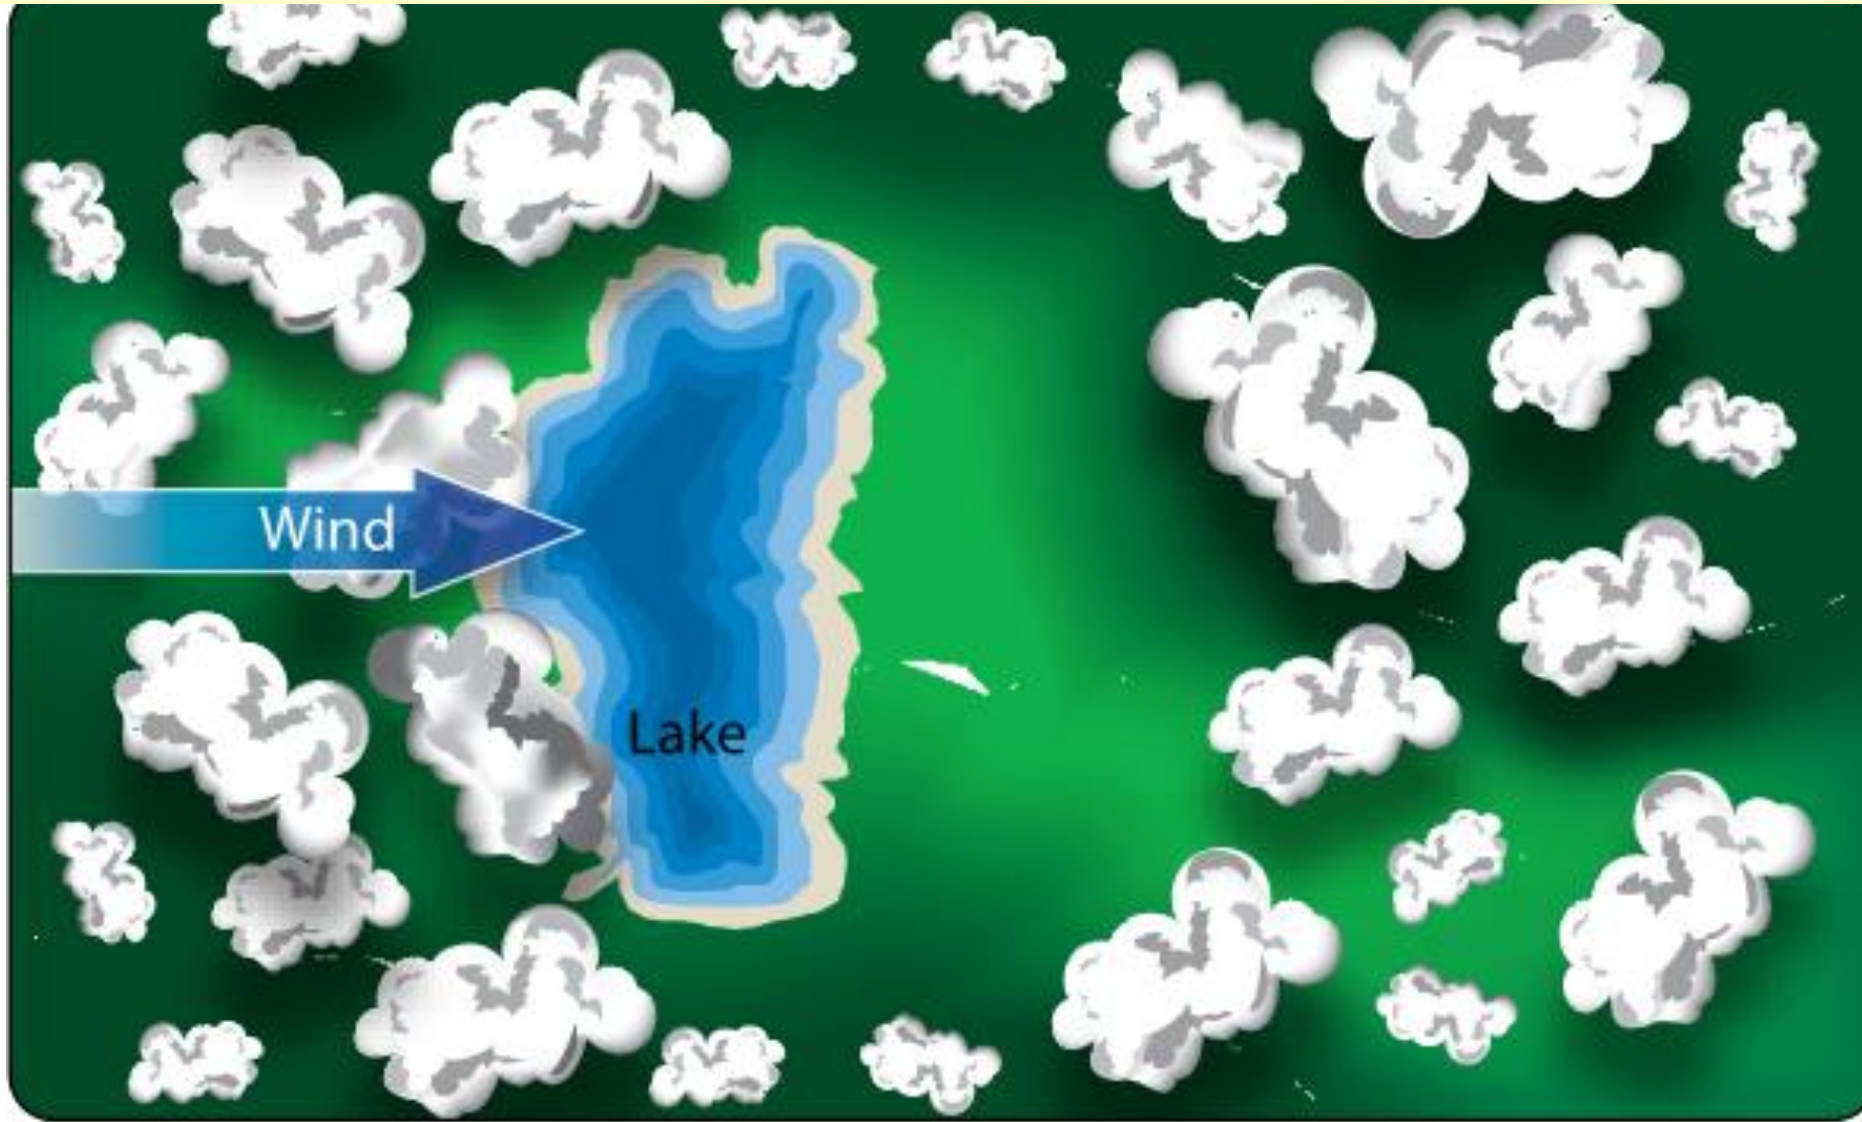
Figure 10-6. *Blue hole in a field of cumulus downwind of a lake.*
