A Likely Weather Factor in the United Flight 169 Accident, Newark Liberty International Airport, 3 May 2026

Cruces Atmospheric Sciences Forum
16 May 2026

Bottom Line Up Front:

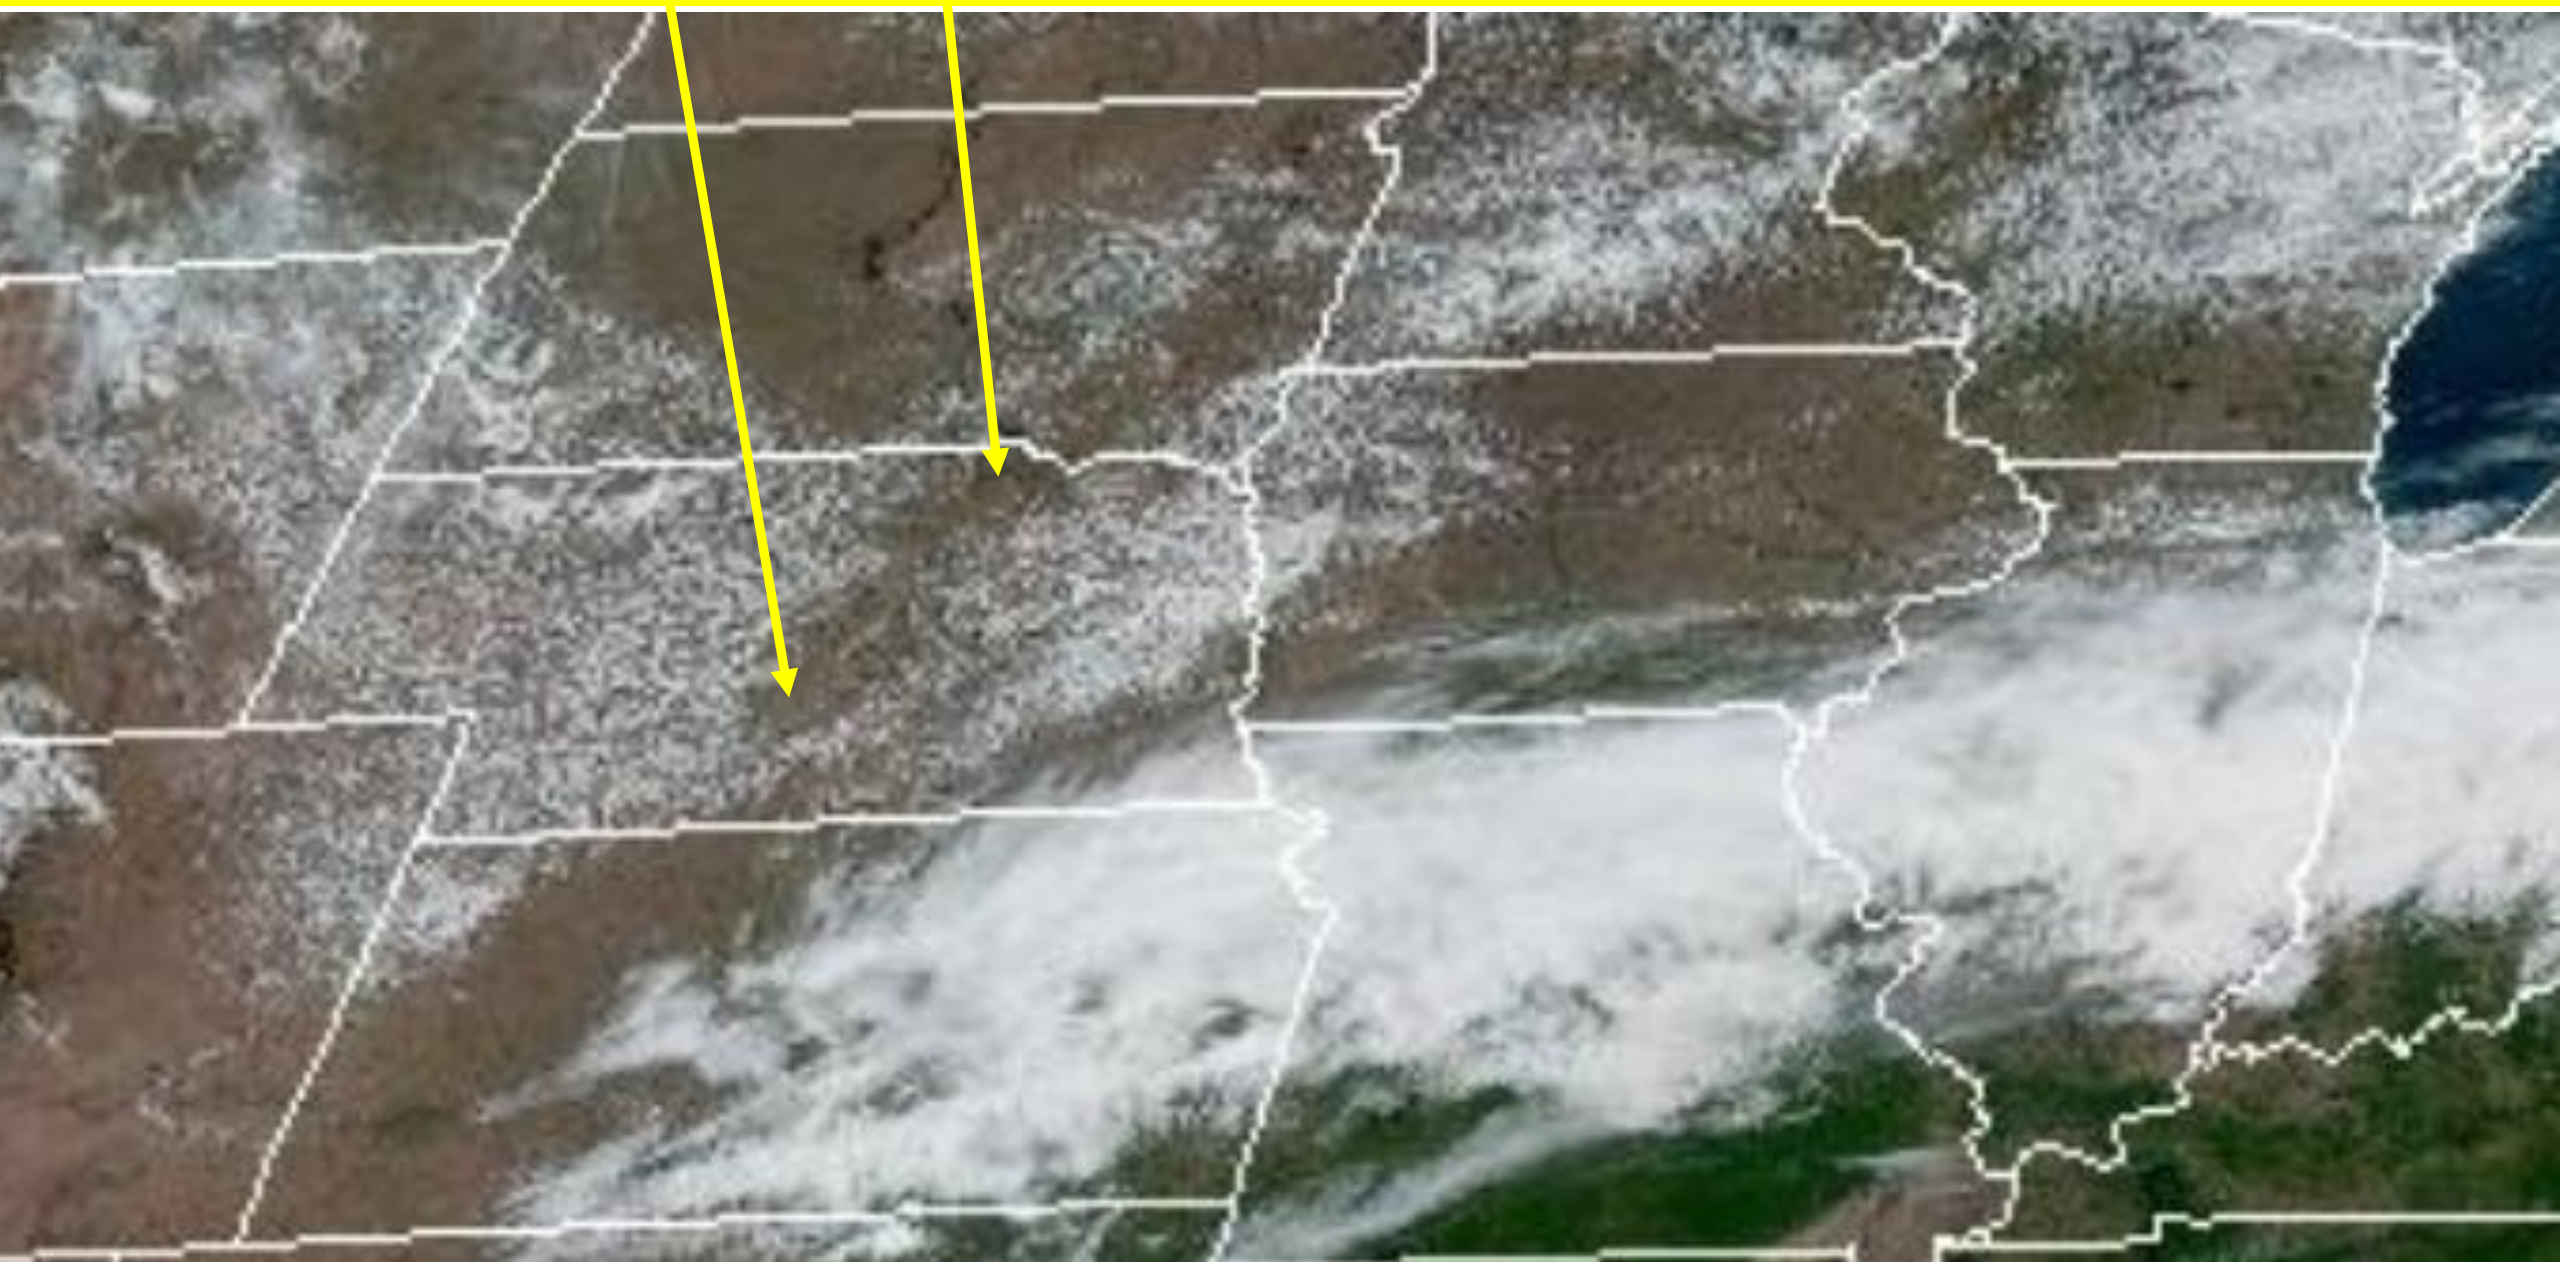
Example of "Blue Holes" developing in central Nebraska on 8 May 2026 at 1910Z, seen on GOES-19

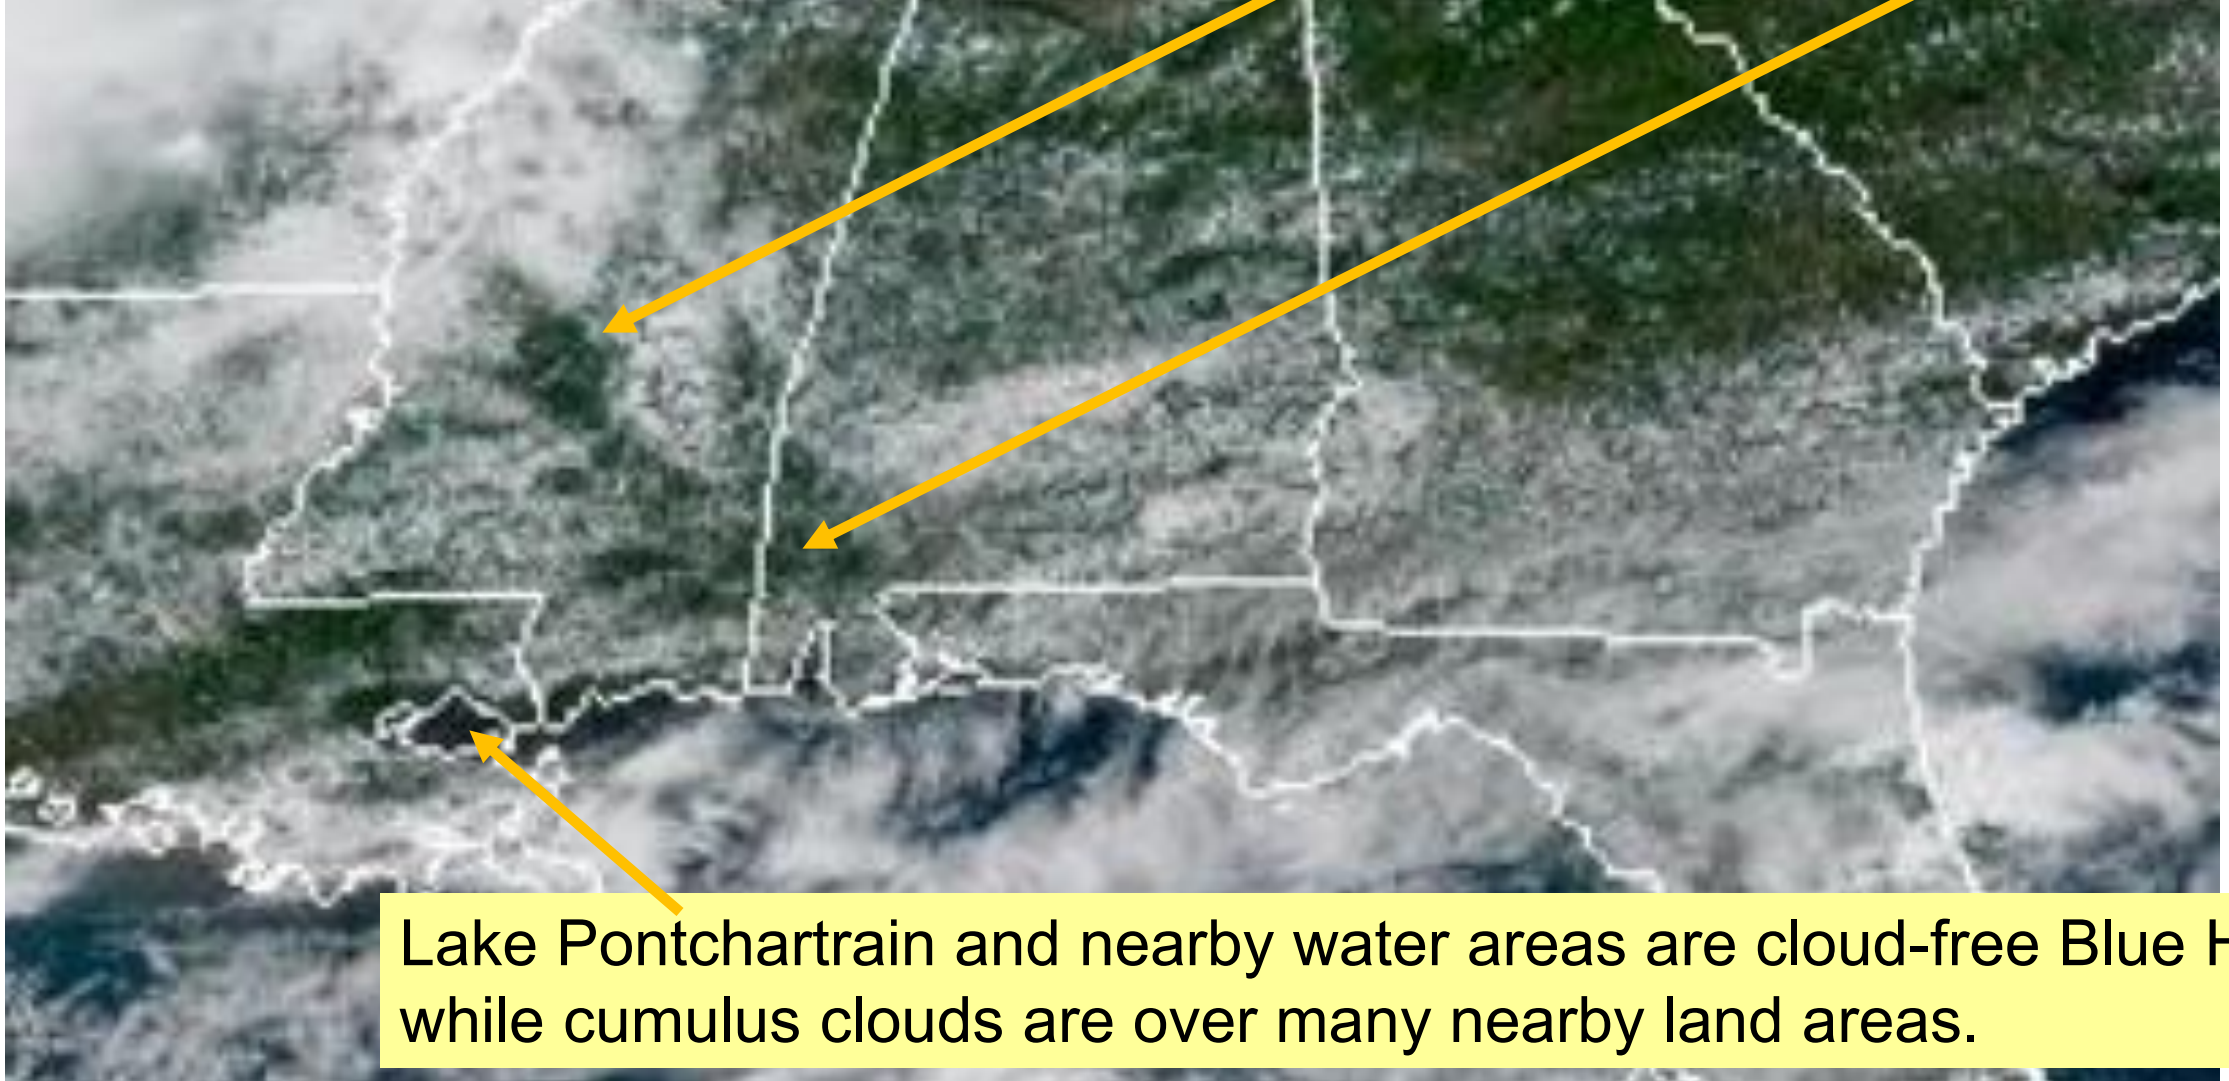
Example of Blue Holes developing in south-Central Mississippi and parts of Alabama on the afternoon of 10 May 2026.

Lake Pontchartrain and nearby water areas are cloud-free Blue Holes while cumulus clouds are over many nearby land areas.

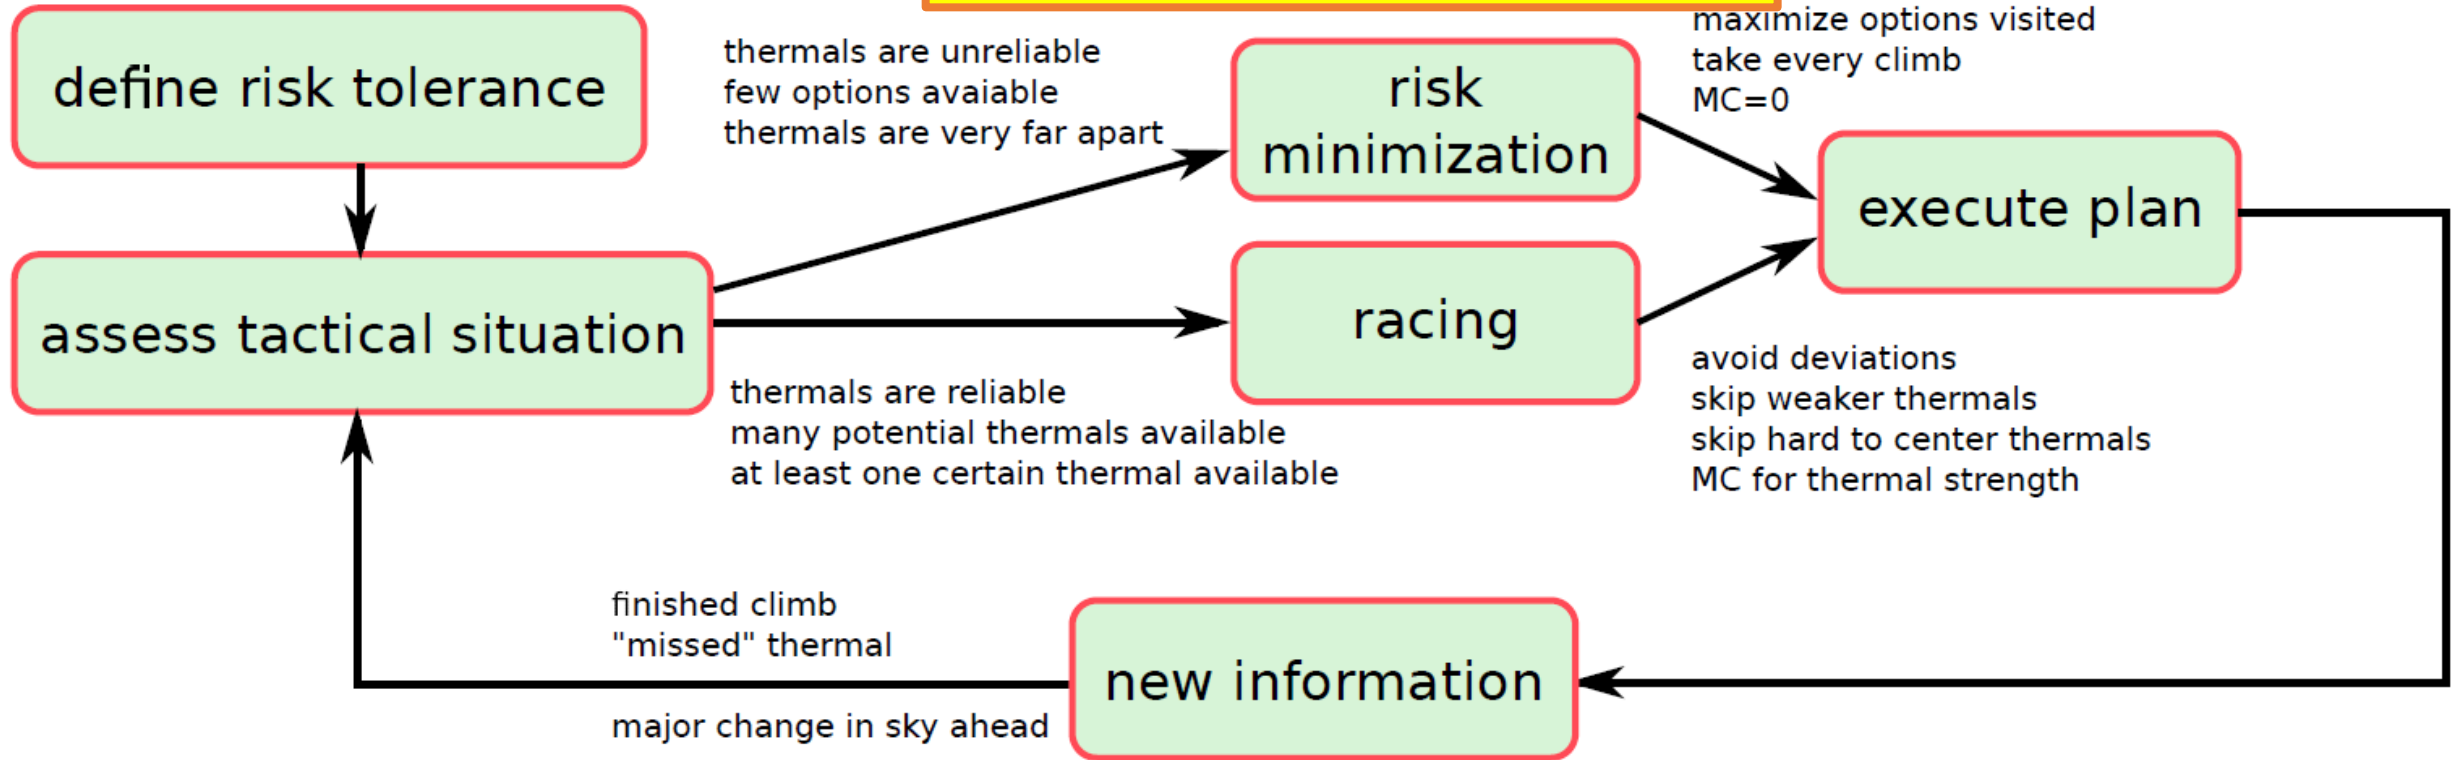
Fig. 8: Flowchart describing the decision-making process for risk-aware thermal soaring. Gear-shifting occurs when the pilot receives new information which reveals a change in the risk situation and reevaluates the decision-making frame. This could happen for example when missing an expected climb or when reaching a “blue hole” with few clouds.

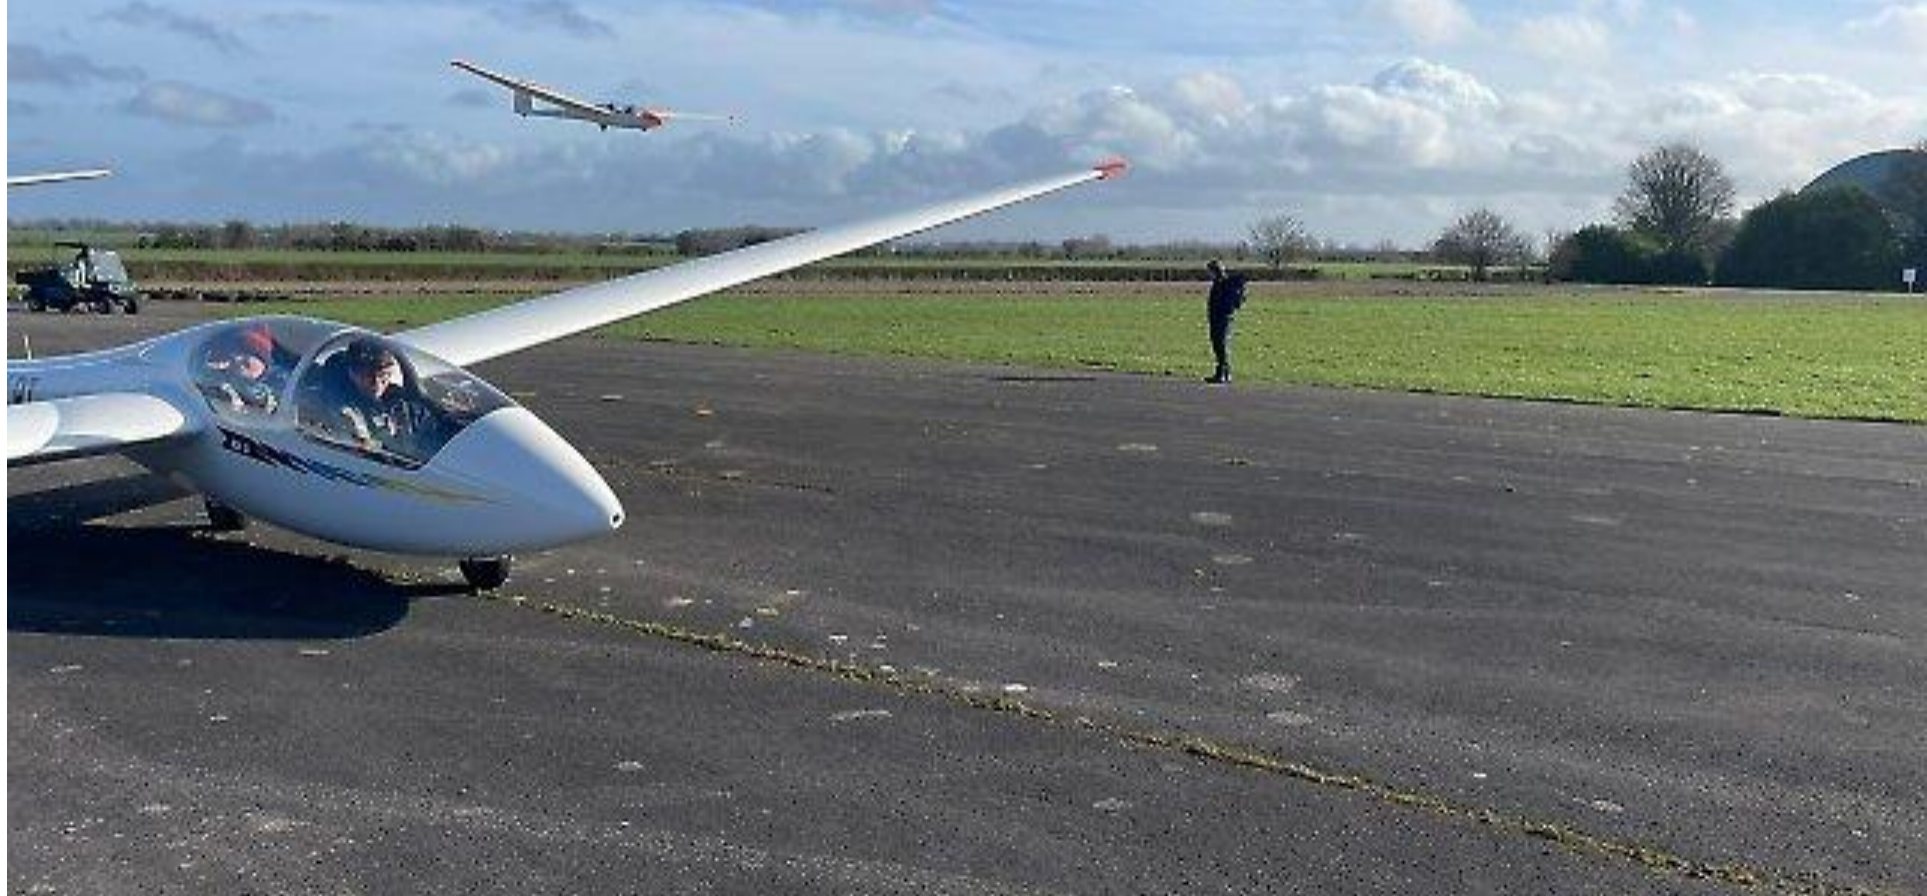
This might be a Blue Hole, as depicted in this image from the Brits from the Cotswolds Gliding Club
